REPORT NO : DT-160613-2

SPECIMEN : BOXER-6421

TEST / INSPECTION ITEMS : Drop Test

TESTING / INSPECTION REPORT

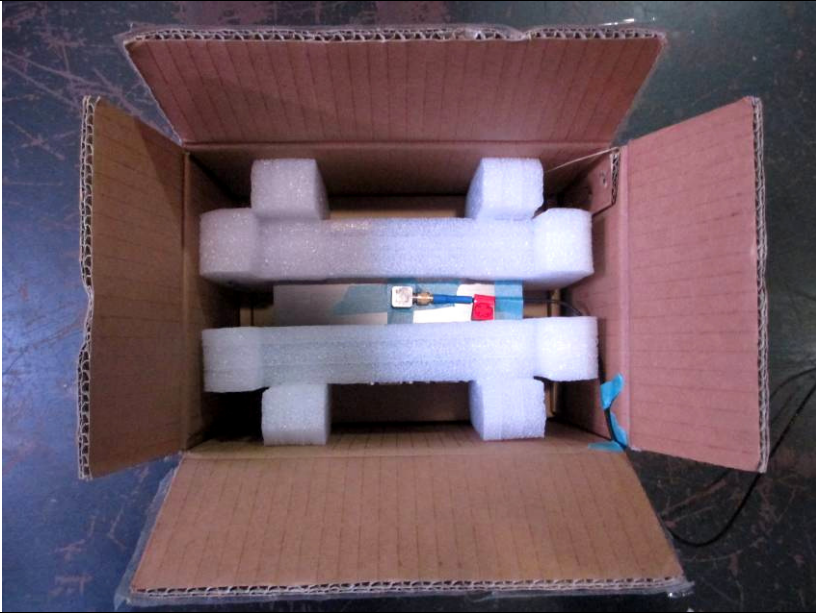
(1)--After the test, booting function was normal.
(2)--No visible damages were found.

Testing photos – Test results	
Normal

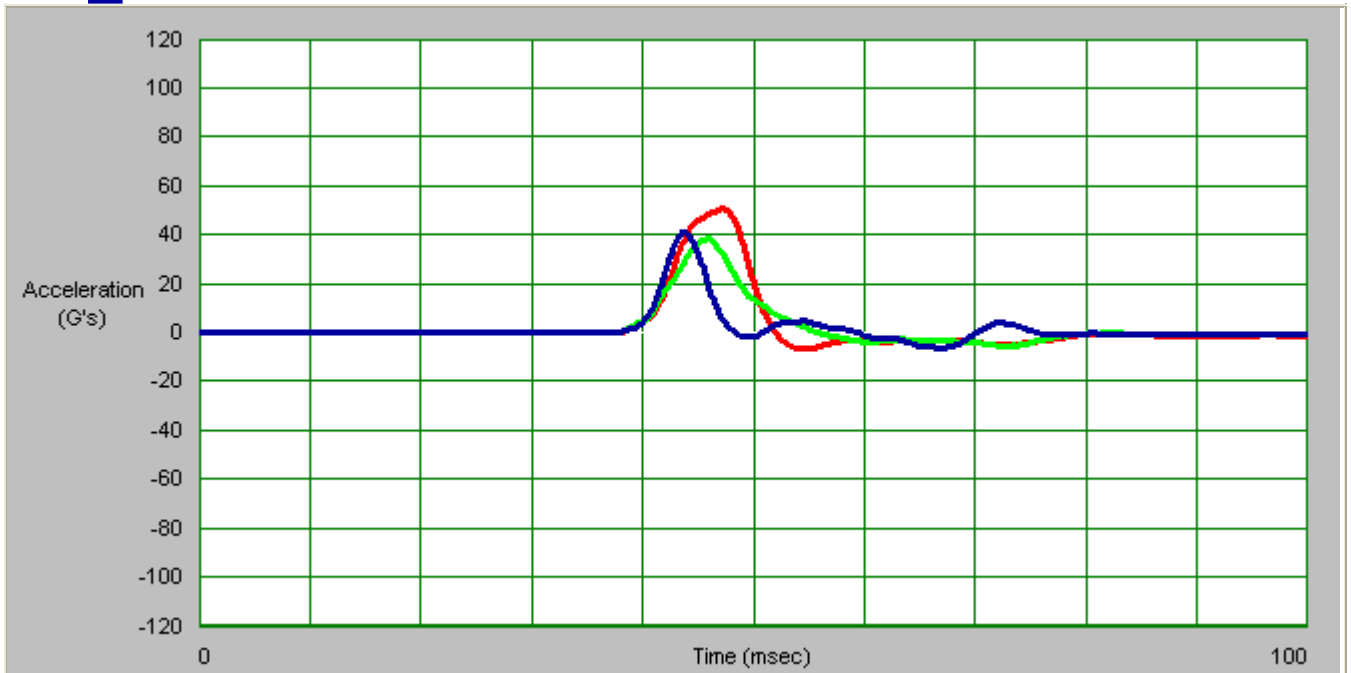
Corner

Channel Description:	G's	msec	In/S	Filter Hz	Max G's	Min G's
Ch1	X axis	50.40	11.00	138.08	220.00	50.40	-6.81
Ch2	Y axis	38.33	13.90	107.80	220.00	38.33	-5.66
Ch3	Z axis	41.10	7.60	68.54	220.00	41.10	-6.53

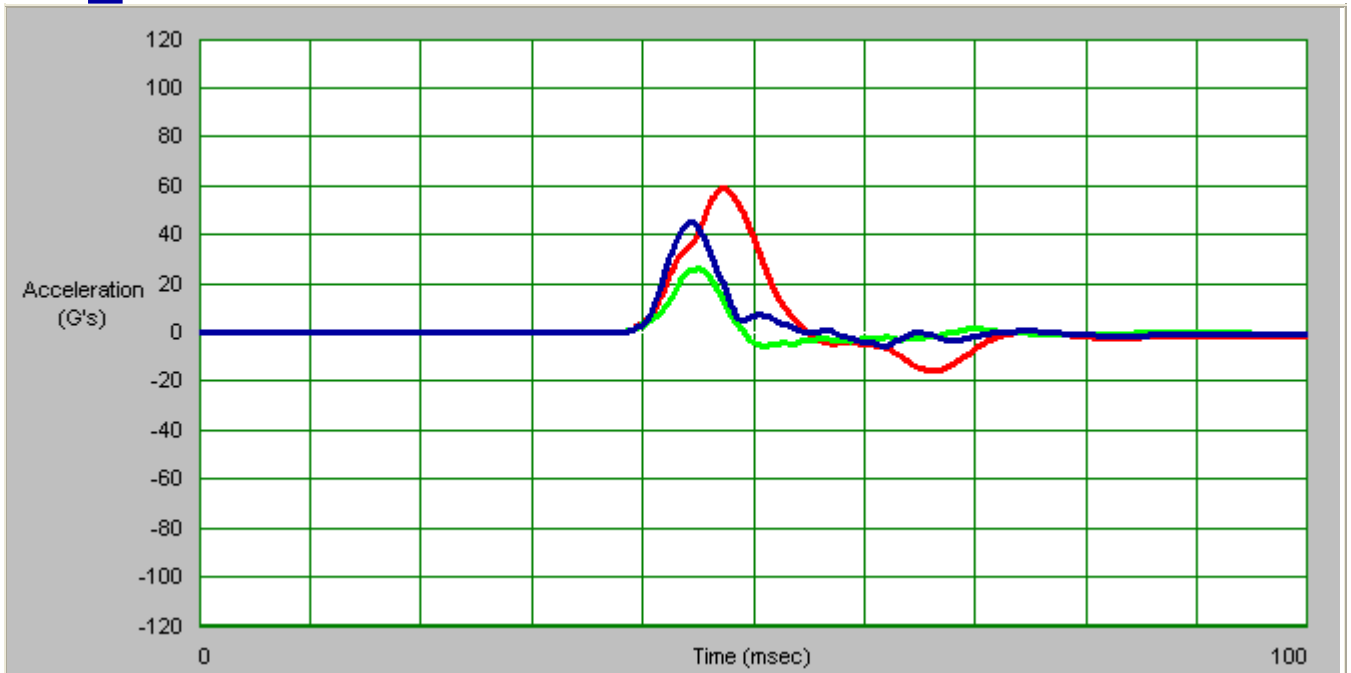
Edge-1

Channel Description:	G's	msec	In/S	Filter Hz	Max G's	Min G's
Ch1	X axis	58.79	13.30	172.45	220.00	58.79	-15.65
Ch2	Y axis	25.97	9.00	51.64	220.00	25.97	-5.40
Ch3	Z axis	45.09	11.80	99.35	220.00	45.09	-5.86

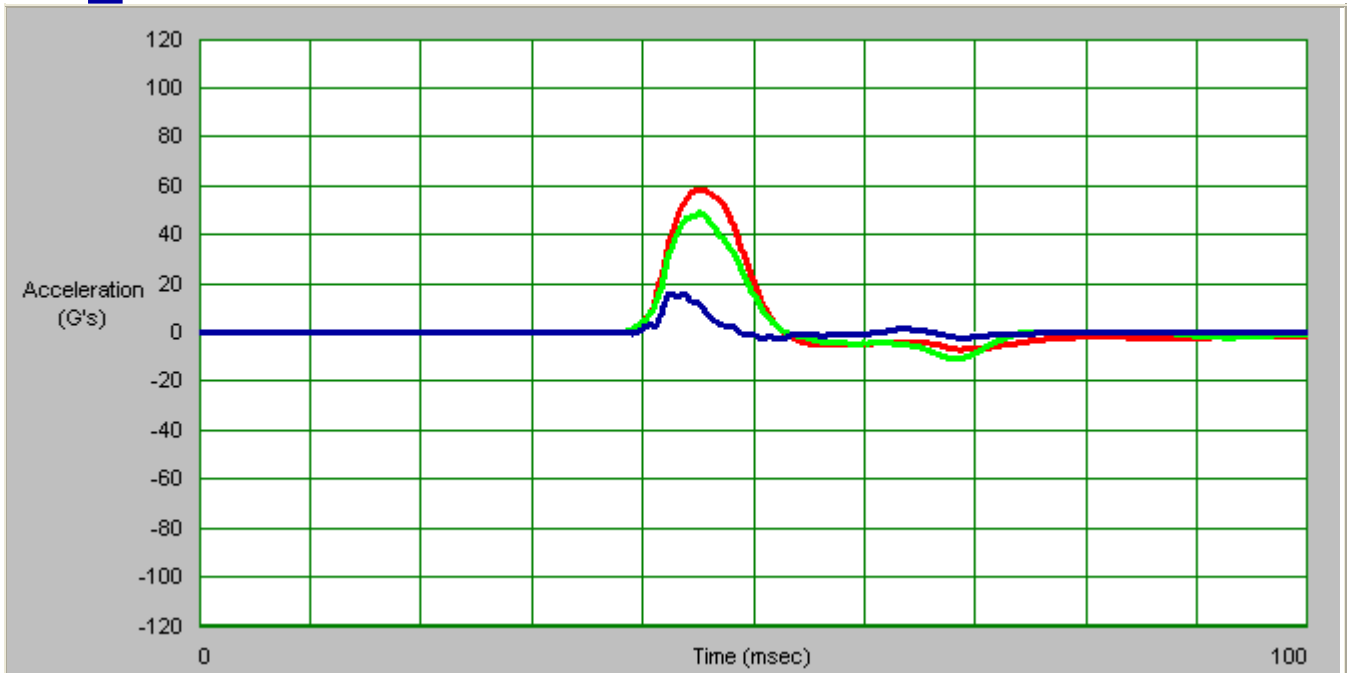
Edge-2

Channel Description:	G's	msec	In/S	Filter Hz	Max G's	Min G's
Ch1	X axis	58.36	11.40	165.33	220.00	58.36	-7.09
Ch2	Y axis	48.77	11.50	133.87	220.00	48.77	-11.00
Ch3	Z axis	15.95	8.50	27.37	220.00	15.95	-2.64

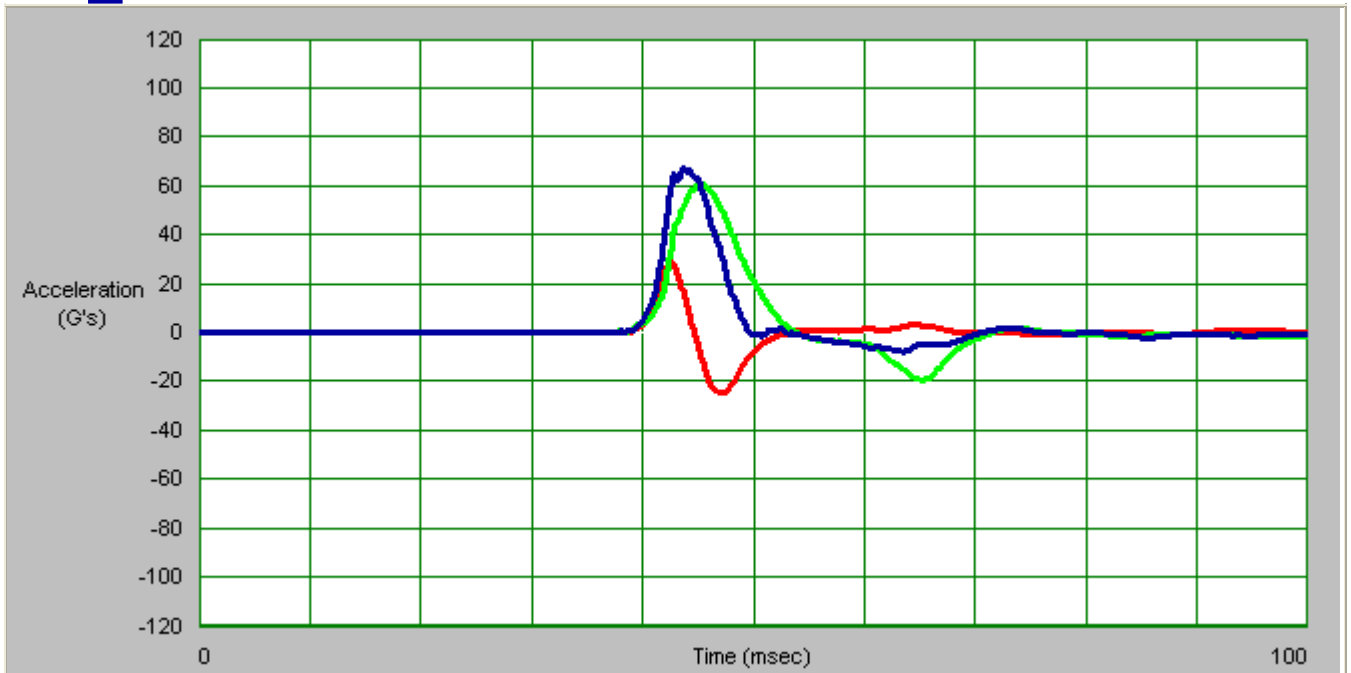
Edge-3

Channel Description:	G's	msec	In/S	Filter Hz	Max G's	Min G's
Ch1	X axis	28.91	4.60	29.05	220.00	28.91	-24.74
Ch2	Y axis	60.74	11.60	160.98	220.00	60.74	-19.62
Ch3	Z axis	67.37	8.80	137.88	220.00	67.37	-7.89

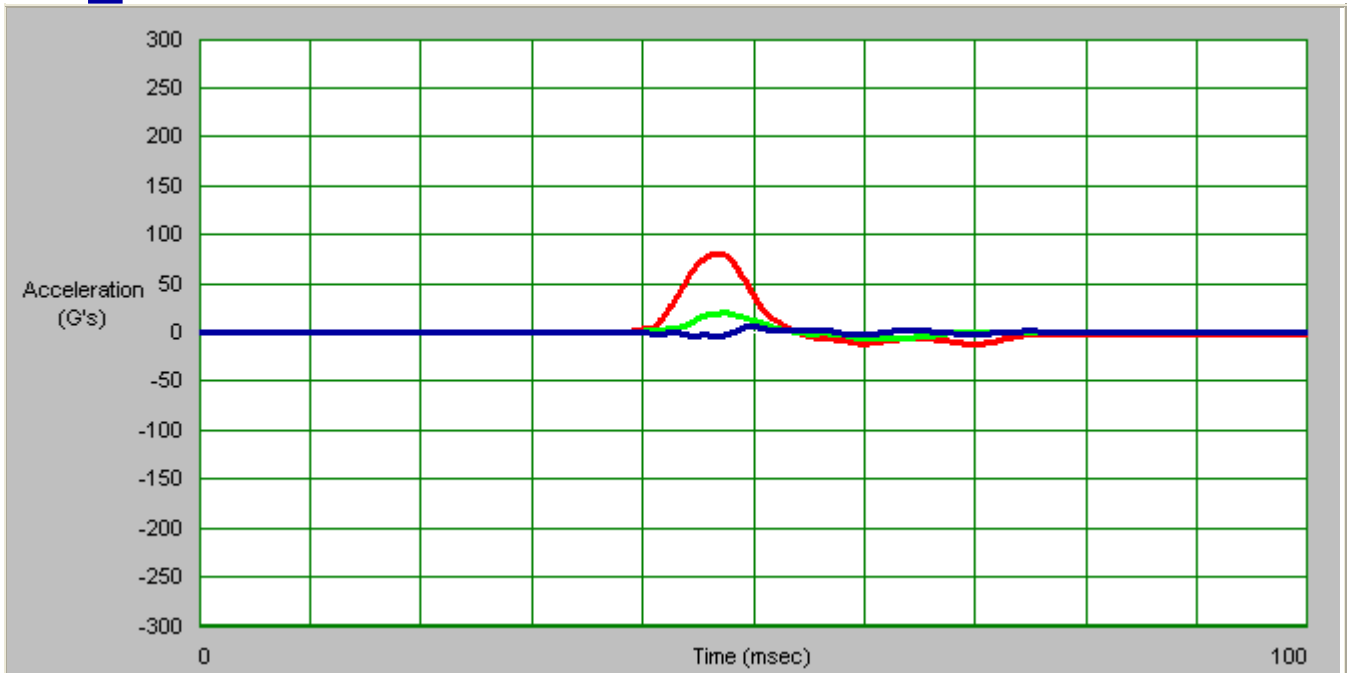
Face-1

Channel Description:	G's	msec	In/S	Filter Hz	Max G's	Min G's
Ch1	X axis	80.85	11.40	212.79	220.00	80.85	-12.07
Ch2	Y axis	19.65	11.70	49.62	220.00	19.65	-6.58
Ch3	Z axis	5.62	9.10	8.53	220.00	5.62	-4.31

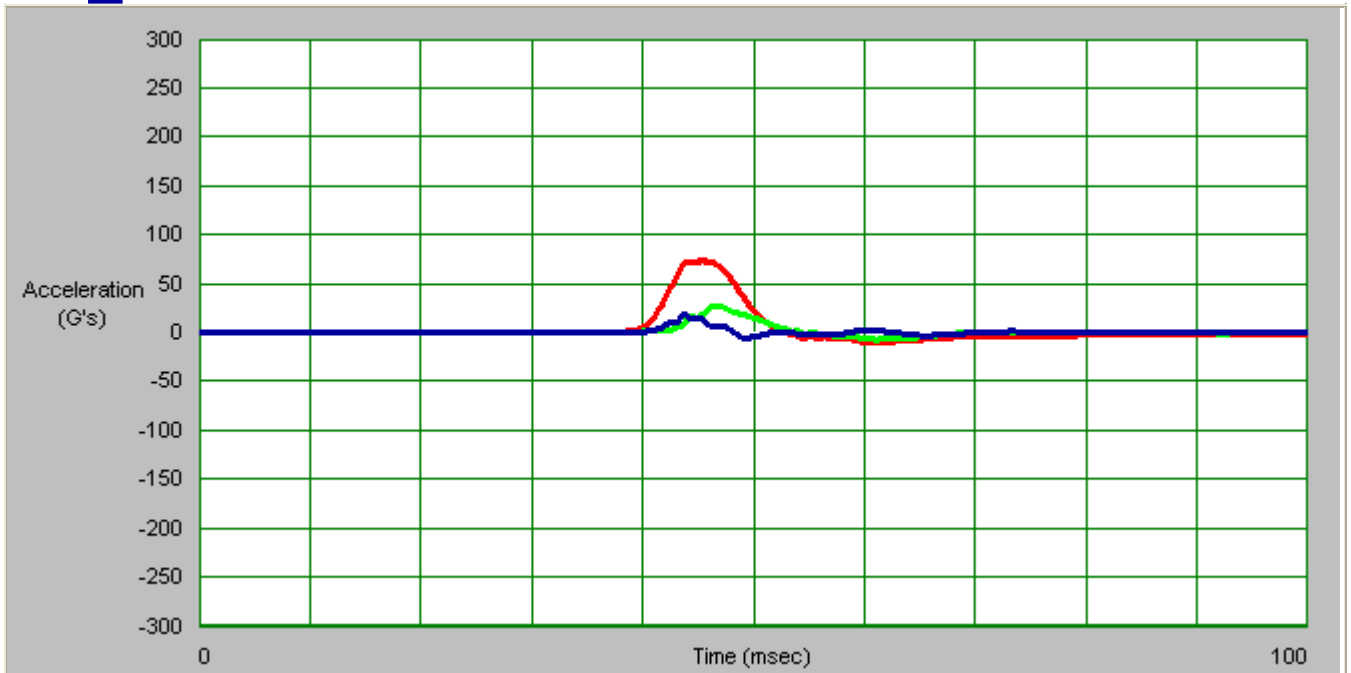
Face-2

Channel Description:	G's	msec	In/S	Filter Hz	Max G's	Min G's
Ch1	X axis	73.49	11.30	202.89	220.00	73.49	-10.71
Ch2	Y axis	26.48	10.70	62.50	220.00	26.48	-7.24
Ch3	Z axis	18.22	7.30	25.90	220.00	18.22	-6.16

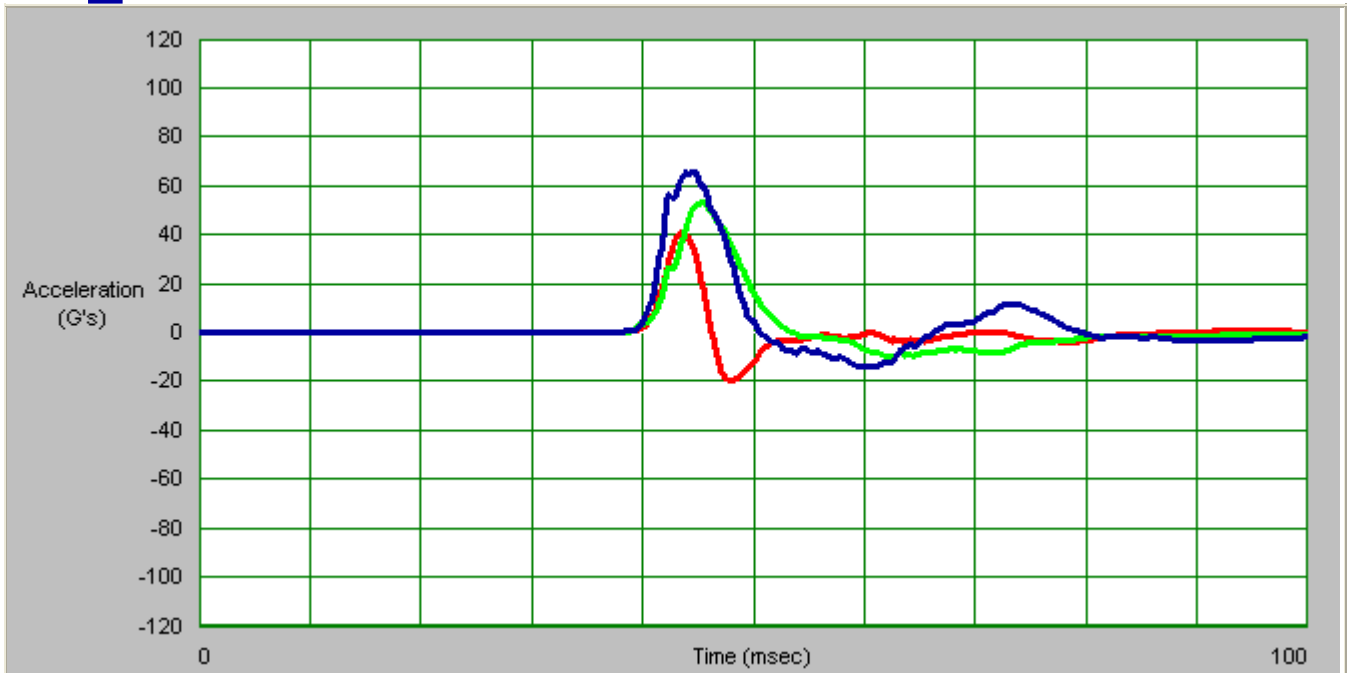
Face-3

Channel Description:	G's	msec	In/S	Filter Hz	Max G's	Min G's
Ch1	X axis	41.00	5.70	55.42	220.00	41.00	-19.78
Ch2	Y axis	52.97	11.30	133.28	220.00	52.97	-10.57
Ch3	Z axis	65.80	9.40	152.68	220.00	65.80	-14.29

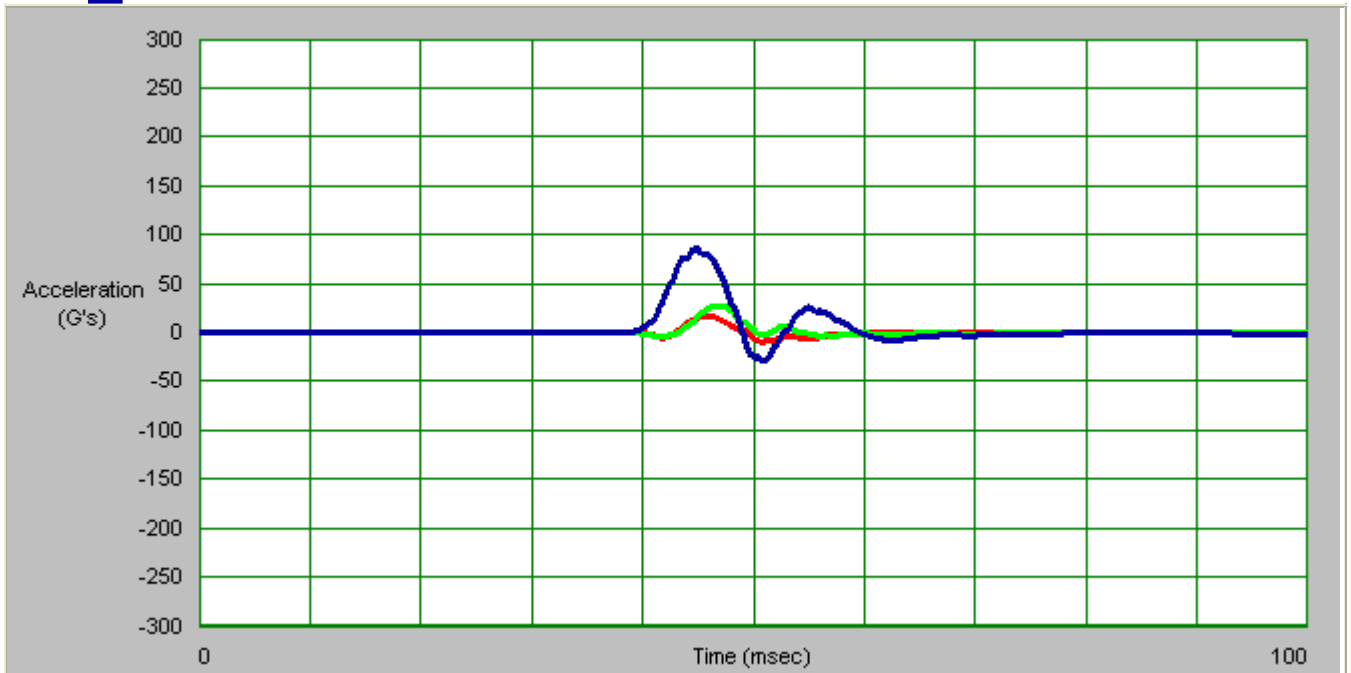
Face-4

Channel Description:	G's	msec	In/S	Filter Hz	Max G's	Min G's
Ch1	X axis	17.39	5.70	23.94	220.00	17.39	-9.60
Ch2	Y axis	27.09	6.50	42.44	220.00	27.09	-4.36
Ch3	Z axis	86.19	8.30	174.82	220.00	86.19	-29.24

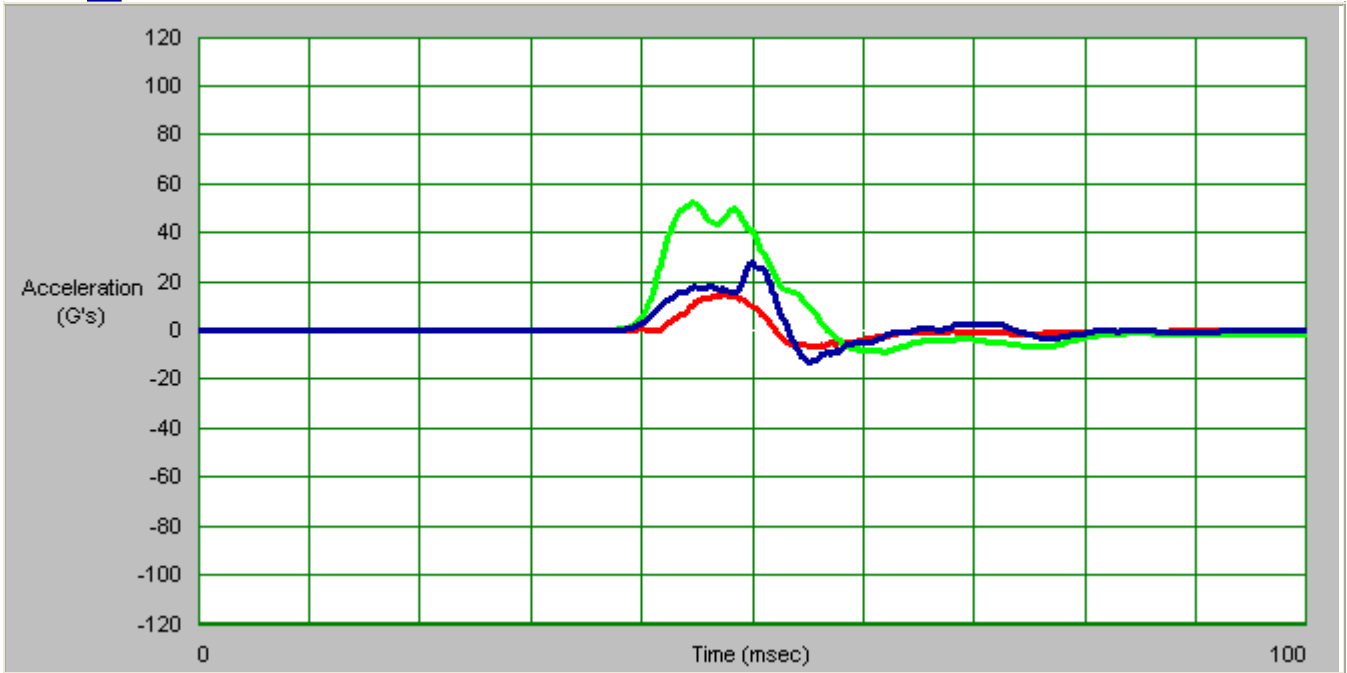
Face-5

Channel Description:	G's	msec	In/S	Filter Hz	Max G's	Min G's
Ch1	X axis	14.59	10.00	37.33	220.00	14.59	-6.88
Ch2	Y axis	52.11	16.10	203.44	220.00	52.11	-8.91
Ch3	Z axis	27.47	13.10	79.28	220.00	27.47	-12.86

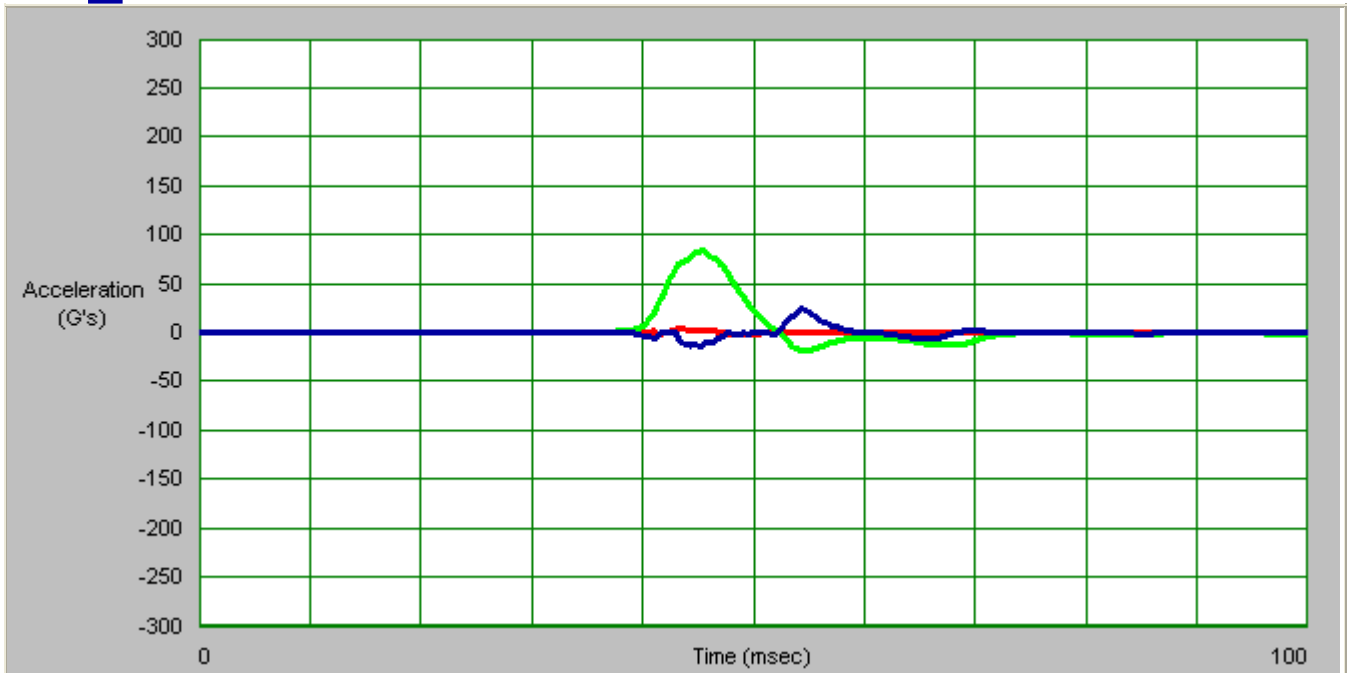
Face-6

Channel Description:	G's	msec	In/S	Filter Hz	Max G's	Min G's
Ch1	X axis	4.11	4.50	3.53	220.00	4.11	-2.24
Ch2	Y axis	83.31	11.10	221.86	220.00	83.31	-18.33
Ch3	Z axis	23.66	5.90	29.53	220.00	23.66	-14.62
