GENE-CV05

PCB Rev. A0.2

Temperature/Humidity Test Report

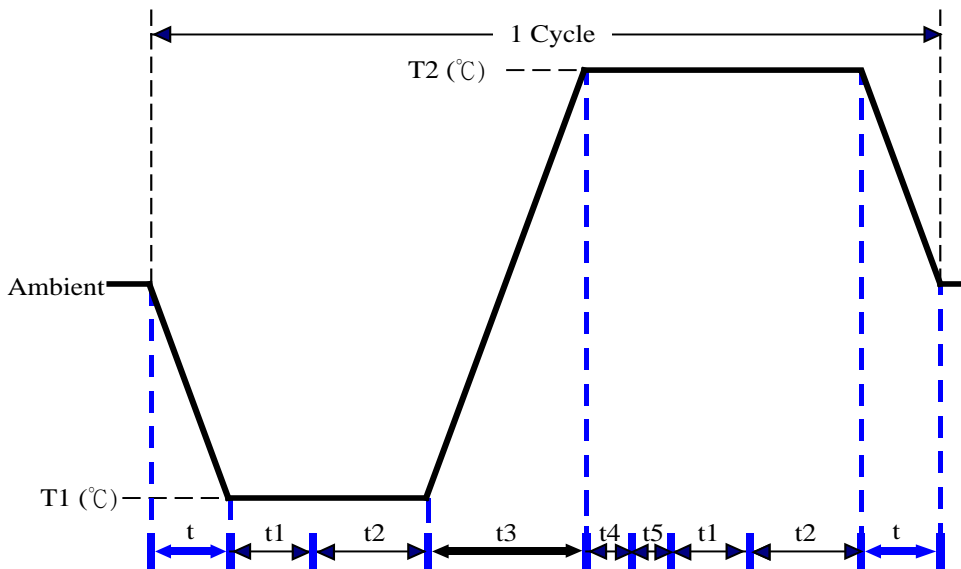
During high and low temperature, problems were encountered with the COM ports. Adjust the COM ports speed down to 9600bps in Configuration of BurnInTest V6.0 which were passed with no problem occurred. (Conditional Passed)
