Report No. : DH1509080007A Version : B

## TEMPORARY IMMERSION AND DUST TEST REPORT

Company : <u>AAEON Technology Inc.</u>

Model Name : AIOT-QM SERIES

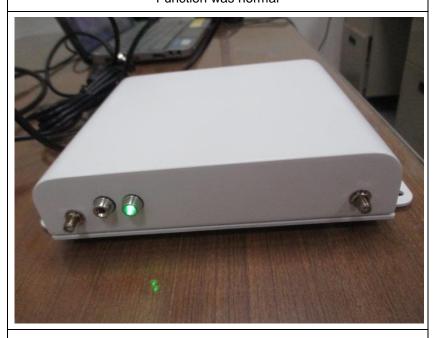
#### **Before testing**

Function was normal

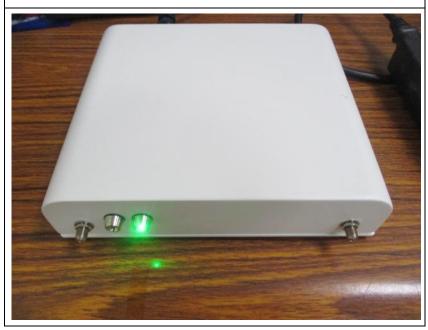
#### After testing

Function was normal

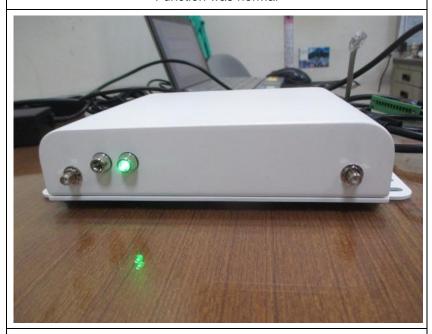
#### **Before testing**

#### Function was normal

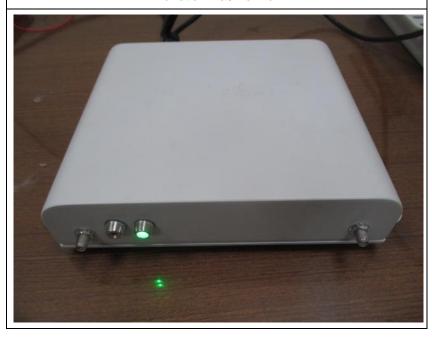
#### After testing

#### Function was normal
