REPORT NO : VT-141215-5

COMPANY : AAEON Technology Inc.  
ADDRESS : 5F, No.135, Lane 235, Pao Chiao Rd.  
Hsin-Tien City, Taipei, Taiwan, R. O. C.  
TEL : 886-2-8919-1234  
FAX : 886-2-8919-1049  
SPECIMEN : BOXER-6403 (With mSATA)  
DATE OF RECEIVED : 2014/12/15  
DATE OF TESTED : 2014/12/15

TEST / INSPECTION ITEMS : Vibration Test

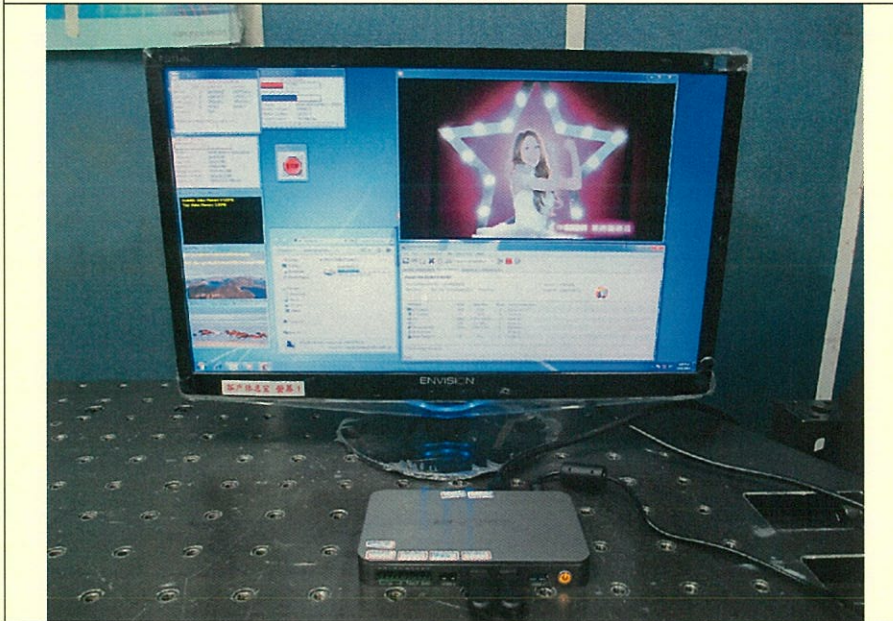
#### After test

(2)—No visible damages were found.
