TESTING / INSPECTION REPORT

REPORT NO : VT-170609-1

SPECIMEN : BOXER-6639M (With SSD)

TEST / INSPECTION ITEMS : Vibration Test

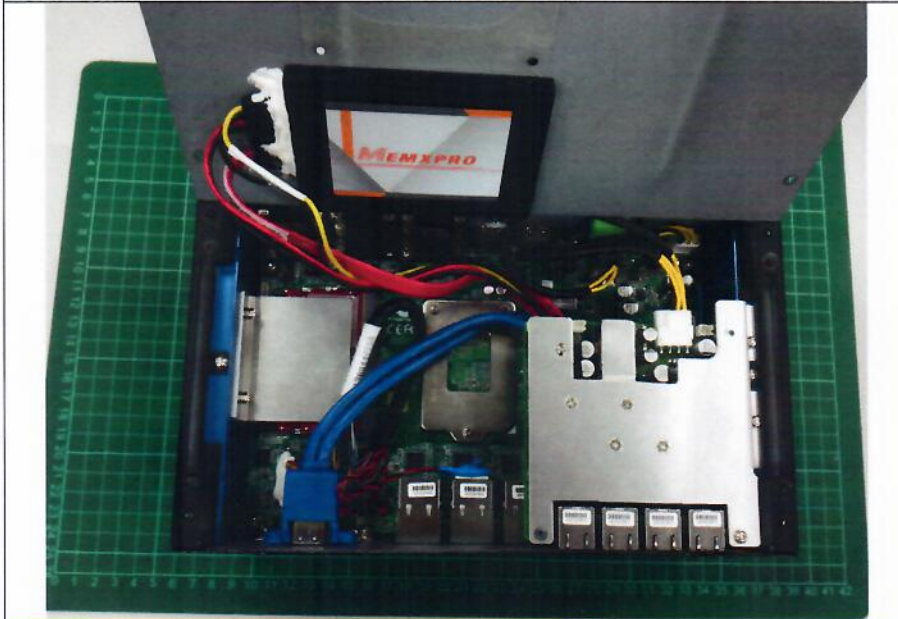
After test-3

(2)—No visible damages were found.
