REPORT NO : VT-120118-7

SPECIMEN : TKS-G20-LN05B (with CFD)

TEST / INSPECTION ITEMS : Vibration Test

## TESTING / INSPECTION REPORT

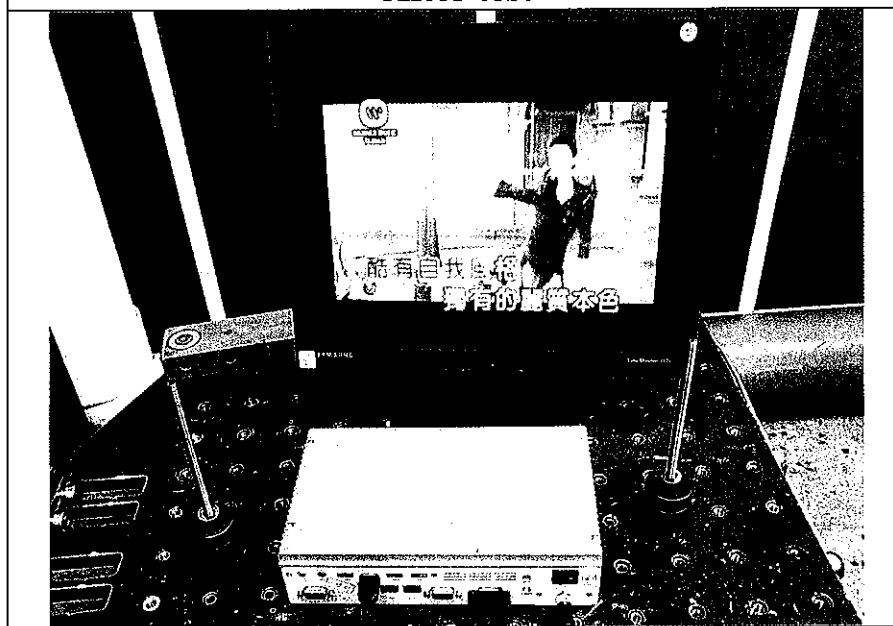
| Describe | PASS | FAIL | Non-Judgment |
|---|---|---|---|
| (2)—No visible damages were found. | | | |
