## TESTING / INSPECTION REPORT

DATE : May 11, 2001  
REPORT NO : DT-010511-1

SPECIMEN : AEC-6200

TEST / INSPECTION ITEMS : Drop Test (See Page 2)

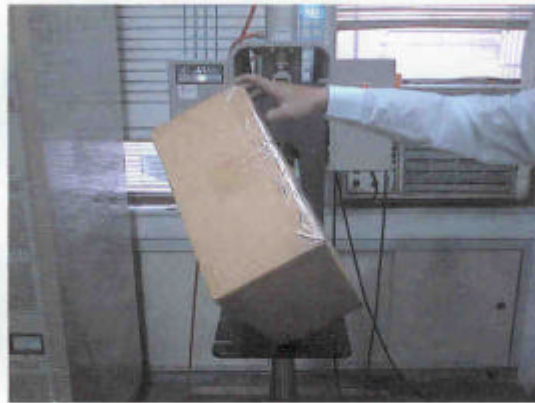
### Testing photos Corner

Appearance check : No damage
