VIBRATION TEST LABORATORY<http://www.kdi.tw><http://www.vibration.com.tw>E-mail: service@kdi.tw**TESTING / INSPECTION REPORT**

REPORT NO : DT-160613-1

SPECIMEN : OMNI-3155

TEST / INSPECTION ITEMS : Drop Test

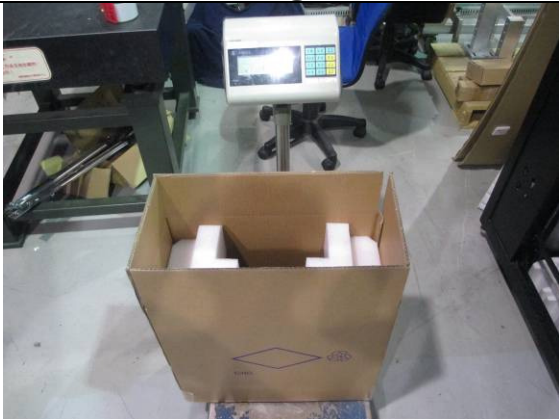
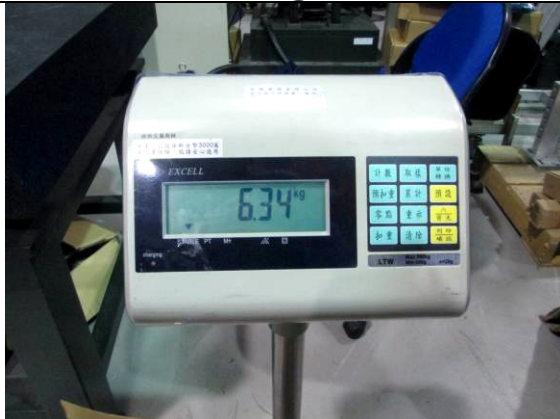
Testing photos – Before test	
Weight	Weight

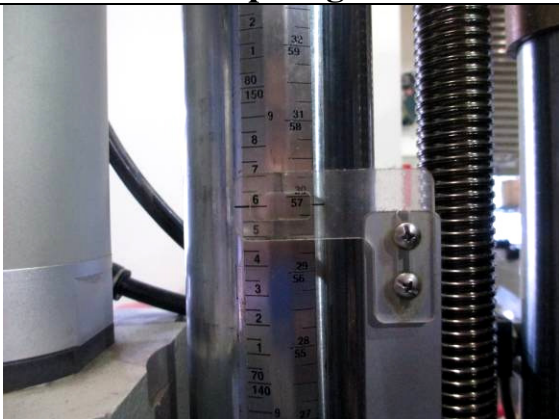
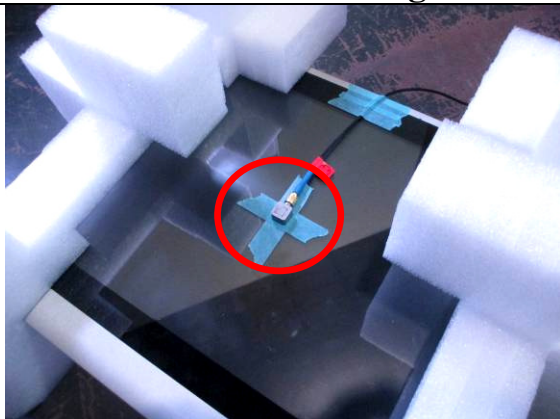
Drop height	Sensor measuring

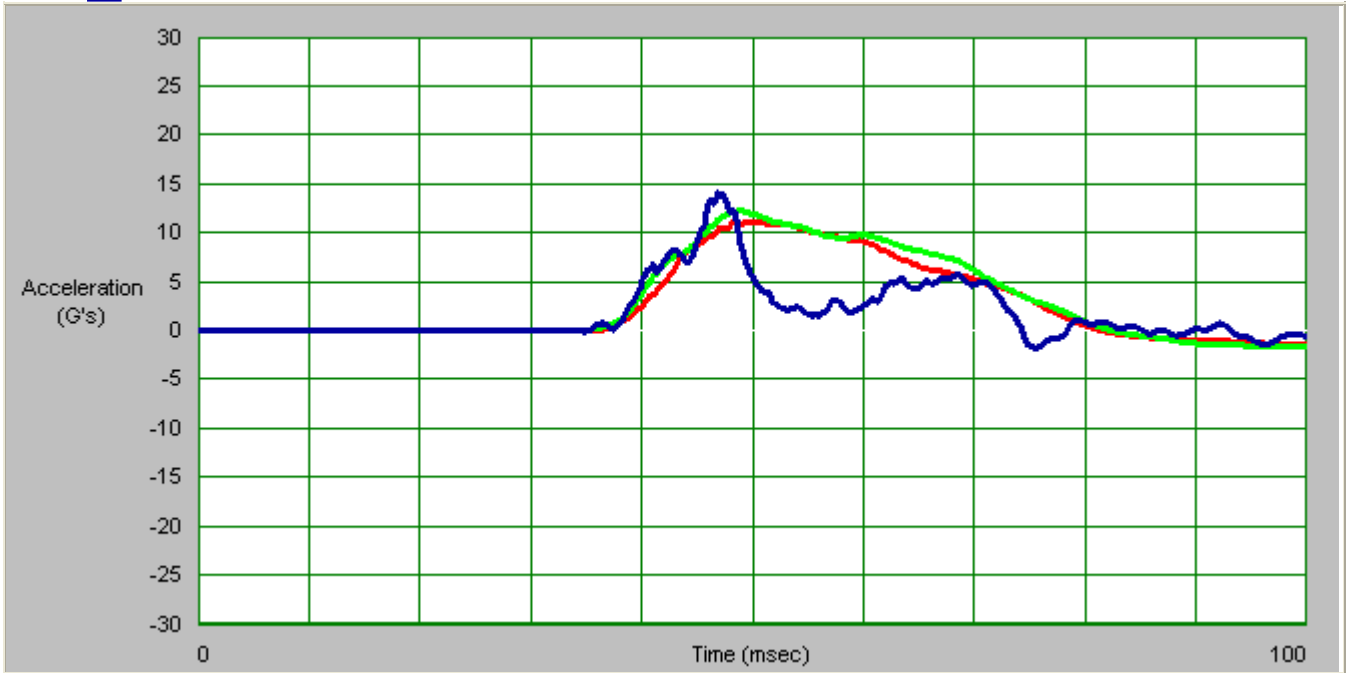
Corner

Acceleration vs Time

Channel Description:	G's	msec	In/S	Filter Hz	Max G's	Min G's
Ch1	X axis	11.15	40.10	109.47	220.00	11.15	-1.53
Ch2	Y axis	12.25	41.30	121.98	220.00	12.25	-1.66
Ch3	Z axis	14.16	35.30	70.09	220.00	14.16	-1.78

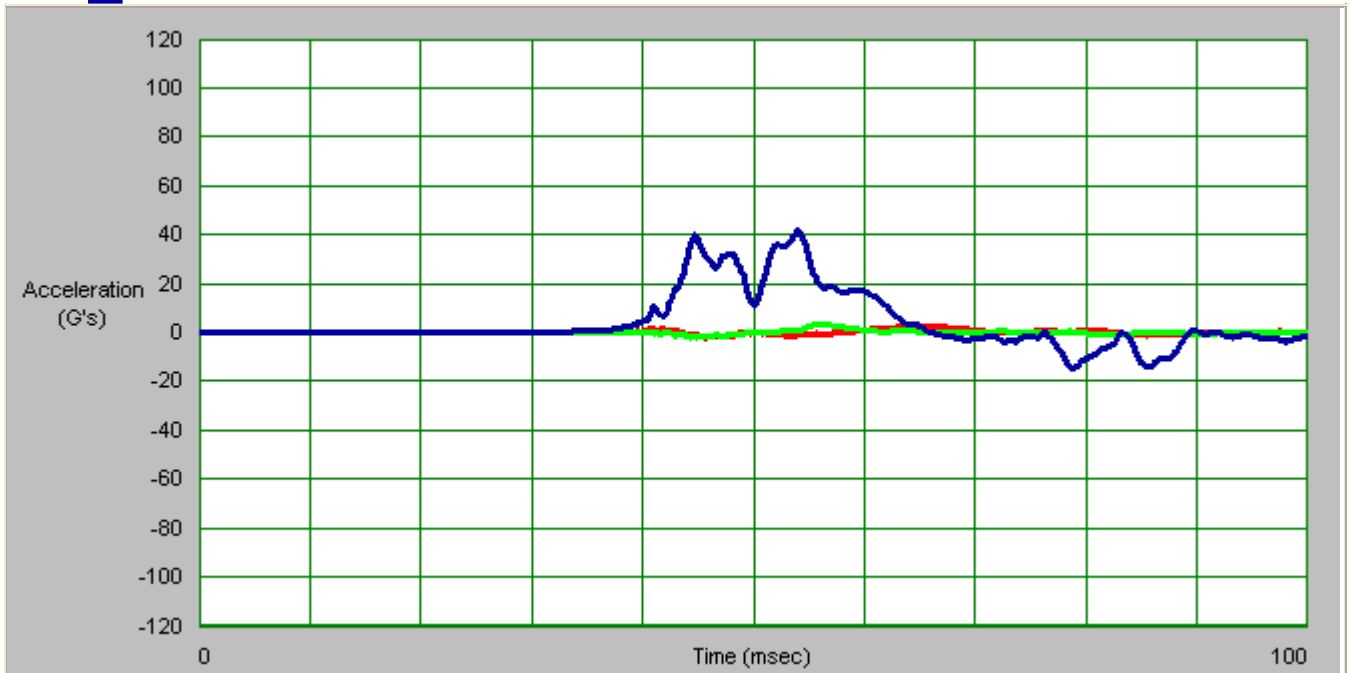
Face-6

Acceleration vs Time

Channel Description:	G's	msec	In/S	Filter Hz	Max G's	Min G's
Ch1	X axis	2.82	12.10	8.03	220.00	2.82	-2.24
Ch2	Y axis	3.35	8.90	6.65	220.00	3.35	-2.15
Ch3	Z axis	42.10	23.80	204.16	220.00	42.10	-14.60
