OMNI-2215-SKU

Carton size: 670(L)*200(W)*525(H) mm

Package Drop Test Report

Report NO:17P030007

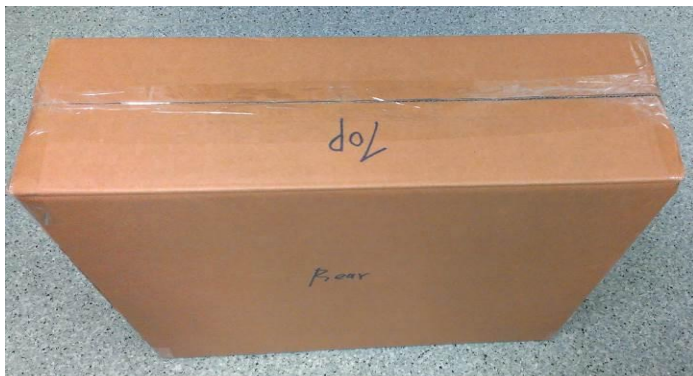
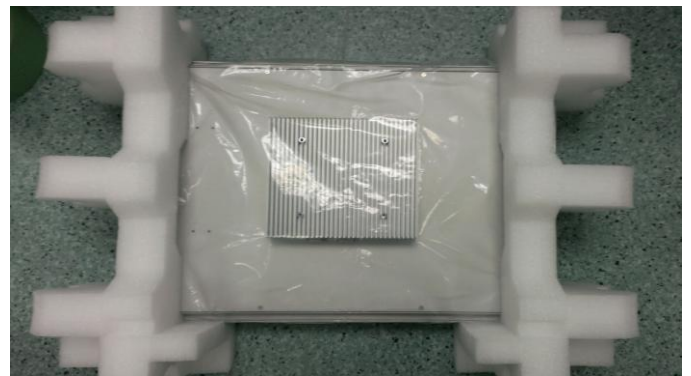
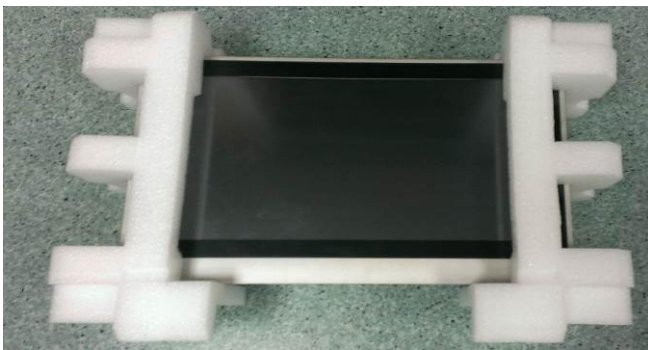
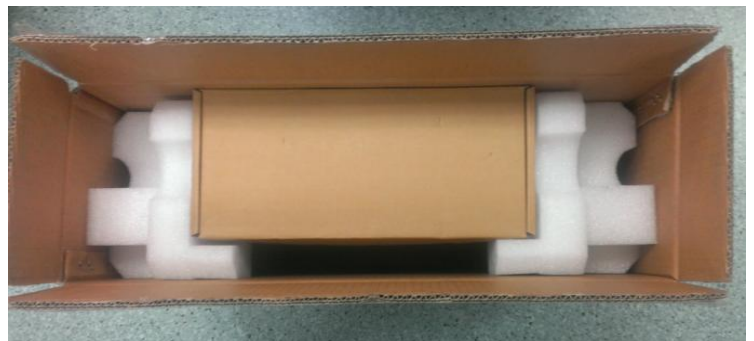
After Test

Summary	<p><input type="checkbox"/> Pass</p> <p><input type="checkbox"/> Fail Note : There is/are ___ defect(s) not list in the report, please check it in the DTS Website.</p> <p><input checked="" type="checkbox"/> Pass with Deviation Comment: The EPE had crack, but structure of EPE and system is OK</p>
---------	--

The EPE had crack, but the structure is OK, System no structure deformation and function was working normally after drop test.

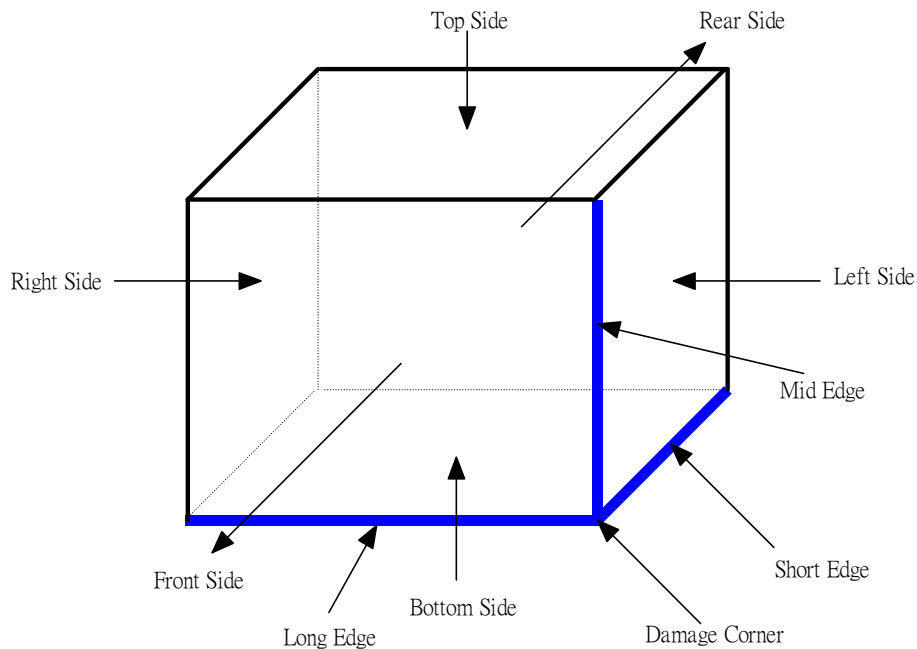
1. Test Phase: One corner. Three edges. Six face
2. Test Cycle: 1 Cycle
3. Test Height: 76cm
4. Test Weight: 9Kg
5. Sample Package: 1unit in single-package.
6. Test Drawing:
