### TESTING / INSPECTION REPORT

REPORT NO : DT-001220-1

SPECIMEN : Full-Size CPU Card

TEST / INSPECTION ITEMS : Drop Test (See Page 2)

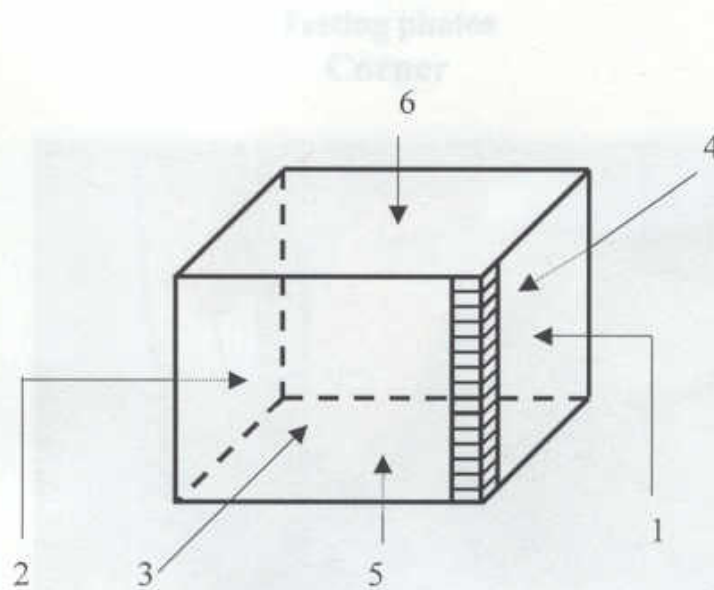
1	The 1-3-5 Corner	Corner
2	The shortest edge radiating from that corner	Edge
3	The next longest edge radiating from that corner	Edge
4	The longest edge radiating from that corner	Edge
5	Flat on one of the smallest faces	Flat
6	Flat on one of the opposite small faces	Flat
7	Flat on one of the medium faces	Flat
8	Flat on one of the opposite medium faces	Flat
9	Flat on one of the largest faces	Flat
10	Flat on one of the opposite largest faces	Flat

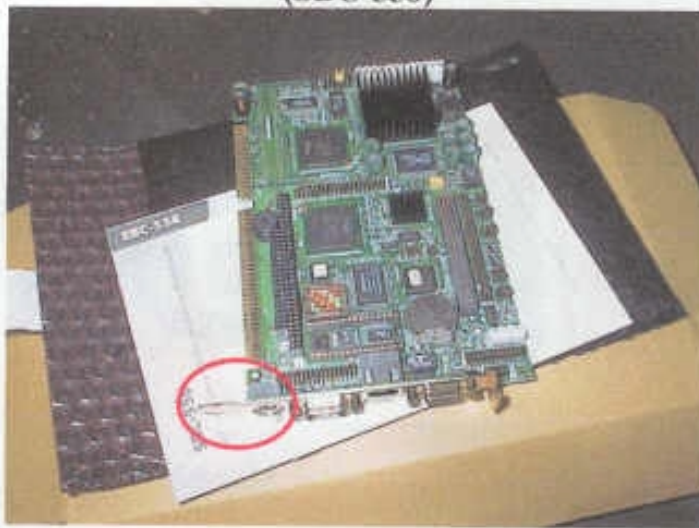
(SBC-558)

Appearance
Full-Size CPU Card	No damage
Half-Size CPU Card	Damage (See page 12~13)
Compact Board	No damage
PC/104	No damage
Media PC	No damage

### Testing photos Damage

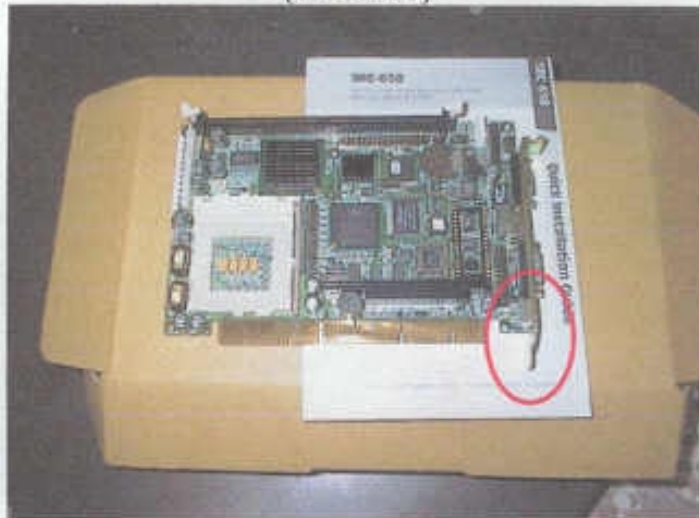
(SBC-658)

### Testing photos Damage
