**TESTING / INSPECTION REPORT**

REPORT NO : DT-150806-1

SPECIMEN : RTC-600A

TEST / INSPECTION ITEMS : Drop Test

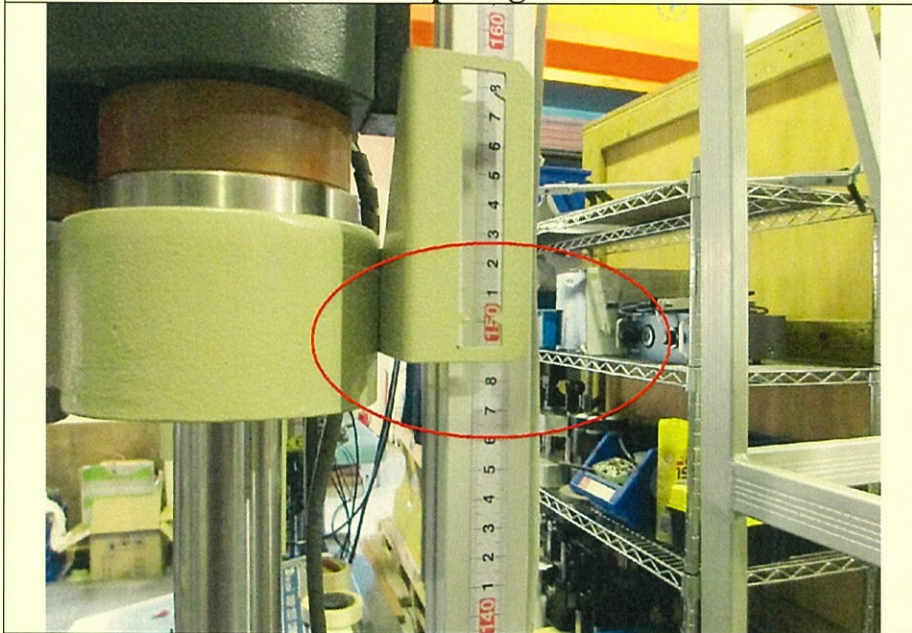
#### Drop height

Drop Height : 150 cm

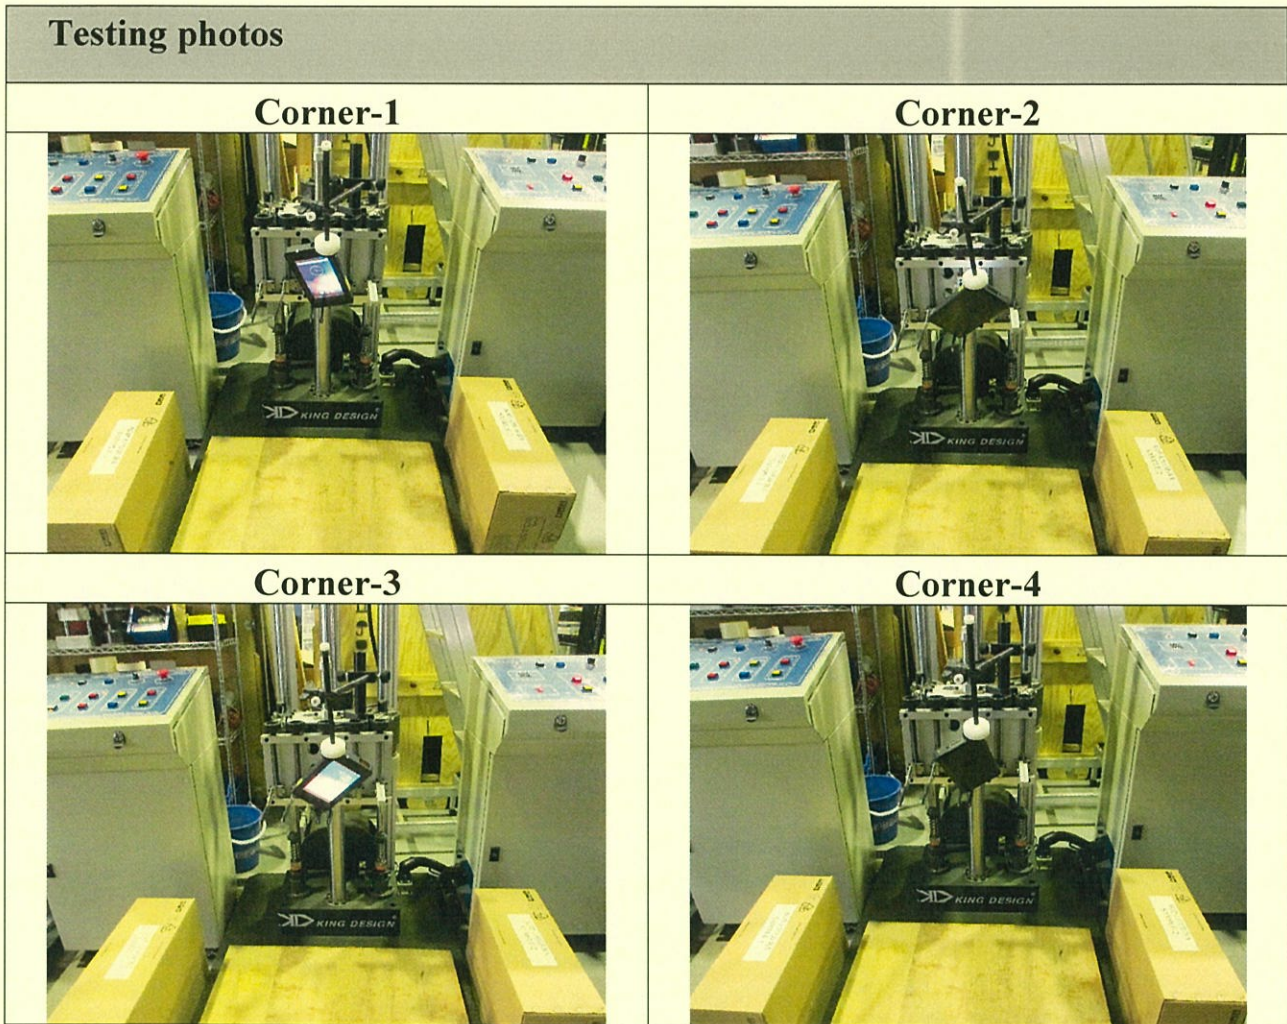
Corner-1	C
Corner-2	F
Corner-3	D
Corner-4	E
Corner-5	B
Corner-6	G
Corner-7	A
Corner-8	H
Edge-1	CG
Edge-2	BF
Edge-3	DH
Edge-4	AE
Edge-5	CD
Edge-6	EF
Edge-7	AB
Edge-8	GH
Edge-9	AC
Edge-10	FH
Edge-11	BD
Edge-12	EG
Flat-1	CDGH
Flat-2	ABEF
Flat-3	ACEG
Flat-4	BDFH
Flat-5	EGFH
Flat-6	ABCD
