TESTING / INSPECTION REPORT

REPORT NO : DT-001220-1

SPECIMEN : Full-Size CPU Card

TEST / INSPECTION ITEMS : Drop Test (See Page 2)

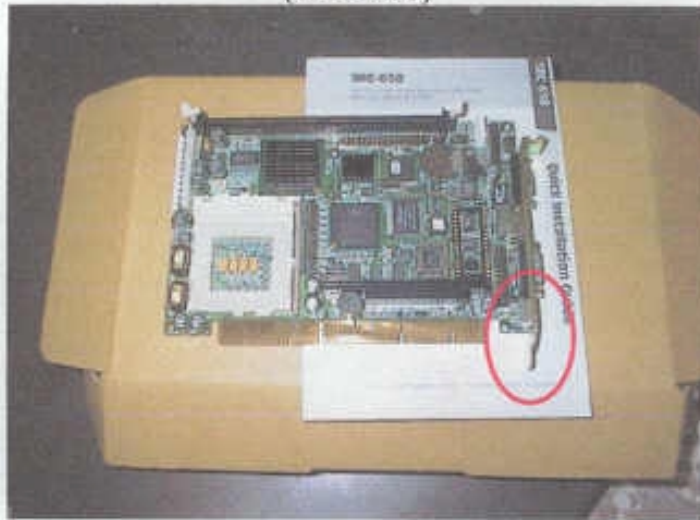
(SBC-658)

Appearance
Full-Size CPU Card	No damage
Half-Size CPU Card	Damage (See page 12~13)
Compact Board	No damage
PC/104	No damage
Media PC	No damage

Testing photos Damage
