TESTING / INSPECTION REPORT

REPORT NO : DT-001220-1

COMPANY : AAEON Technology Inc.

TEST / INSPECTION ITEMS : Drop Test (See Page 2)

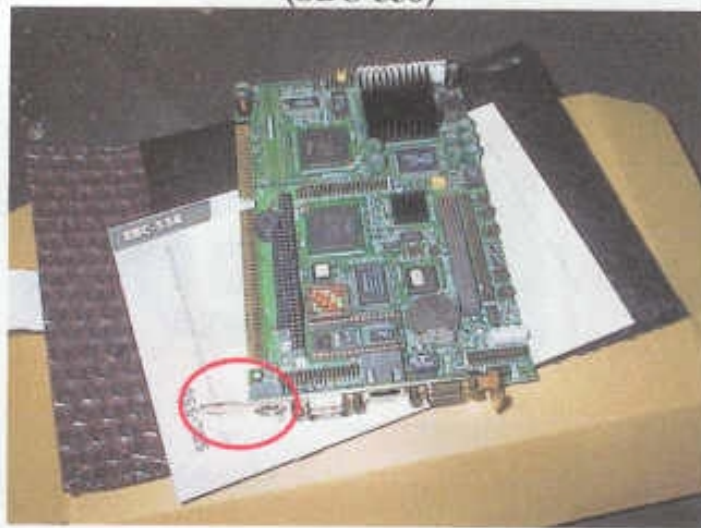
(SBC-558)

Appearance
Full-Size CPU Card	No damage
Half-Size CPU Card	Damage (See page 12~13)
Compact Board	No damage
PC/104	No damage
Media PC	No damage

Testing photos Damage

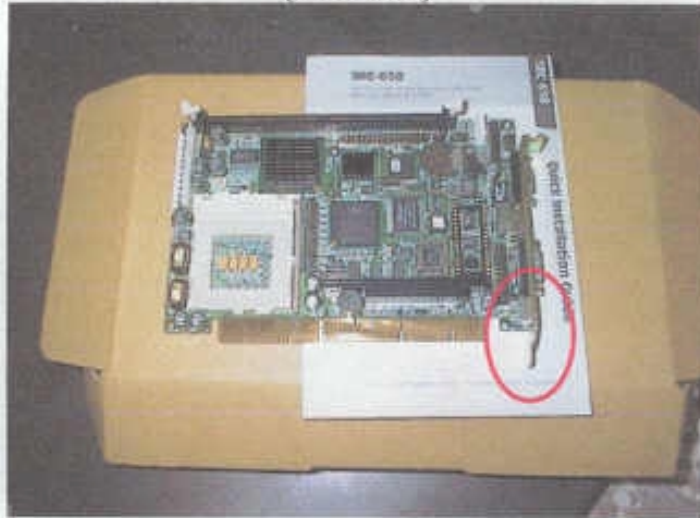
(SBC-658)

Testing photos Damage
