## TESTING / INSPECTION REPORT

REPORT NO : DT-001220-1

COMPANY : AAEON Technology Inc.

TEST / INSPECTION ITEMS : Drop Test (See Page 2)

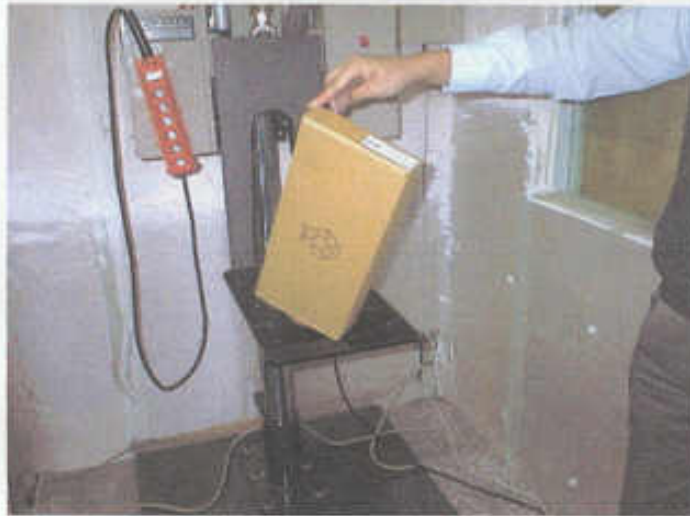
### Testing photos Corner

| Drop Onto | : 1 corner, 3edge & 6 face |
