## TESTING / INSPECTION REPORT

DATE : July 27, 2001  
REPORT NO : DT-010702-1

SPECIMEN : AWS-8150

TEST / INSPECTION ITEMS : Drop Test (See Page 2)

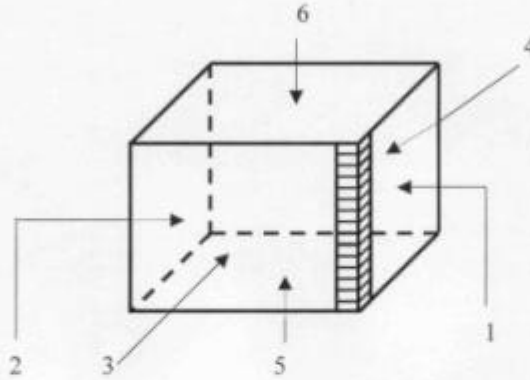
1	The 1-3-5 Corner	Corner
2	The shortest edge radiating from that corner	Edge
3	The next longest edge radiating from that corner	Edge
4	The longest edge radiating from that corner	Edge
5	Flat on one of the bottom faces	Flat
6	Flat on one of the left faces	Flat
7	Flat on one of the top faces	Flat
8	Flat on one of the right faces	Flat
9	Flat on one of the front faces	Flat
10	Flat on one of the rear faces	Flat

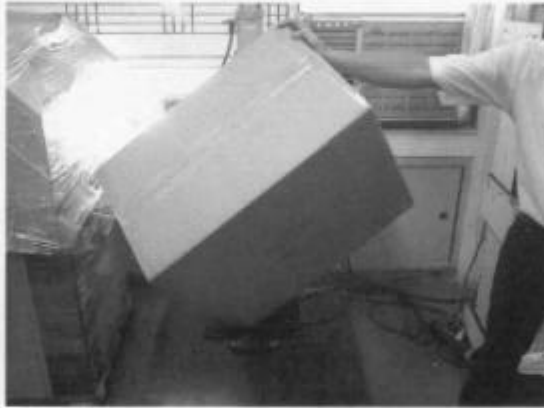
### Testing photos Corner

Appearance check : No damage  
Function check : Normal
