TESTING / INSPECTION REPORT

SPECIMEN : Control Boxes & Chassis

TEST / INSPECTION ITEMS : Vibration Test (See Page 2)

Model : AMB-2023
Quantity : 1 piece

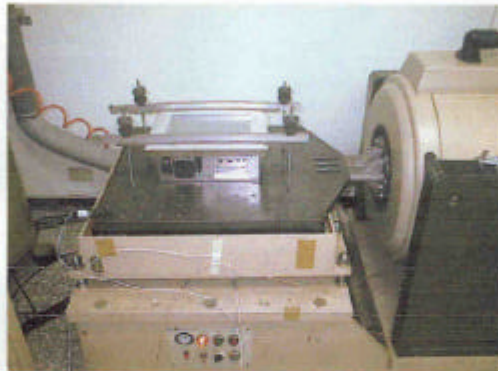
Testing photos AXIS X

Appearance check : After test , the screw of goods was loose.
