KING DESIGN INDUSTRIAL CO., LTD.4F, NO. 3, Lane 270, Pei Shen Road Sec. 3,
Shen Keng Dist., New Taipei City, 222, Taiwan, R.O.C
TEL: 886-2-2662-5100 FAX: 886-2-2662-3094**VIBRATION TEST LABORATORY**http://www.kdi.tw
http://www.vibration.com.tw
E-mail:service@kdi.tw**TESTING / INSPECTION REPORT**

REPORT NO : ST-150721-1

COMPANY : AAEON Technology Inc.
ADDRESS : 5F, No.135, Lane 235, Pao Chiao Rd.
Hsin-Tien City, Taipei, Taiwan, R. O. C.
TEL : 886-2-8919-1234
FAX : 886-2-8919-1049
SPECIMEN : ACS-1U01-BT4 (With 2.5" SATA HDD)
DATE OF RECEIVED : 2015/07/21
DATE OF TESTED : 2015/07/21

TEST / INSPECTION ITEMS : Shock Test

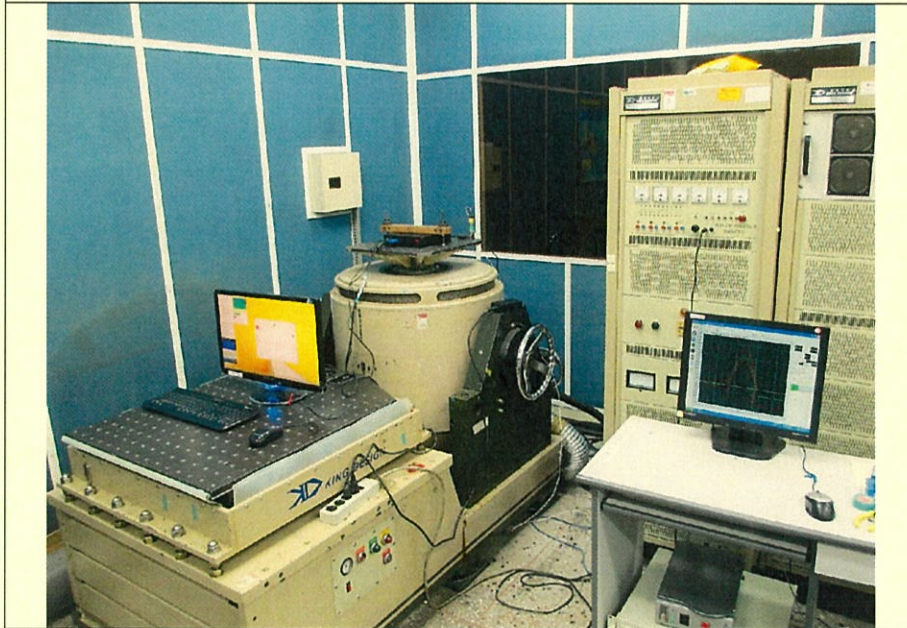
Tester

Testing photos

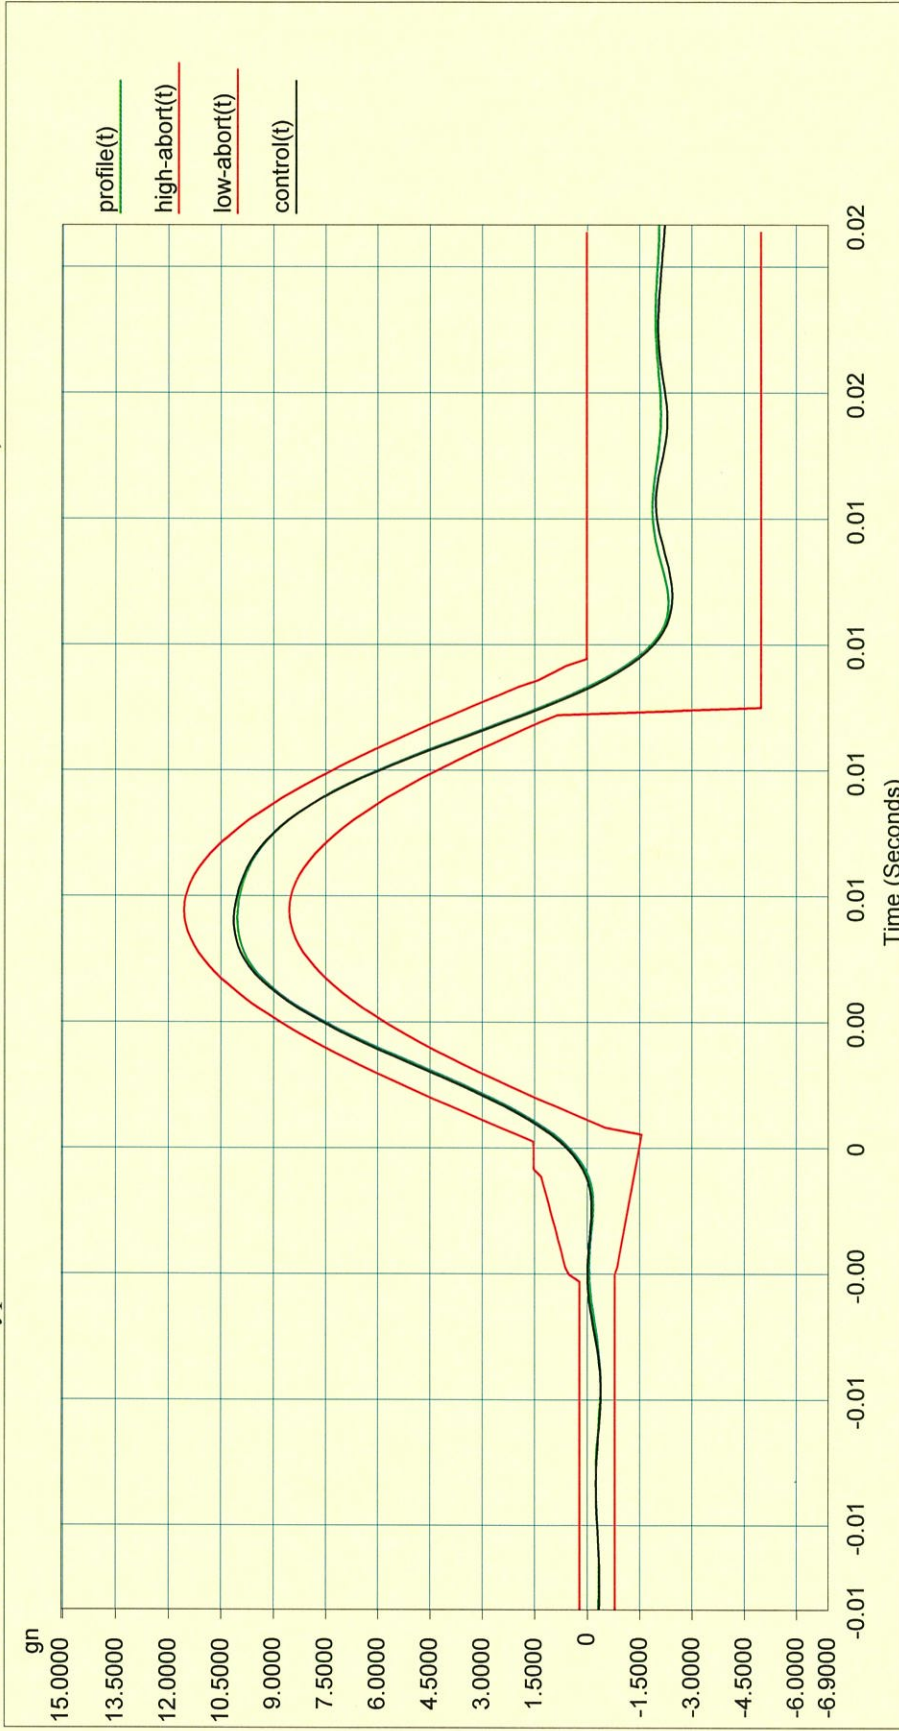
-X axis

Project File Name: 10g 11mS.prj

Profile Name: Test Type: Classical Shock Run Folder: .\RunDefault Jul 21, 2015 11-00-30

Level: 100 % Block Size: 4096 Elapsed Pulses: 10 Full Level Elapsed Pulses: 3
 Frame Time: 0.682667 Seconds Control Peak: 10.108918 Control RMS: 1.098838
 dT: 0.000167 Seconds Demand Peak: 10.000000 Demand RMS: 1.082899 Remaining Pulses: 0
 Pulse Type: Half Sine Amplitude: 10.000000 Pulse Width: 11.000000 ms
