**KING DESIGN INDUSTRIAL CO., LTD.****VIBRATION TEST LABORATORY**4F, NO. 3, Lane 270, Pei Shen Road Sec. 3,  
Shen Keng Dist., New Taipei City, 222, Taiwan, R.O.C  
TEL: 886-2-2662-5100 FAX: 886-2-2662-3094<http://www.kdi.tw>  
<http://www.vibration.com.tw>  
E-mail:service@kdi.tw**TESTING / INSPECTION REPORT**

REPORT NO : ST-140507-1

COMPANY : AAEON Technology Inc.  
ADDRESS : 5F, No.135, Lane 235, Pao Chiao Rd.  
Hsin-Tien City, Taipei, Taiwan, R. O. C.  
TEL : 886-2-8919-1234  
FAX : 886-2-8919-1049  
SPECIMEN : AEC-6638 (With 2.5" SATA HDD)  
DATE OF RECEIVED : 2014/05/07  
DATE OF TESTED : 2014/05/07

TEST / INSPECTION ITEMS : Shock Test

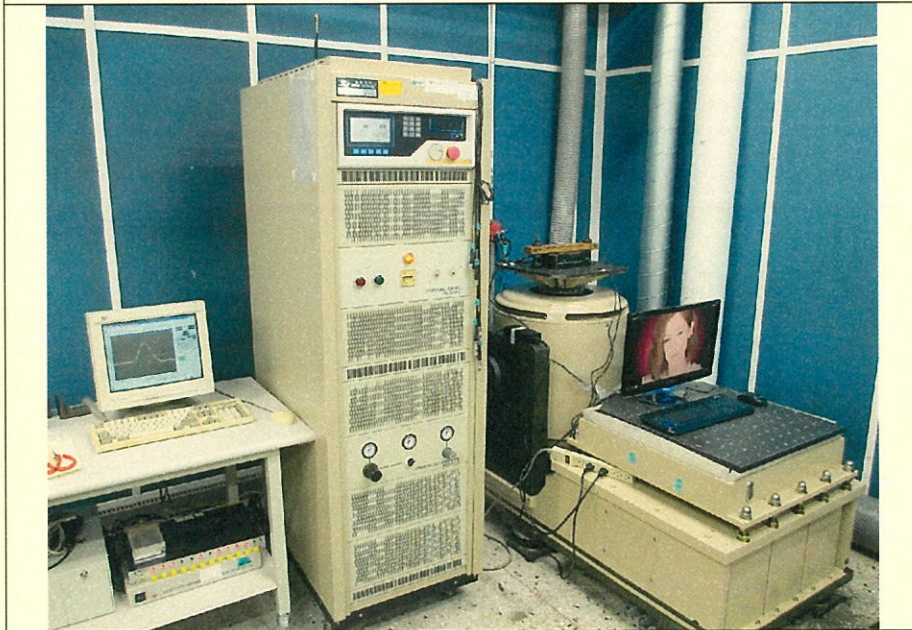
#### Tester

Vibration Tester : KING DESIGN KD-9363EM-600F2K-50N120,  
 S/N : KDS11054986

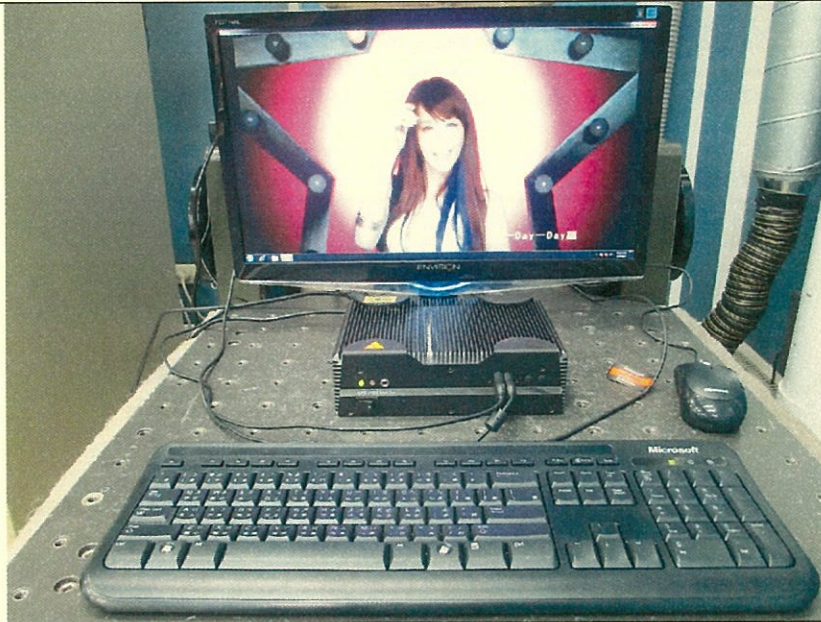
After test-1

Describe	PASS	FAIL	Non-Judgment
Function judgment <sup>(1)</sup>	√	---	---
Appearance check <sup>(2)</sup>	√	---	---
(1)—Booting function was normal after the test. (2)—No visible damages were found.

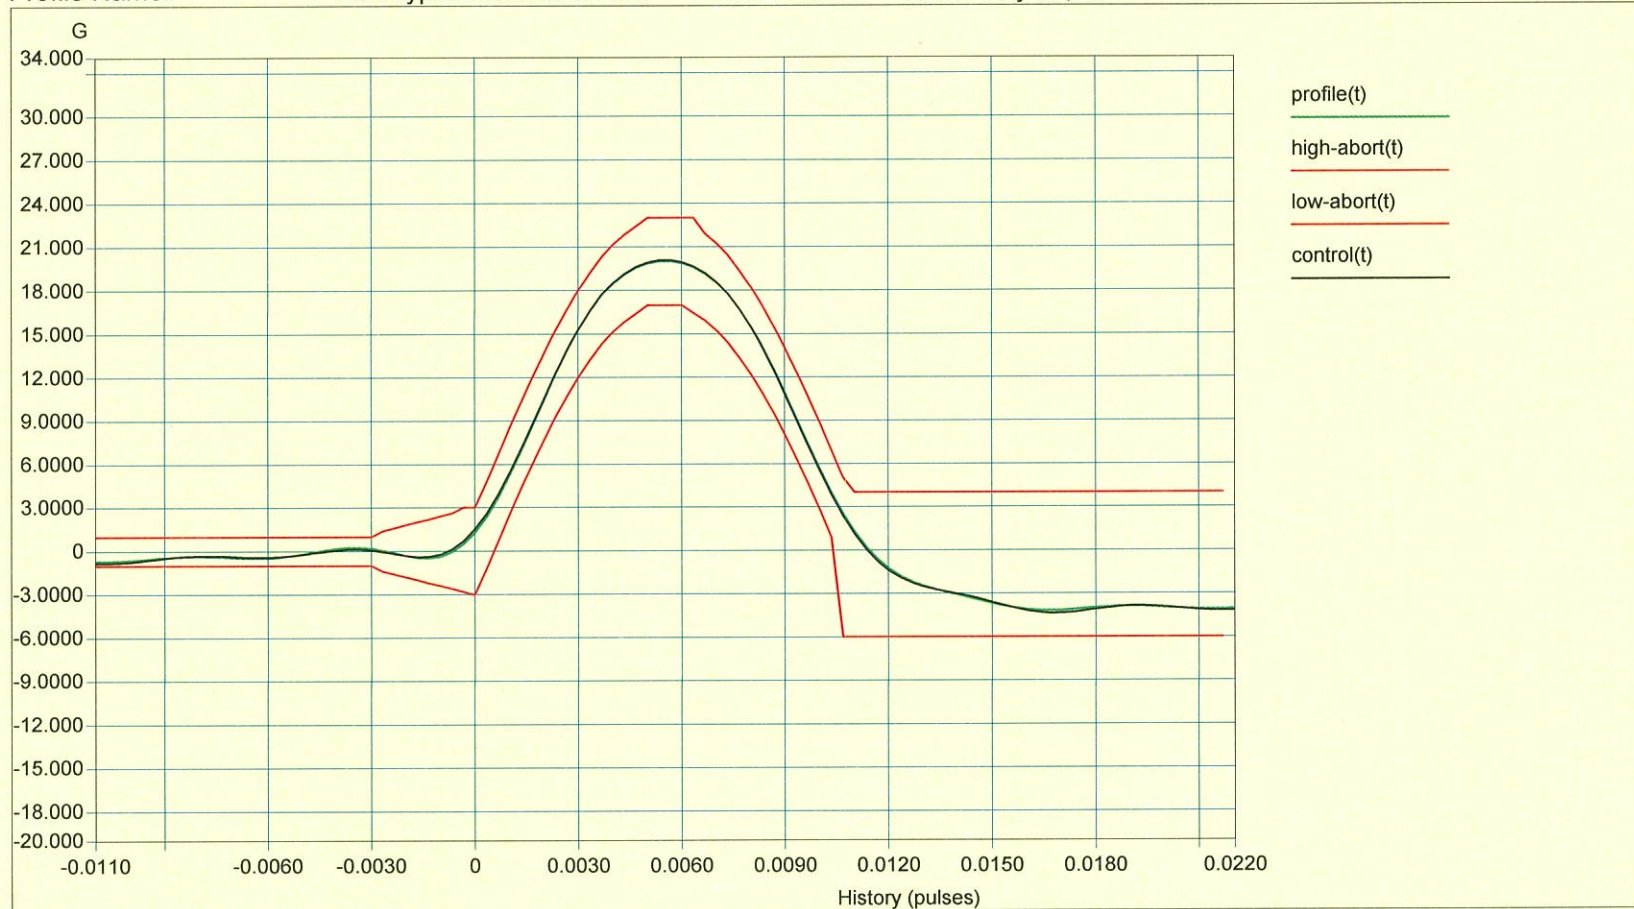
+Y axis

Level: 100 % Block Size: 2048 Elapsed Pulses: 11  
 Frame Time: 0.682667 Seconds Control Peak: 20.080452 G Control RMS: 2.061050 G Full Level Elapsed Pulses: 3  
 dT: 0.000333 Seconds Demand Peak: 20.000000 G Demand RMS: 2.045214 G Remaining Pulses: 0  
 Pulse Type: Half Sine Amplitude: 20.000000 G Pulse Width: 11.000001 ms
