## TESTING / INSPECTION REPORT

REPORT NO : ST-130718-1

COMPANY : AAEON Technology Inc.  
ADDRESS : 5F, No.135, Lane 235, Pao Chiao Rd.  
Hsin-Tien City, Taipei, Taiwan, R. O. C.  
TEL : 886-2-8919-1234  
FAX : 886-2-8919-1049  
SPECIMEN : AEC-6643 (with 2.5" SATA HDD)  
DATE OF RECEIVED : 2013/07/17  
DATE OF TESTED : 2013/07/17

TEST / INSPECTION ITEMS : Shock Test

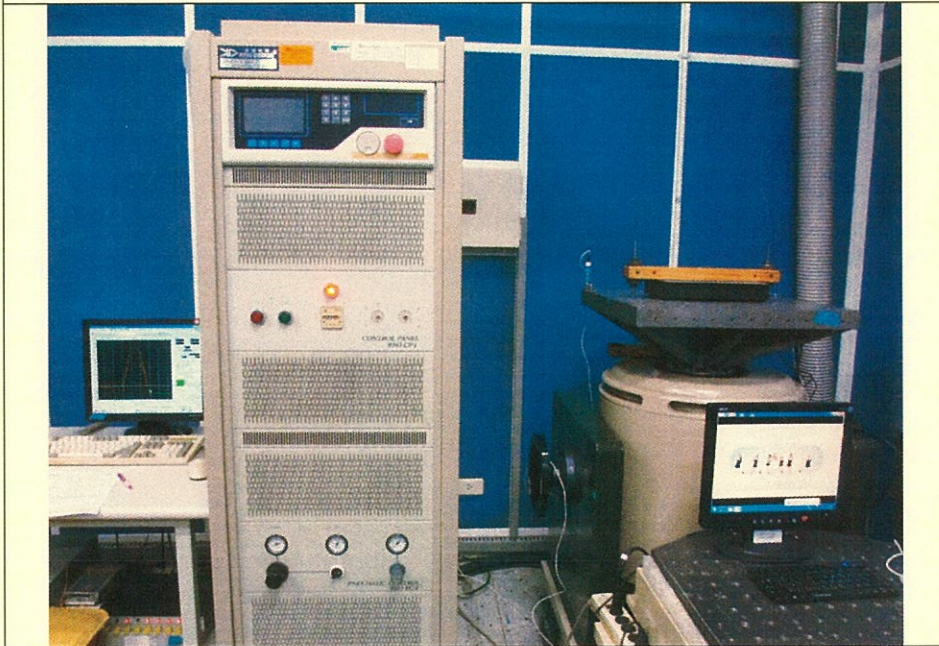
#### Tester

- 1.Vibration Tester : KING DESIGN KD-9363EM-600F2K-50N120,  
S/N : KDS11054986
- 2.Controller : DACTRON Front-End Box, S/N : 4529465
- 3.Control Accelerometer : Wilcoxon Research WR-777, S/N : 4207

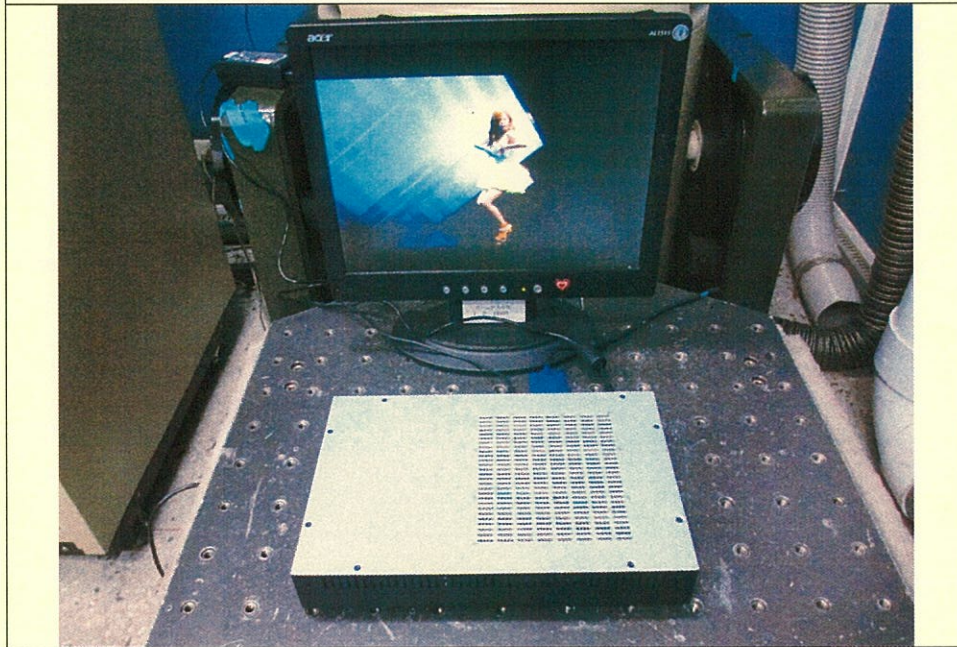
#### After test

(1)—Booting function was normal after the test.  
(2)—No visible damages were found.
