TESTING / INSPECTION REPORT

REPORT NO : ST-110817-2

COMPANY : AAEON Technology Inc.
ADDRESS : 5F, No.135, Lane 235, Pao Chiao Rd.
Hsin-Tien City, Taipei, Taiwan, R. O. C.
TEL : 886-2-8919-1234
FAX : 886-2-8919-1049
SPECIMEN : AGD-315D
DATE OF RECEIVED : 2011/08/16
DATE OF TESTED : 2011/08/16

TEST / INSPECTION ITEMS : Shock Test

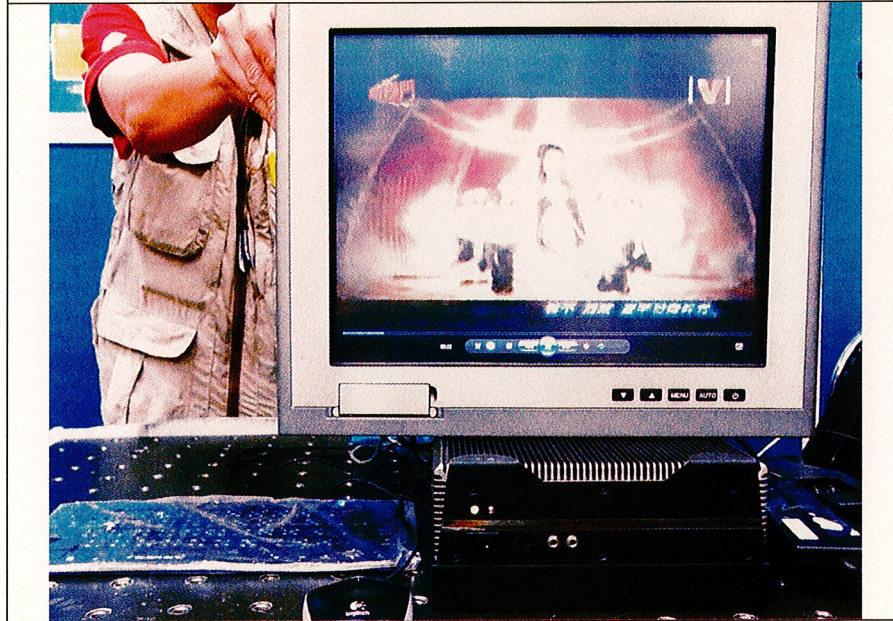
Testing photos

After test

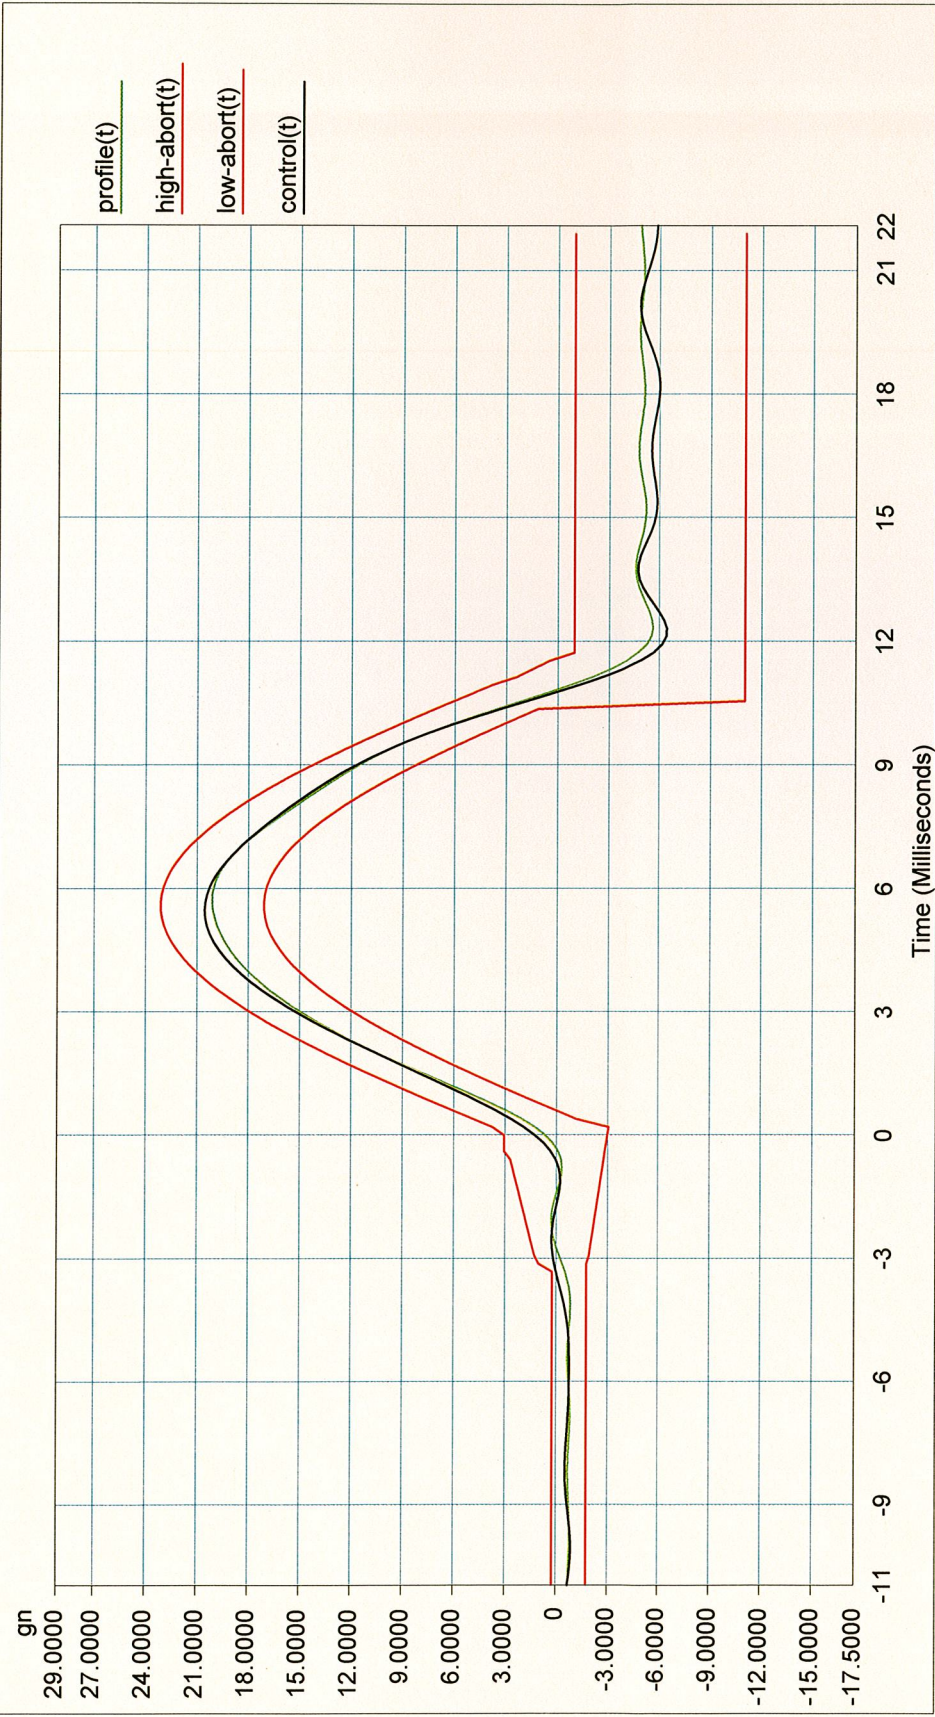
-Y Axis

Project File Name: Shock 20g 11ms.prj

Profile Name: Test Type: Classical Shock Run Folder: .\RunDefault Aug 16, 2011 10-00-29

Level: 100 % Block Size: 2048 Elapsed Pulses: 13
 Frame Time: 0.400000 Seconds Control Peak: 20.452379 Control RMS: 2.970516 Full Level Elapsed Pulses: 3
 dT: 0.000195 Seconds Demand Peak: 20.000000 Demand RMS: 2.877971 Remaining Pulses: 0
 Pulse Type: Half Sine Amplitude: 20.000000 Pulse Width: 11.000000 ms
