TESTING / INSPECTION REPORT

REPORT NO : ST-130422-5

SPECIMEN : AHP-1083 (with SATA HDD)

TEST / INSPECTION ITEMS : Shock Test

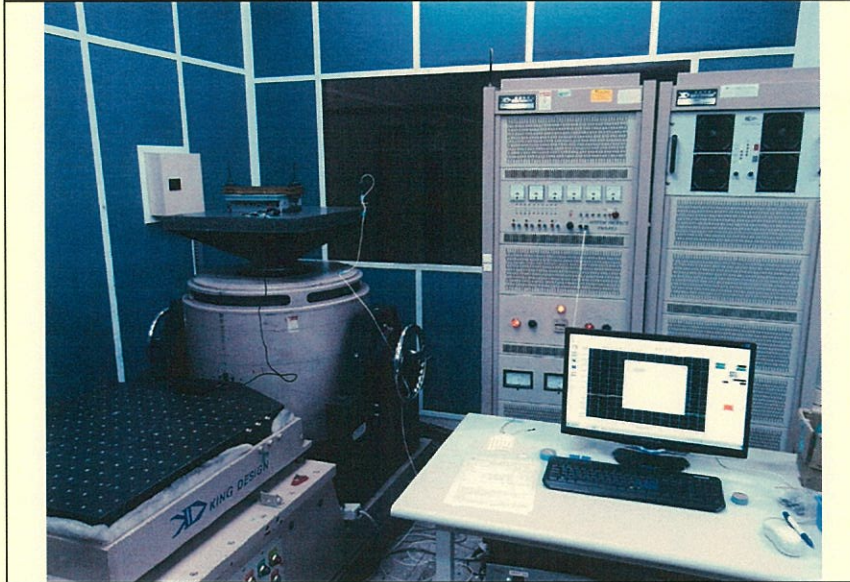
Testing photos

Tester
