TESTING / INSPECTION REPORT

REPORT NO : ST-111212-2

COMPANY : AAEON Technology Inc.
ADDRESS : 5F, No.135, Lane 235, Pao Chiao Rd.
Hsin-Tien City, Taipei, Taiwan, R. O. C.
TEL : 886-2-8919-1234
FAX : 886-2-8919-1049
SPECIMEN : AHP-2122HTT (with 2.5" SATA HDD)
DATE OF RECEIVED : 2011/12/09
DATE OF TESTED : 2011/12/09

TEST / INSPECTION ITEMS : Shock Test

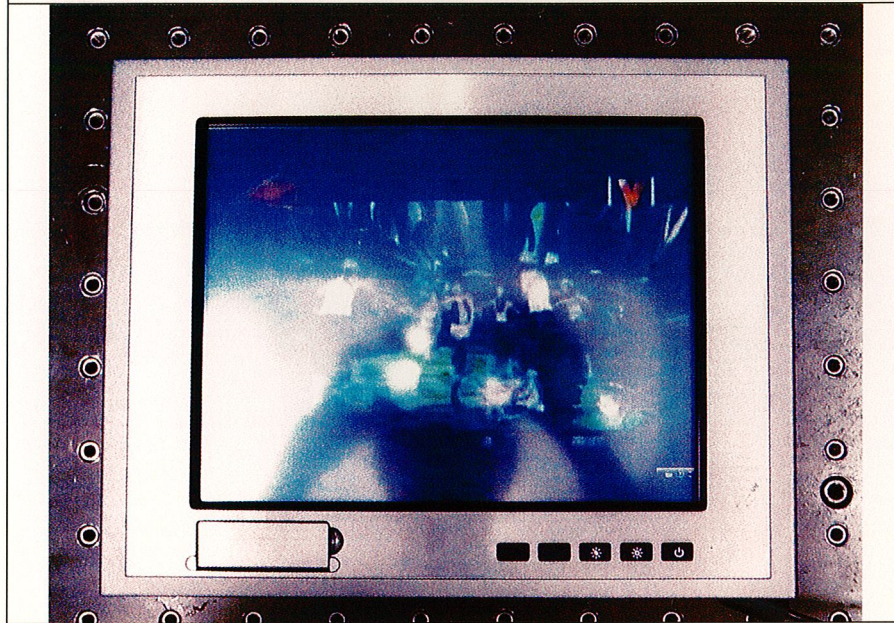
After test

Describe	PASS	FAIL	Non-Judgment
Function judgment ⁽¹⁾	√	---	---
Appearance check ⁽²⁾	√	---	---
(1)—Bootting function was normal after the test.			
(2)—No visible damages were found.
