KING DESIGN INDUSTRIAL CO., LTD.4F, NO. 3, Lane 270, Pei Shen Road Sec. 3,
Shen Keng Dist., New Taipei City, 222, Taiwan, R.O.C
TEL: 886-2-2662-5100 FAX: 886-2-2662-3094**VIBRATION TEST LABORATORY**http://www.kdi.tw
http://www.vibration.com.tw
E-mail:service@kdi.tw**TESTING / INSPECTION REPORT**

REPORT NO : ST-130916-1

COMPANY : AAEON Technology Inc.
ADDRESS : 5F, No.135, Lane 235, Pao Chiao Rd.
Hsin-Tien City, Taipei, Taiwan, R. O. C.
TEL : 886-2-8919-1234
FAX : 886-2-8919-1049
SPECIMEN : NVR-B75-A10(With 3.5" HDD*6)
DATE OF RECEIVED : 2013/09/16
DATE OF TESTED : 2013/09/16

TEST / INSPECTION ITEMS : Shock Test

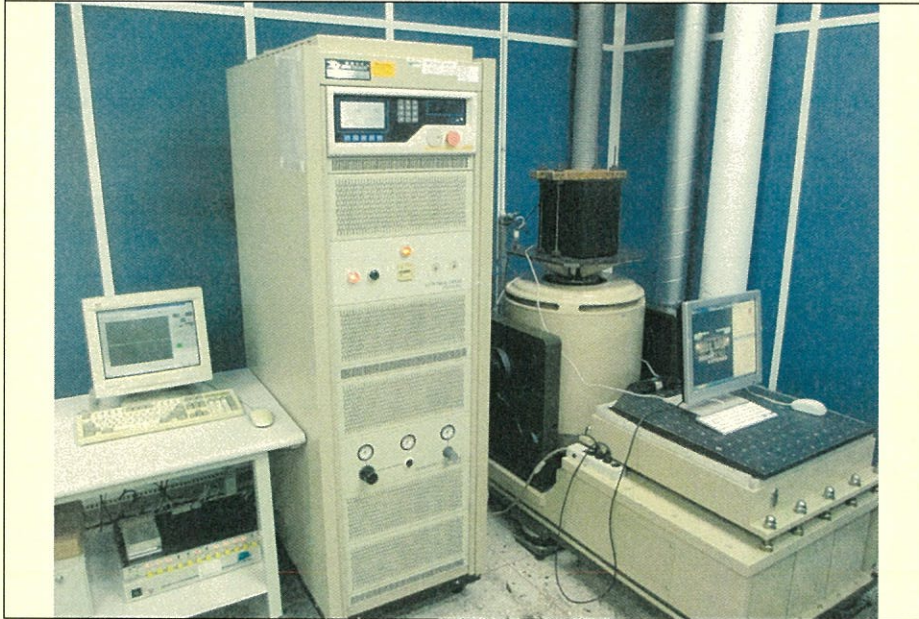
Tester
