RELIABILITY TEST LABORATORY<http://www.kdi.tw><http://www.vibration.com.tw>E-mail: service@kdi.tw**TESTING / INSPECTION REPORT**

REPORT NO : ST-120103-5

SPECIMEN : POP-70-G5

TEST / INSPECTION ITEMS : Shock Test

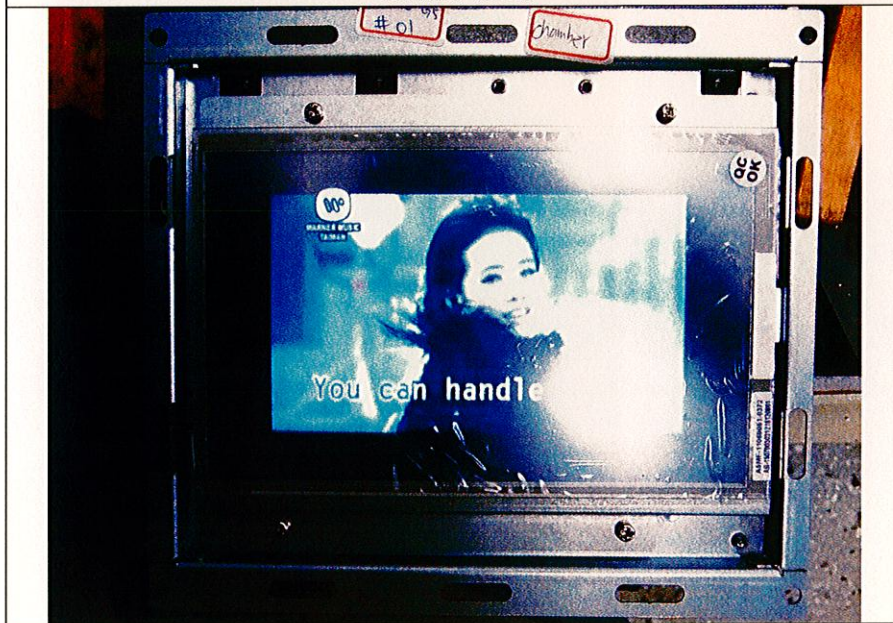
After test

| Describe | PASS | FAIL | Non-Judgment |
|---|---|---|---|
| Appearance check ⁽²⁾ | √ | --- | --- |
| (1)—Booting function was normal after the test. (2)—No visible damages were found. | | | |

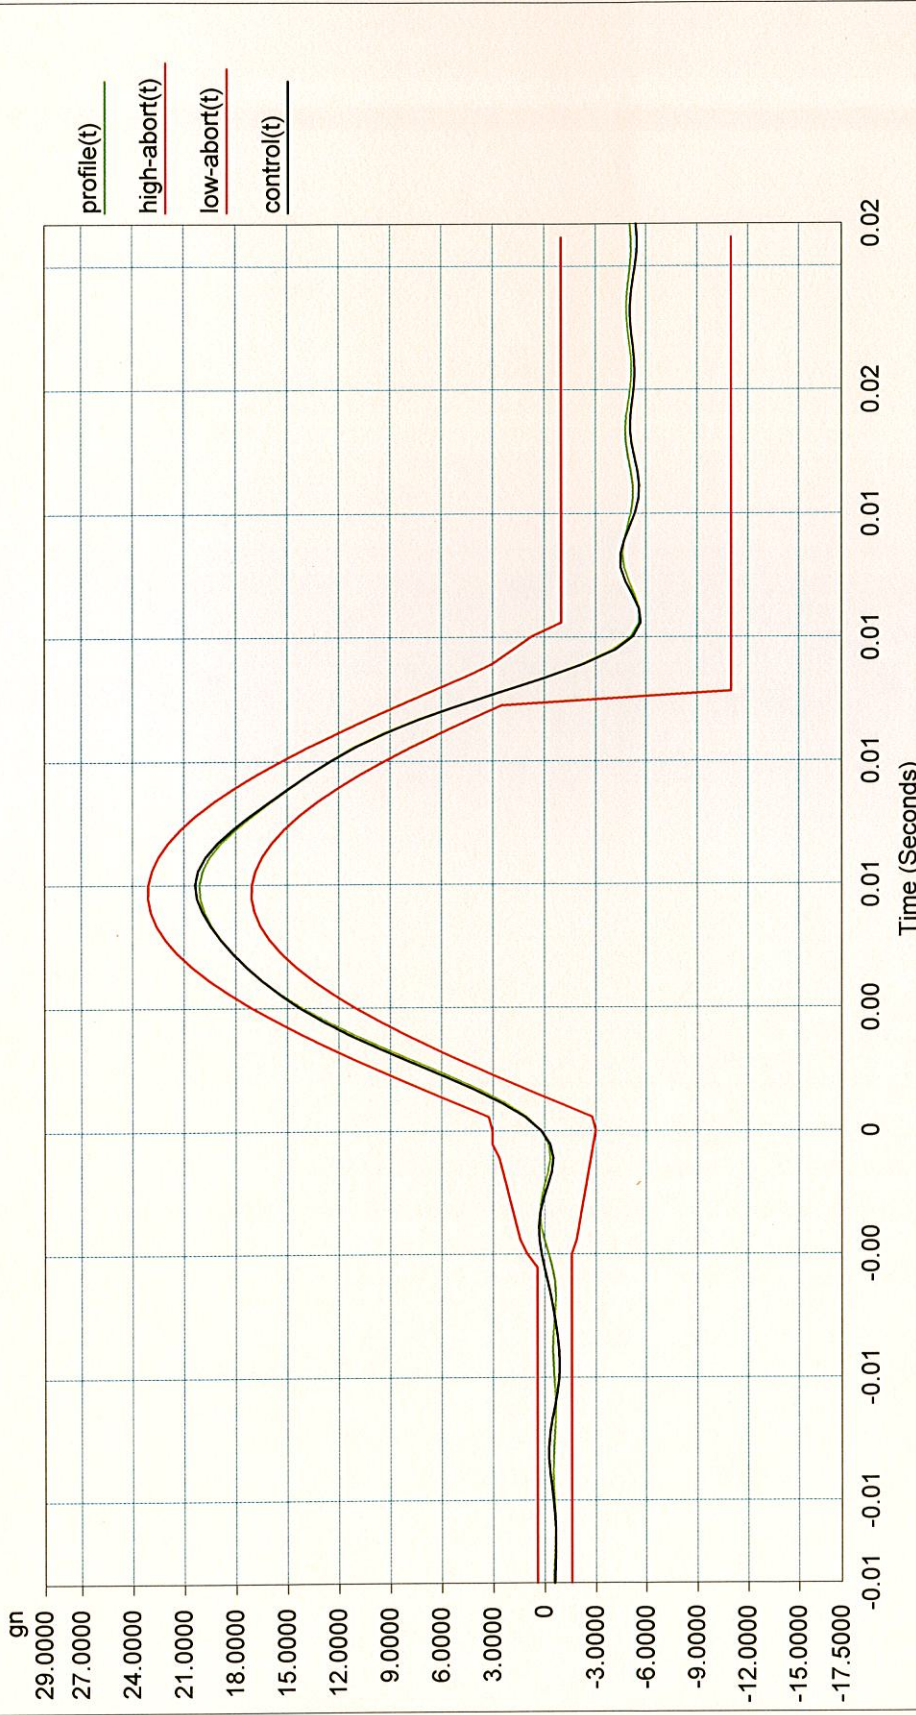
+Z Axis

Project File Name: 20g 11mS.prj

Profile Name: Test Type: Classical Shock Run Folder: .\RunDefault Dec 30, 2011 09-55-37

Level: 100 % Block Size: 2048 Elapsed Pulses: 12
 Frame Time: 0.682667 Seconds Control Peak: 20.232676 Control RMS: 2.233885 Full Level Elapsed Pulses: 3
 dT: 0.000333 Seconds Demand Peak: 20.000000 Demand RMS: 2.201481 Remaining Pulses: 0
 Pulse Type: Half Sine Amplitude: 20.000000 Pulse Width: 11.000000 ms

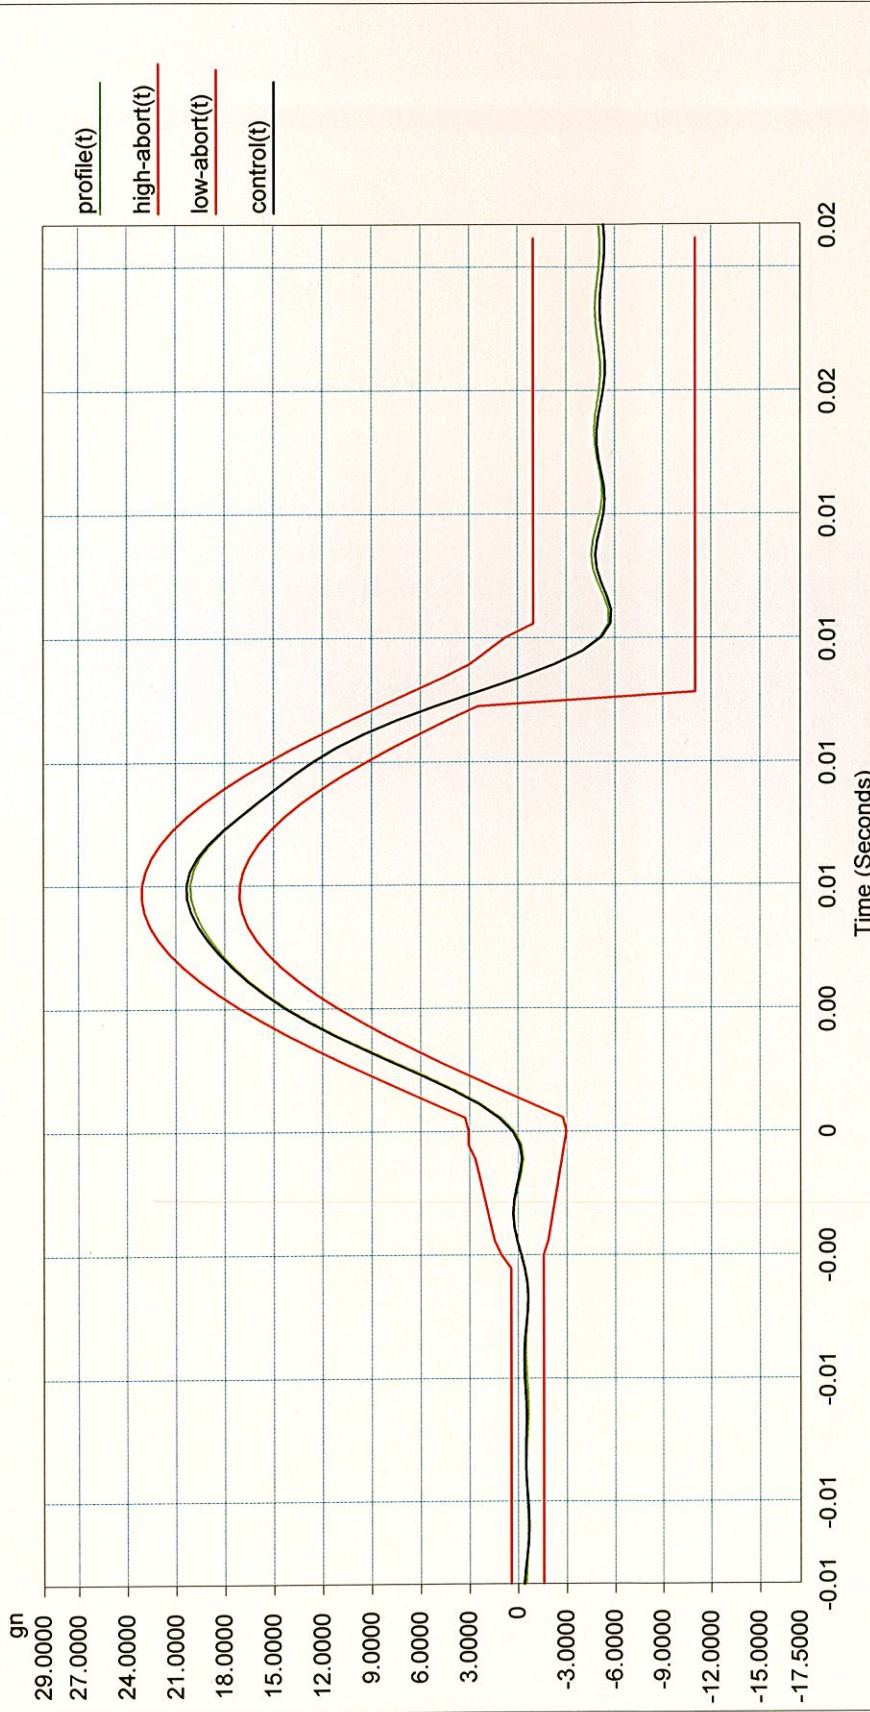
-Z Axis

Project File Name: 20g 11mS.prj

Profile Name: Test Type: Classical Shock Run Folder: .\RunDefault Dec 30, 2011 09-57-36

Level: 100 % Block Size: 2048 Elapsed Pulses: 12
 Frame Time: 0.682667 Seconds Control Peak: 20.227753 Control RMS: 2.233490 Full Level Elapsed Pulses: 3
 dT: 0.000333 Seconds Demand Peak: 20.000000 Demand RMS: 2.201481 Remaining Pulses: 0
 Pulse Type: Half Sine Amplitude: 20.000000 Pulse Width: 11.000000 ms
