TESTING / INSPECTION REPORT

REPORT NO : ST-130521-2

COMPANY : AAEON Technology Inc.
ADDRESS : 5F, No.135, Lane 235, Pao Chiao Rd.
Hsin-Tien City, Taipei, Taiwan, R. O. C.
TEL : 886-2-8919-1234
FAX : 886-2-8919-1049
SPECIMEN : TKS-P20-CV01-ASG (with mSATA)
DATE OF RECEIVED : 2013/05/21
DATE OF TESTED : 2013/05/21

TEST / INSPECTION ITEMS : Shock Test

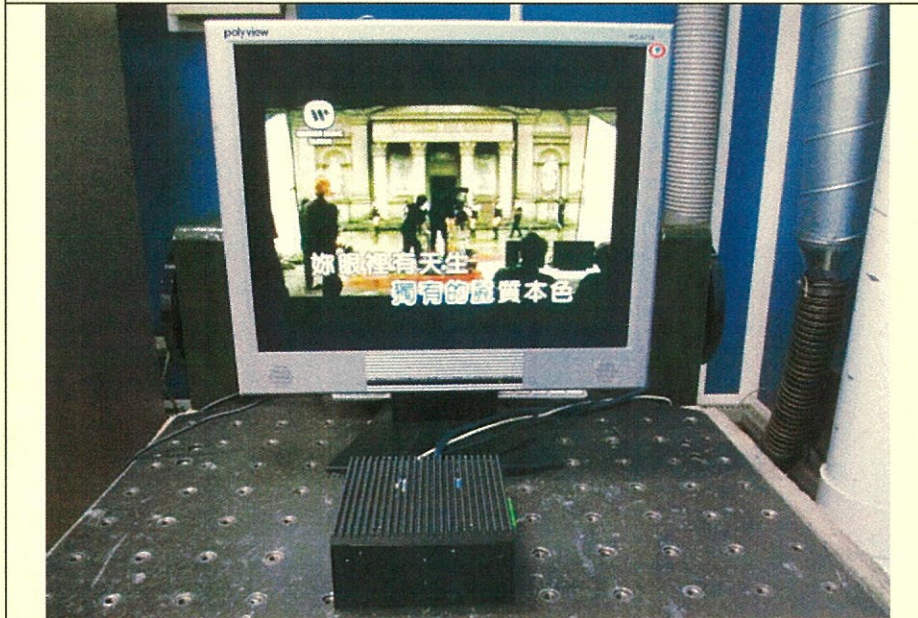
After test

(1)—Booting function was normal after the test.
(2)—No visible damages were found.

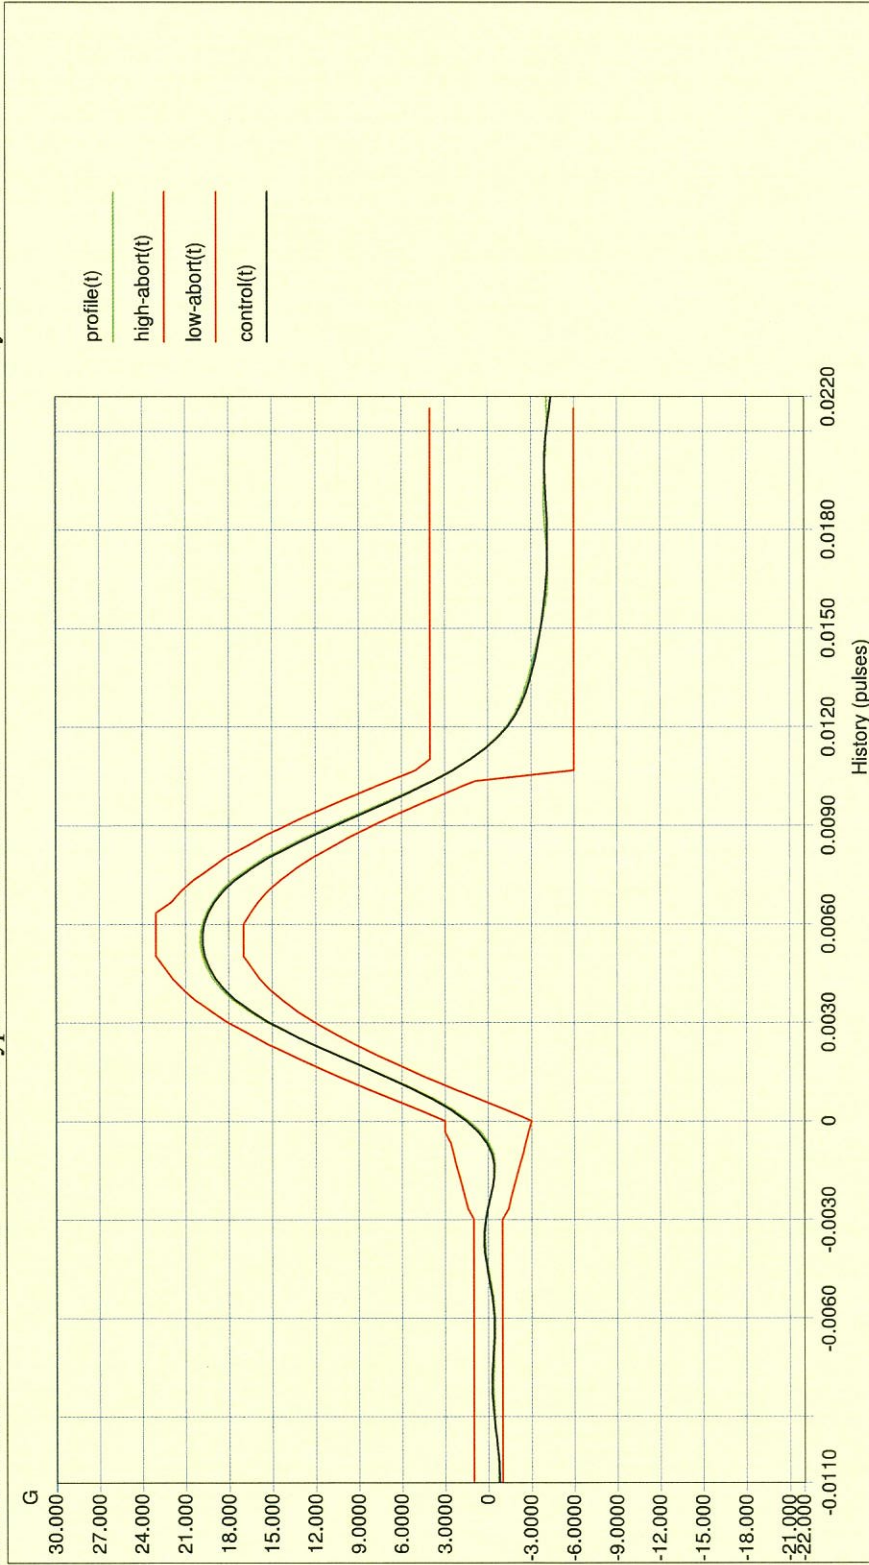
+X axis

Profile Name: 20G 11mSec Test Type: Classical Shock Run Folder: .\Run May 21,2013 13-28-52

Level: 100 % Block Size: 2048 Elapsed Pulses: 11
 Frame Time: 0.682667 Seconds Control Peak: 19.849804 G Control RMS: 2.042739 G Full Level Elapsed Pulses: 3
 dT: 0.000333 Seconds Demand Peak: 20.000000 G Demand RMS: 2.045214 G Remaining Pulses: 0
 Pulse Type: Half Sine Amplitude: 20.000000 G Pulse Width: 11.000001 ms

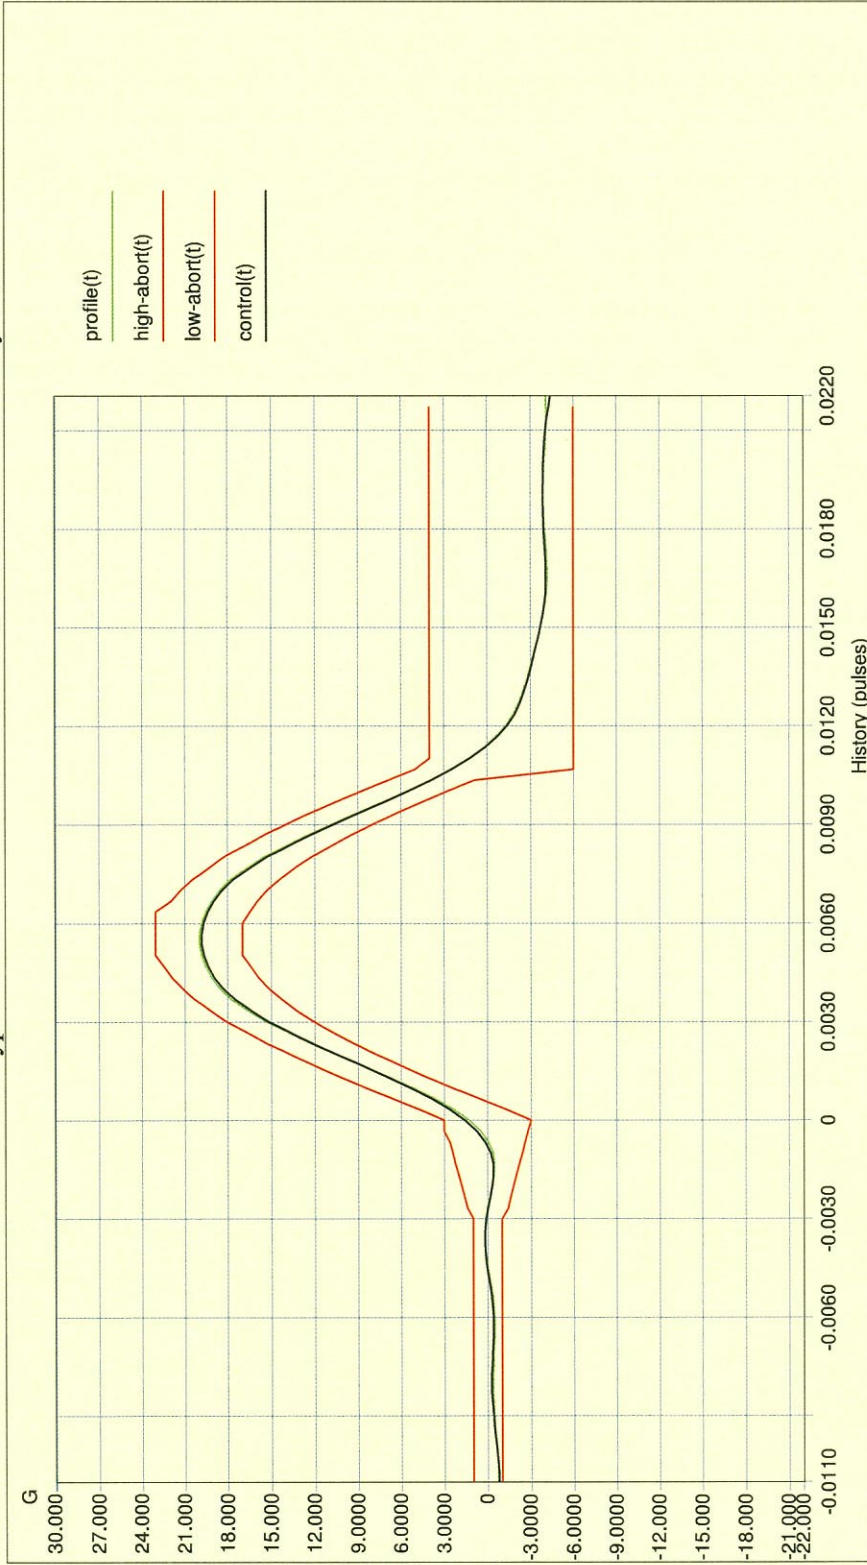
+Z axis

Profile Name: 20G 11mSec Test Type: Classical Shock Run Folder: .\Run May 21,2013 13-22-19

Level: 100 % Block Size: 2048 Elapsed Pulses: 11
 Frame Time: 0.682667 Seconds Control Peak: 19.857389 G Control RMS: 2.042290 G Full Level Elapsed Pulses: 3
 dT: 0.000333 Seconds Demand Peak: 20.000000 G Demand RMS: 2.045214 G Remaining Pulses: 0
 Pulse Type: Half Sine Amplitude: 20.000000 G Pulse Width: 11.000001 ms
