REPORT NO : ST-160108-1

COMPANY : AAEON Technology Inc.  
ADDRESS : 5F, No.135, Lane 235, Pao Chiao Rd.  
Hsin-Tien City, Taipei, Taiwan, R. O. C.  
TEL : 886-2-8919-1234  
FAX : 886-2-8919-1049  
SPECIMEN : VPC-3300S (With SSD)  
DATE OF RECEIVED : 2016/01/08  
DATE OF TESTED : 2016/01/08

TEST / INSPECTION ITEMS : Shock Test

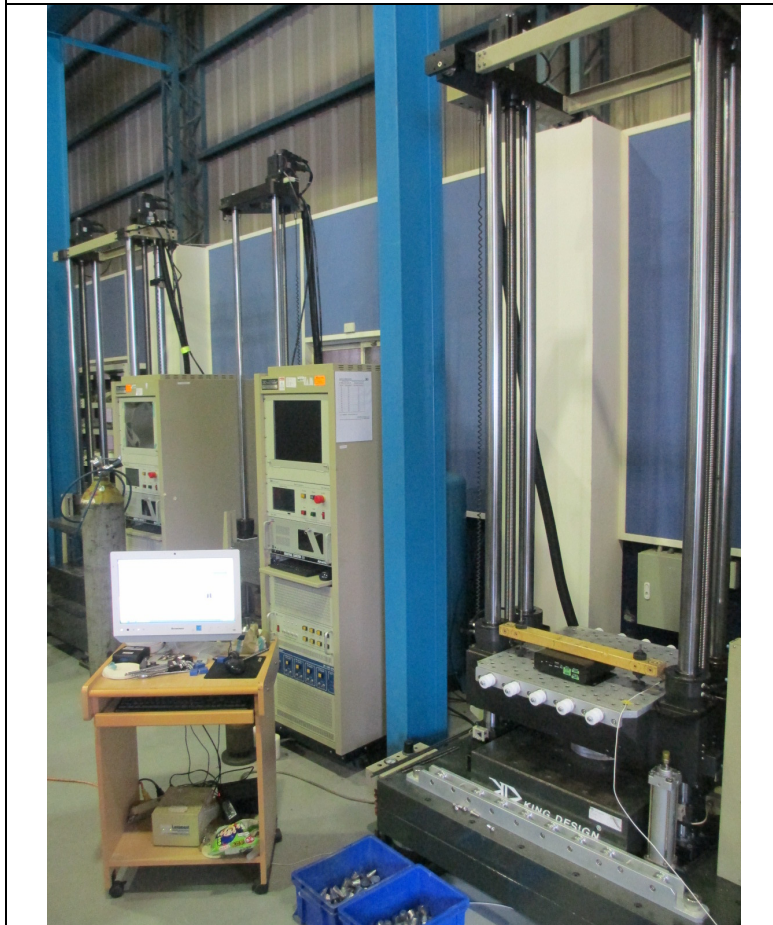
#### Tester

### Testing photos (Non-Operating)

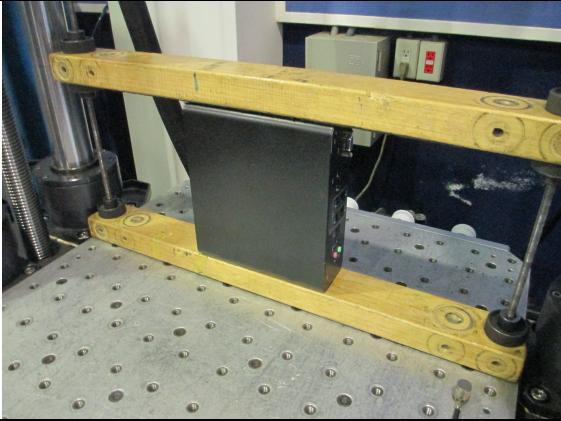
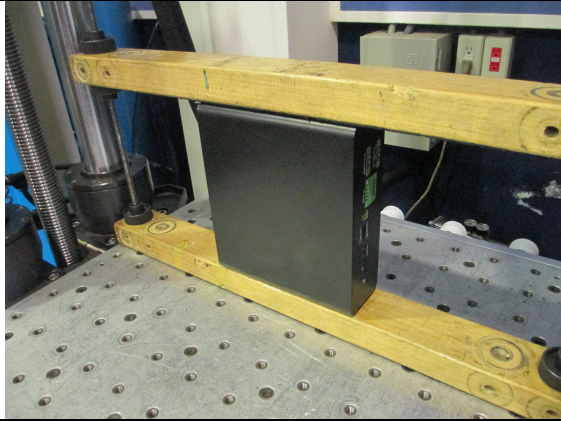
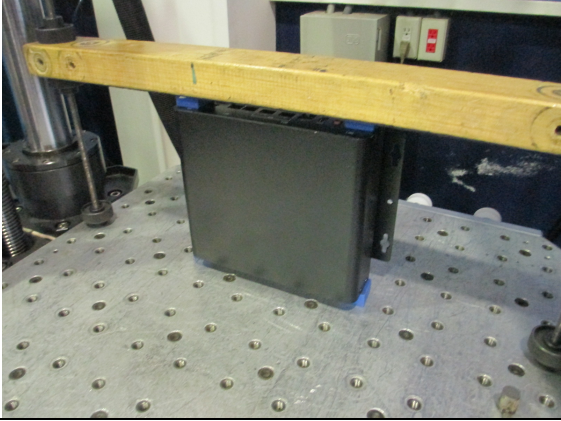
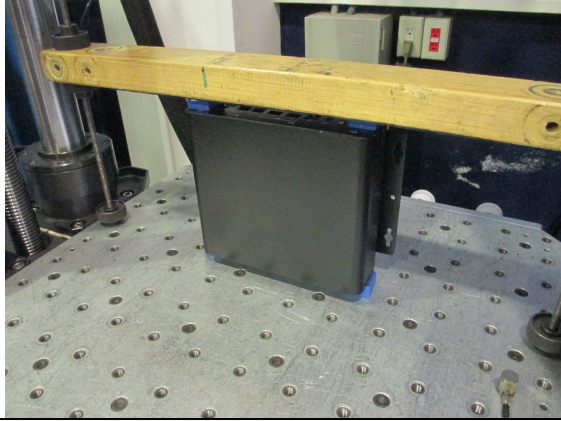
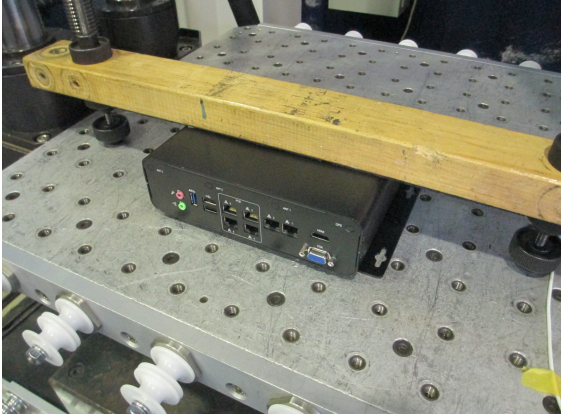
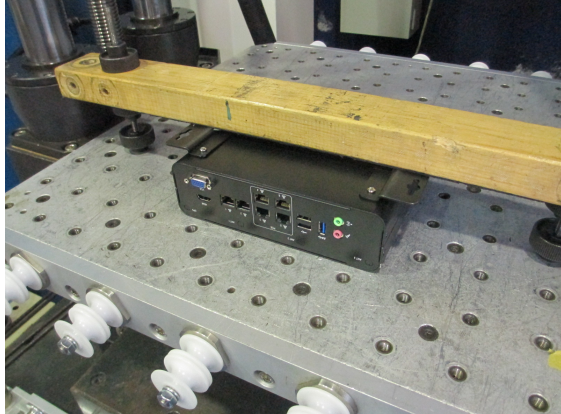
Testing photos (Non-Operating)	
<b>+X axis</b>	<b>-X axis</b>

<b>+Y axis</b>	<b>-Y axis</b>

<b>+Z axis</b>	<b>-Z axis</b>

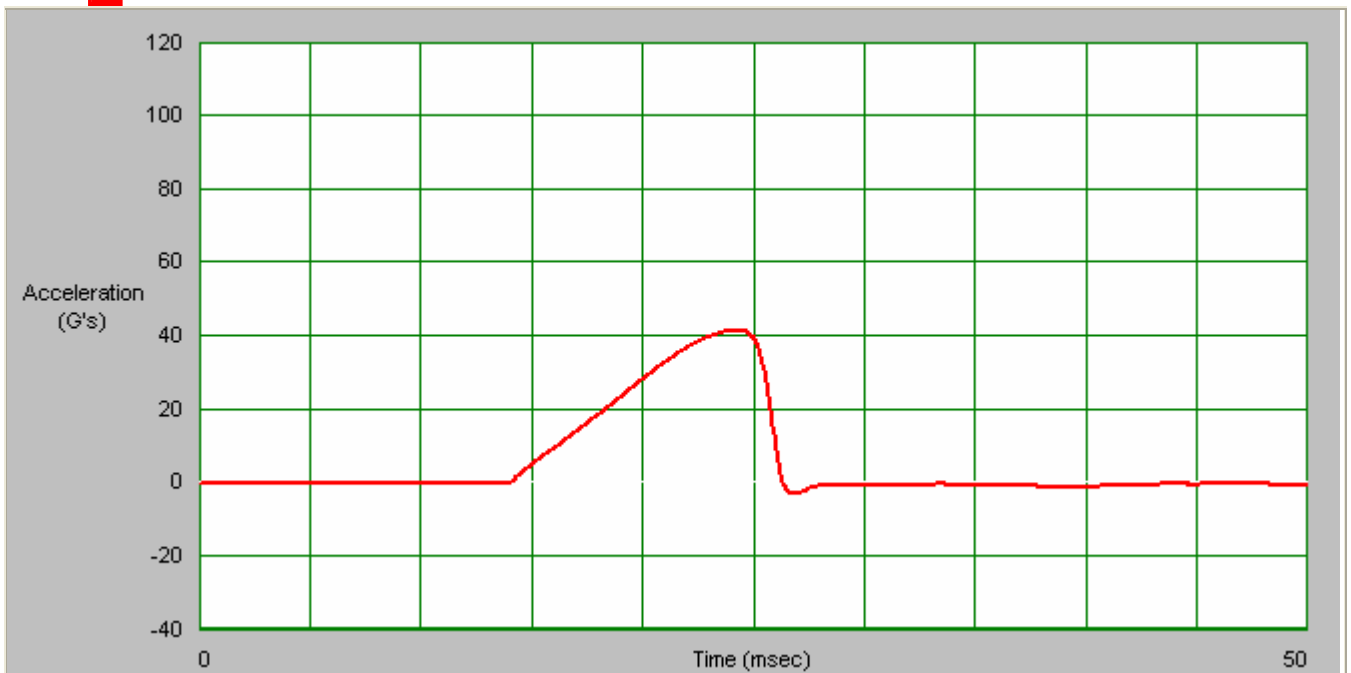
-Y axis Operating

Channel Description:	G's	msec	cm/s	Filter Hz	Max G's	Min G's
Ch1 <span style="color: red;">█</span> CTRL	40.13	11.35	291.11	500.00	40.13	-4.59

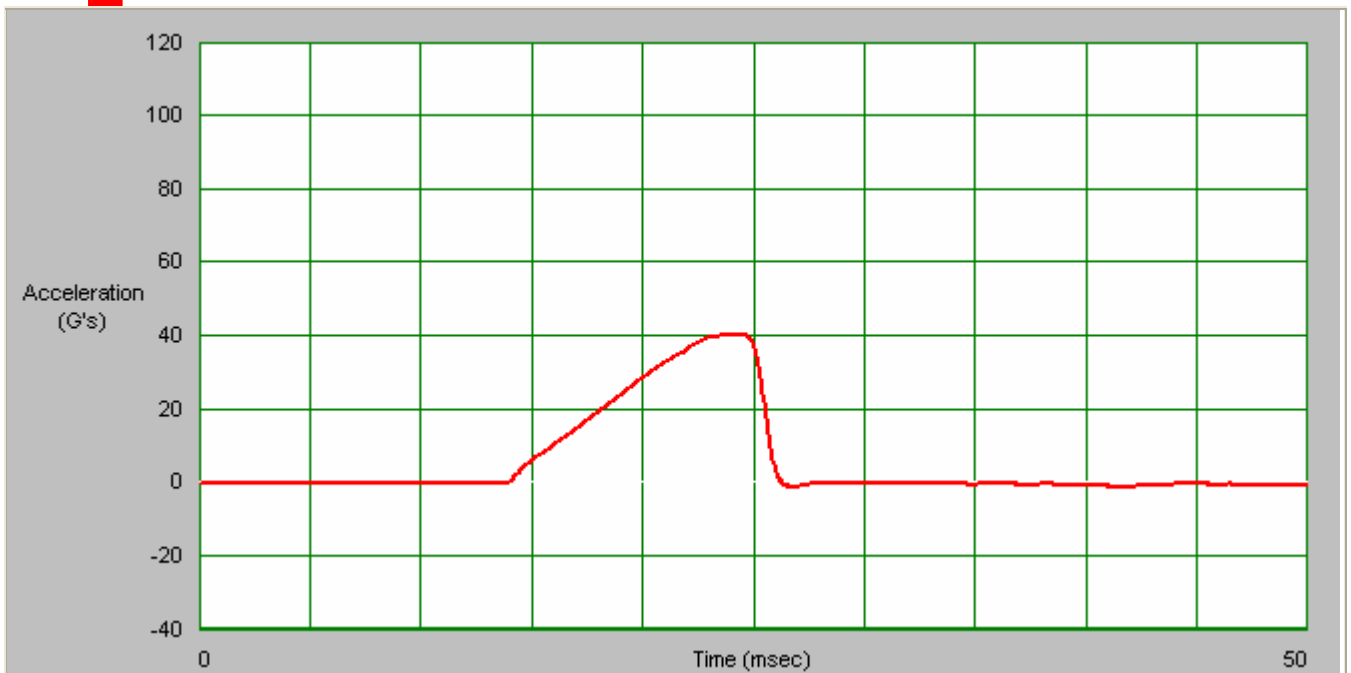
+Z axis Operating

Channel Description:	G's	msec	cm/s	Filter Hz	Max G's	Min G's
Ch1 <span style="color: red;">█</span> CTRL	40.23	11.40	287.00	500.00	40.23	-1.47

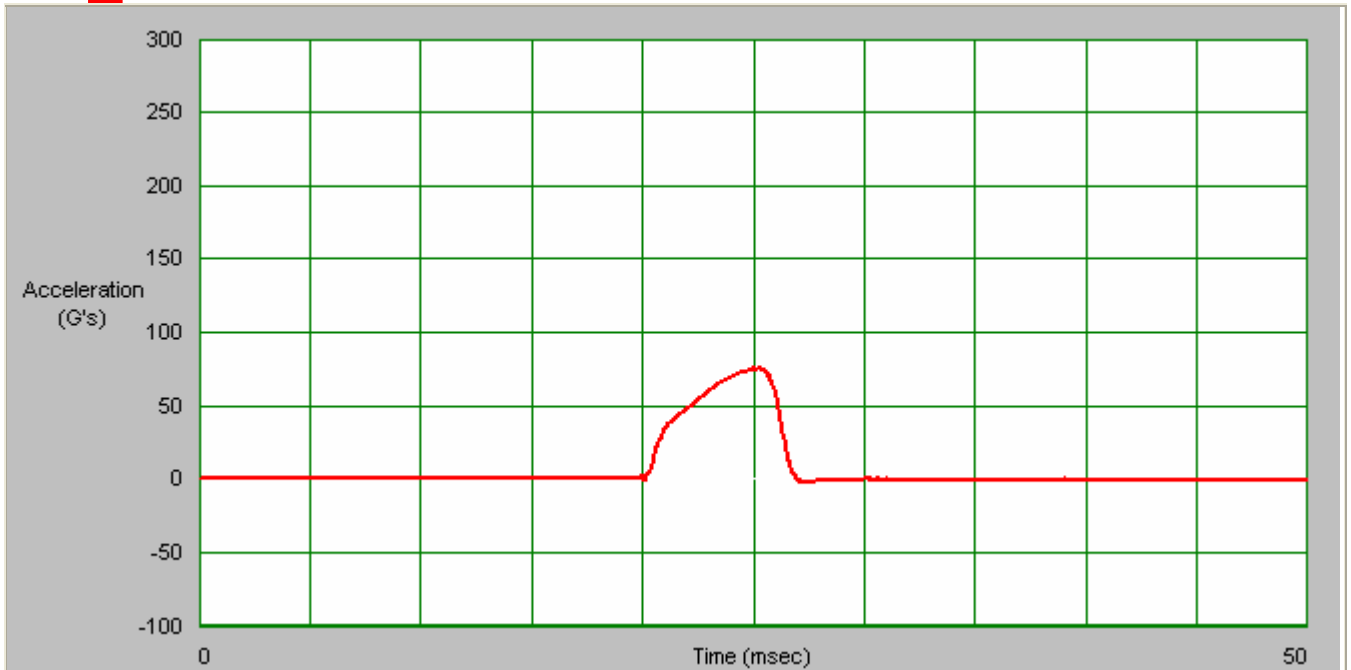
-Y axis Non-Operating

Channel Description:	G's	msec	cm/s	Filter Hz	Max G's	Min G's
Ch1 CTRL	75.14	6.40	337.49	500.00	75.14	-2.87

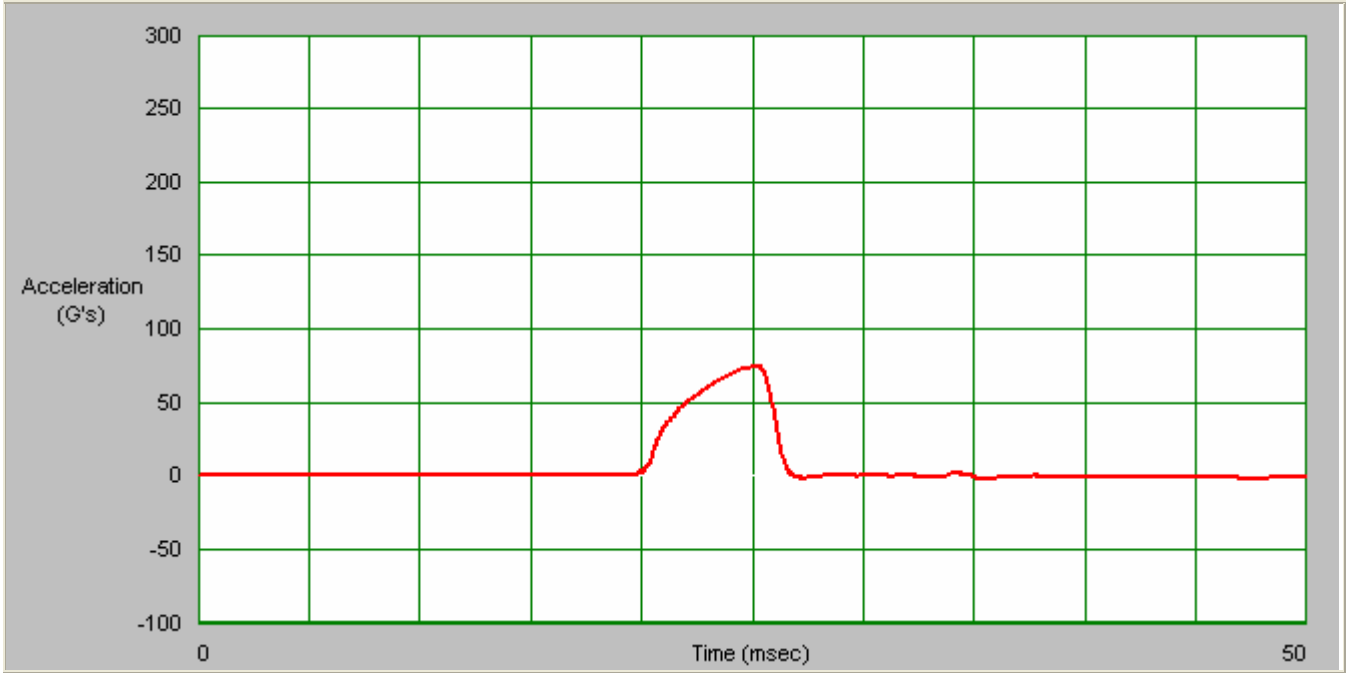
-Z axis Non-Operating

Channel Description:	G's	msec	cm/s	Filter Hz	Max G's	Min G's
Ch1 CTRL	74.40	6.25	322.69	500.00	74.40	-2.63
