TESTING / INSPECTION REPORT

REPORT NO : ST-160108-2

COMPANY : AAeon Technology Inc.
ADDRESS : 5F, No.135, Lane 235, Pao Chiao Rd.
Hsin-Tien City, Taipei, Taiwan, R. O. C.
TEL : 886-2-8919-1234
FAX : 886-2-8919-1049
SPECIMEN : VPC-5500S (With SSD)
DATE OF RECEIVED : 2016/01/08
DATE OF TESTED : 2016/01/08

TEST / INSPECTION ITEMS : Shock Test

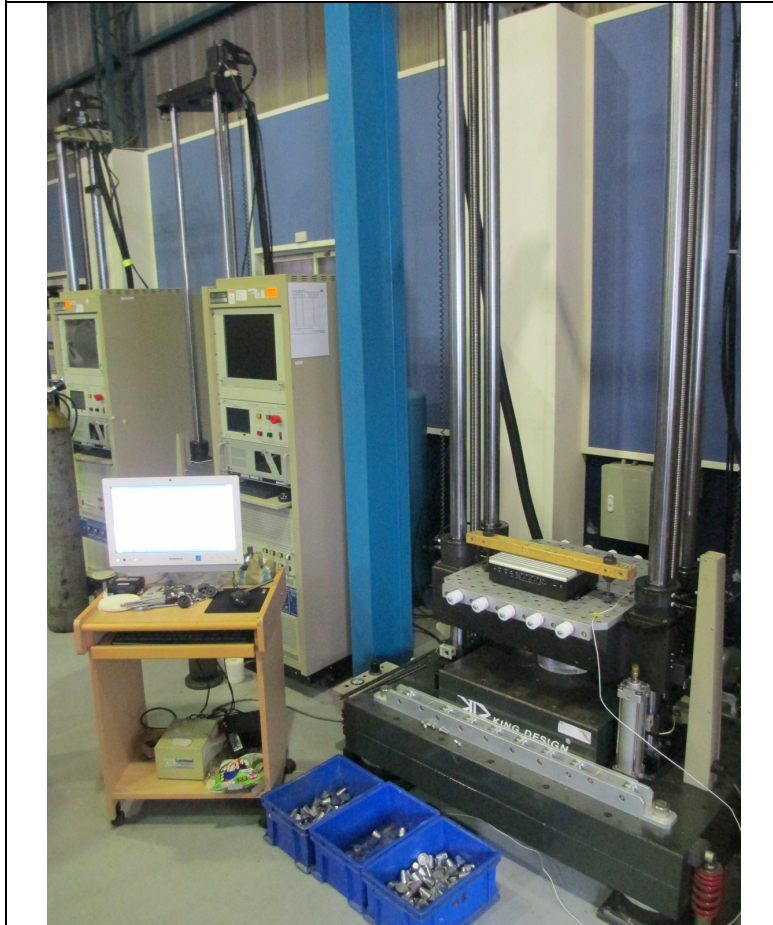
Testing photos (Non-Operating)

Tester

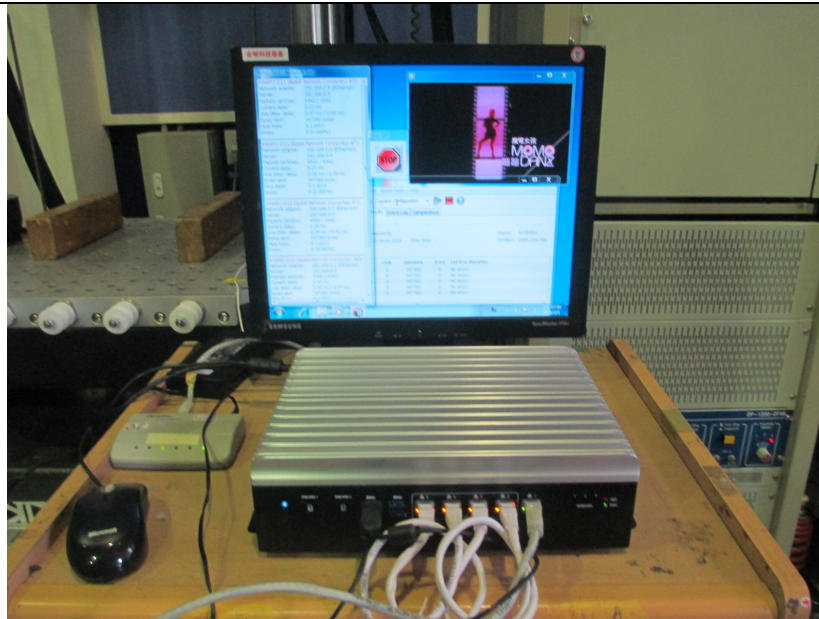
Testing photos

Describe	PASS	FAIL	Non-Judgment
Function judgment ⁽¹⁾	√	---	---
Appearance check ⁽²⁾	√	---	---
(1)—Booting function was normal after the test. (2)—No visible damages were found.

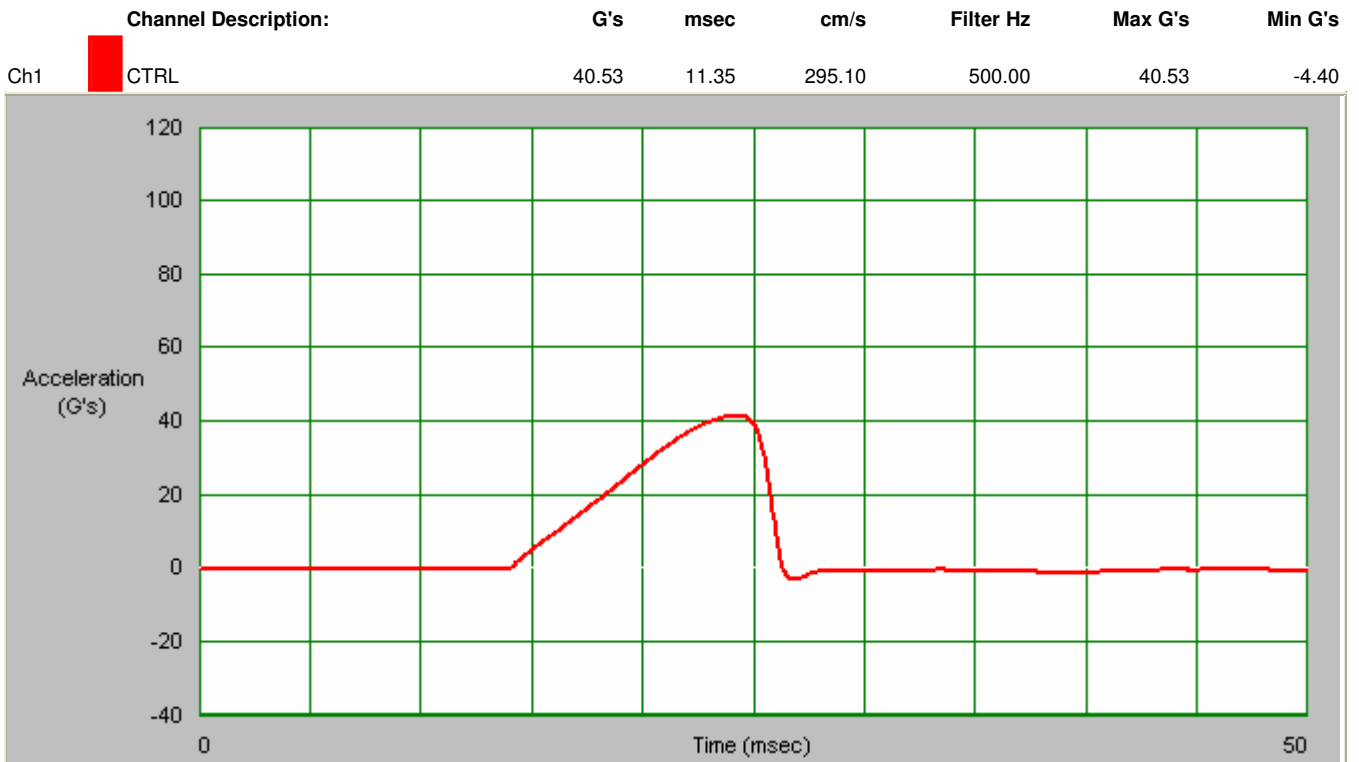
-Z axis Operating

Acceleration vs Time

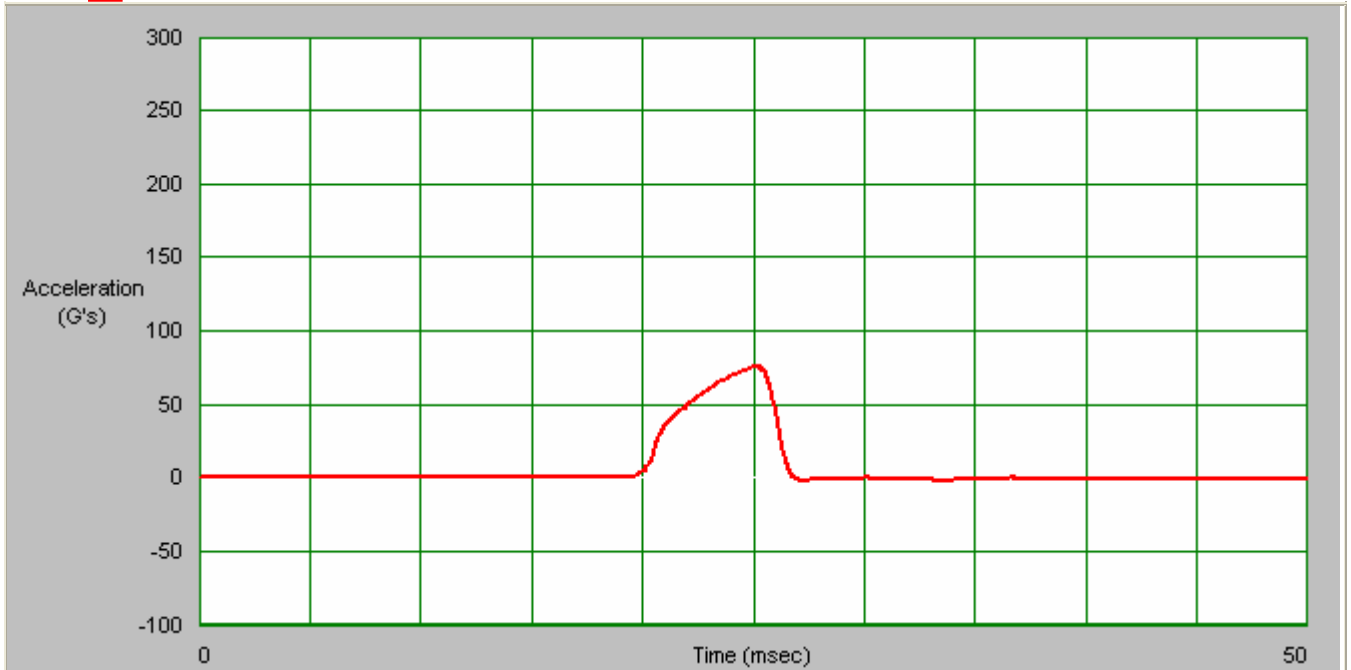
+X axis Non-Operating

Acceleration vs Time

Channel Description:	G's	msec	cm/s	Filter Hz	Max G's	Min G's
Ch1 CTRL	75.68	6.45	331.59	500.00	75.68	-2.05
