# GENE-APL6

## Thermal Image Analysis Report

**2. Test Product: GENE-APL6**

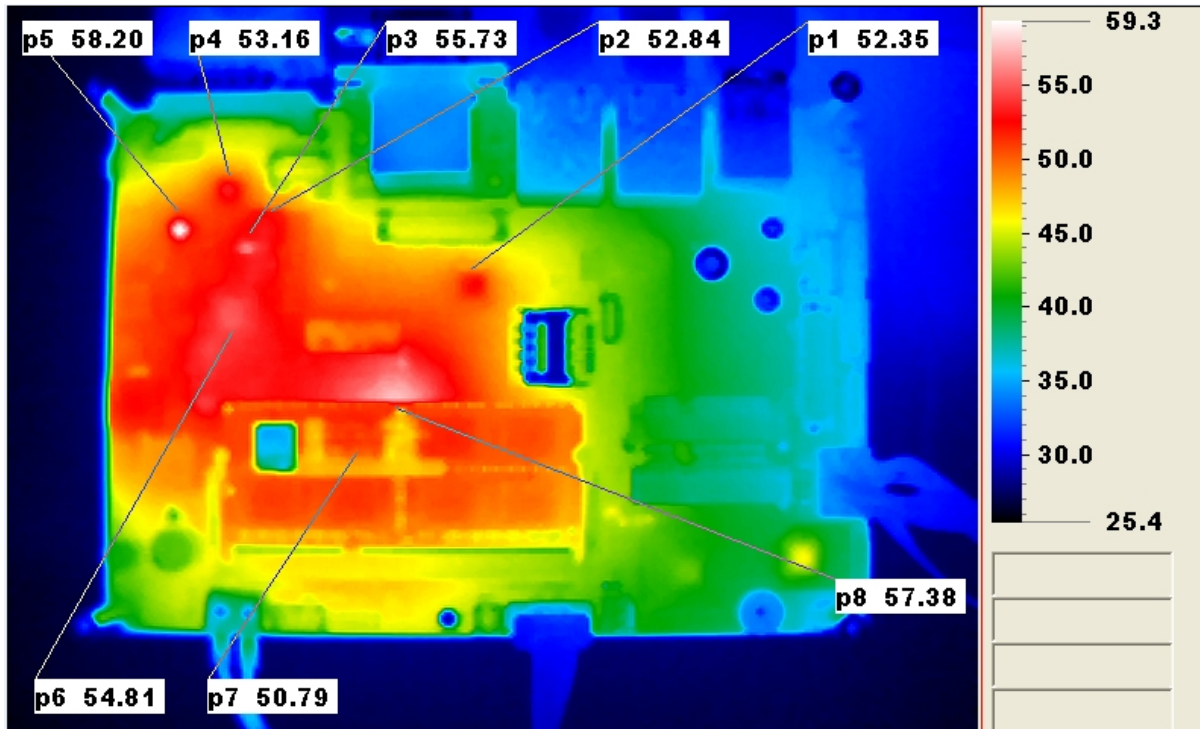
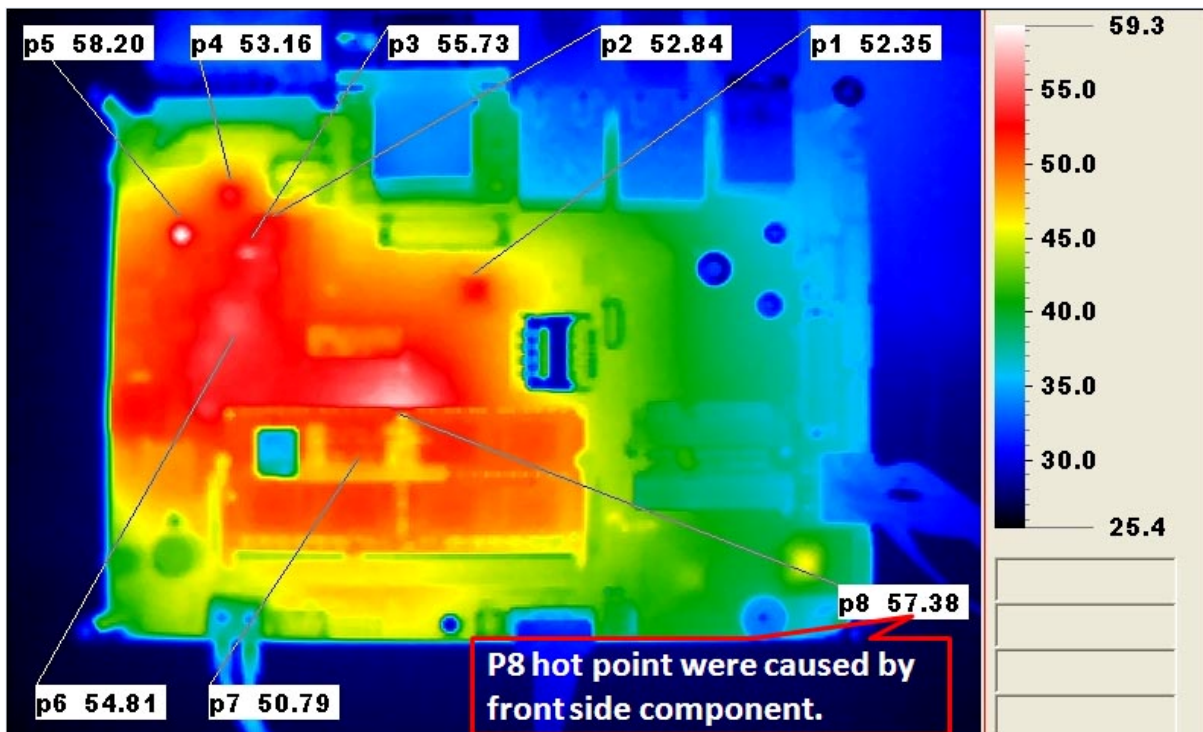
**Temperature Profile Test:**  
**Component Side:**

Summary	<input type="checkbox"/> <b>Pass</b>  <input type="checkbox"/> <b>Fail</b>  <input checked="" type="checkbox"/> <b>Pass with Deviation</b> <b>Comment:</b> <u>There are 6 temperature points marginal passed, the functions are stable.</u>				
	<b>Test Result Summary</b>				
	Critical	Major	Minor	Enhancement	
Defect Found	0	0	0	6	
Defect Unsolved	0	0	0	6

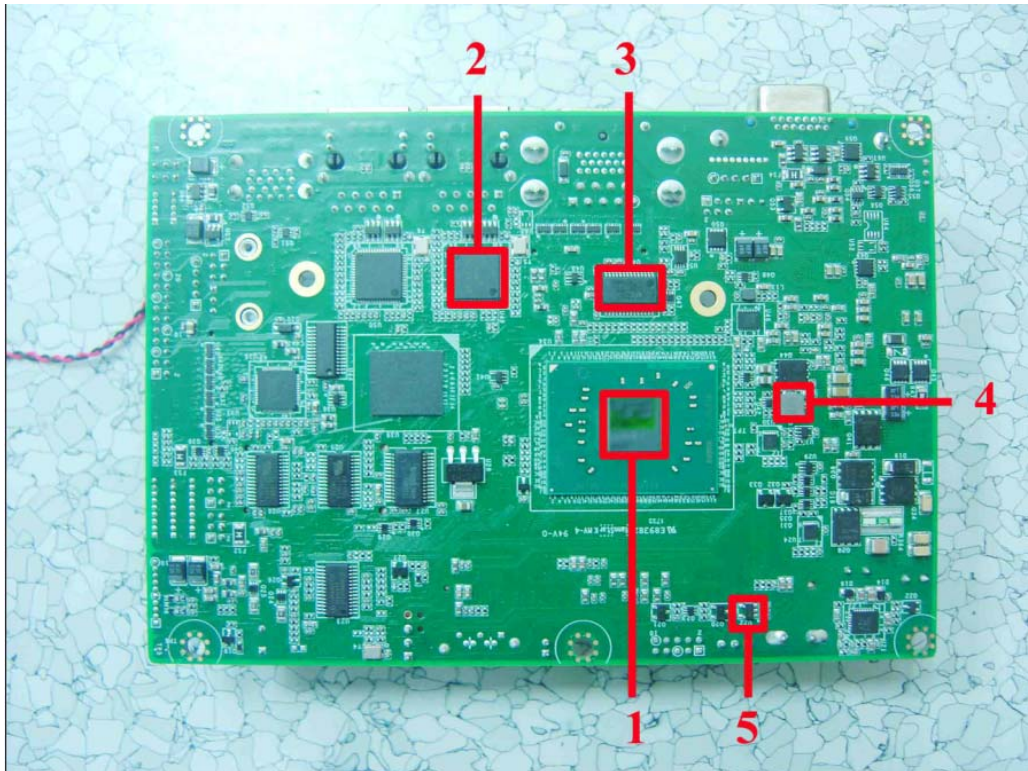
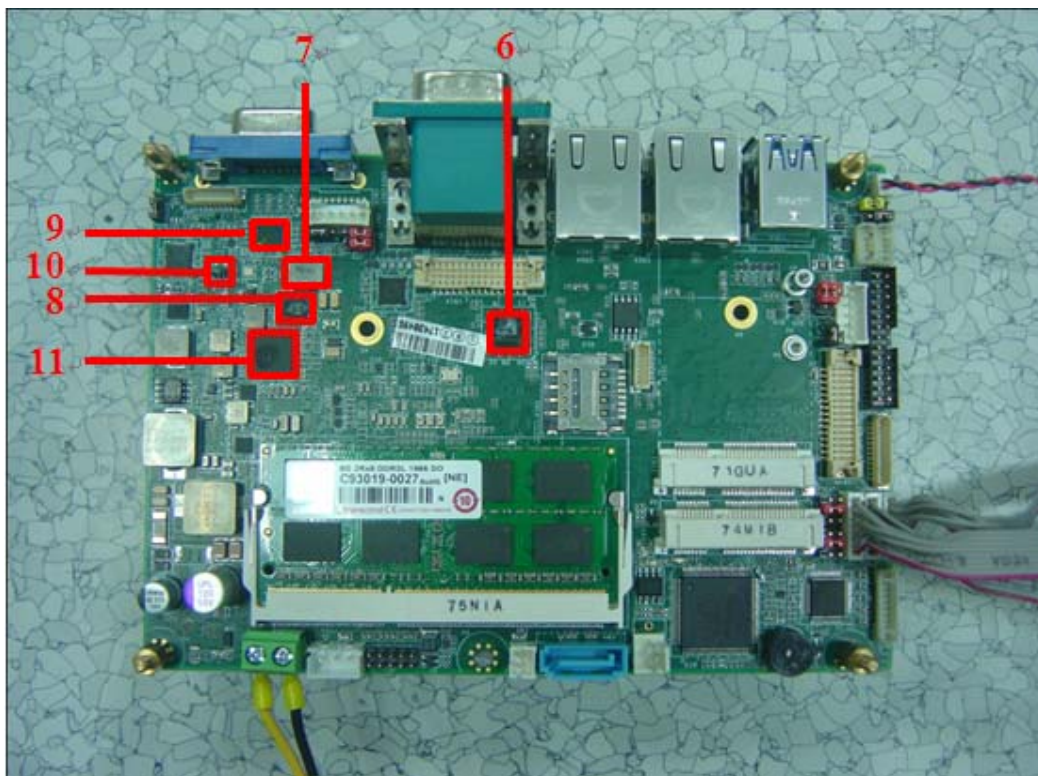
Measuring Thermal Couple Position :

Point	Position	Describe	Tc (*1) (°C)	TAT(*2)		TPT(*3)	Note
				26.0°C	60°C		
1	U34	(TF)INTEL CPU.Apollo Lake.Pentium N4200.2.5GHz	105	53.8	88.8		
2	U49	(TF)IC.PCI-E GigaBit Ethernet Chipset. Intel.I211AT	85	54.1	89.1	Note 4	
3	U47	(TF)IC.RS232 Driver/Receiver. TI.TRS213IDBR	85	53.6	88.6	Note 4	
4	L12	(TF)Coil.0.47uH.DCR=14mΩ.Idc=7.5A. HDT.MPCA-0420-R47-	125	59.6	94.6		
5	U22	(TF)IC.Regulator.EXAR.SPX5205M5-L-5.0	125	57.8	92.8		
6	U9	(TF)IC.Display Port to LVDS Converter NXP.PTN3460IBS/F2MP	96.8	56.0	91.0	Note 4	
7	L8	(TF)COIL.CYNTEC.PCMB063T-R22MS	125	56.8	91.8		
8	Q15	(TF)PWR.DUAL N-MOSFET.FAIRCHILD.FDMS3664S	100	56.7	91.7	Note 4	
9	U19	(TF)IC.DisplayPort to VGA Converter. Chrontel.CH7517A-BF	125	57.5	92.5		
10	U13	(TF)IC.LDO. ANPEC.APL5325BI-TRG	100	65.8	100.8		
11	U7	(TF)IC.PMIC.Intel Apollo Lake TI.TPS650942A0RSKR	100	59.7	94.7	Note 4	
12		Memory chipset	95	57.2	92.2	Note 4

- "Tc" indicates the component's case maximum temperature value specified in its datasheet.
  - "TAT" indicates the actual measured temperature under product specification.
  - "TPT" indicates the predicted temperature under 25°C working environmental.
  - Judgment Criteria:**
    - **Fail** :  $T_m > T_c + 5^\circ\text{C}$ ; The measured value is over specification plus margin.
    - **Margin** :  $T_c + 5^\circ\text{C} > T_m > T_c - 10^\circ\text{C}$ ; The measured value is within specification with margin.
- For FANLESS system application, it is strongly recommended to add thermal dissipation design for better reliability.
- **Pass** :  $T_m < T_c - 10^\circ\text{C}$ ; The measured value is with safety margin.
- RTC battery avoid to put on heat position.** Please do not exceed battery temperature specification.
  - Defect NO.** : [000000LABD01](#)
