TESTING / INSPECTION REPORT

DATE : May 30,2001
 REPORT NO : VT-010530-1

SPECIMEN : AEC-204

TEST / INSPECTION ITEMS : Vibration Test (See Page 2)

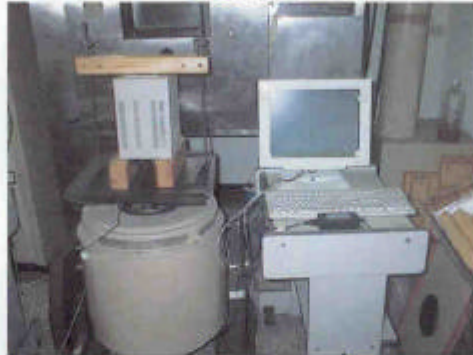
AXIS X

Testing photos

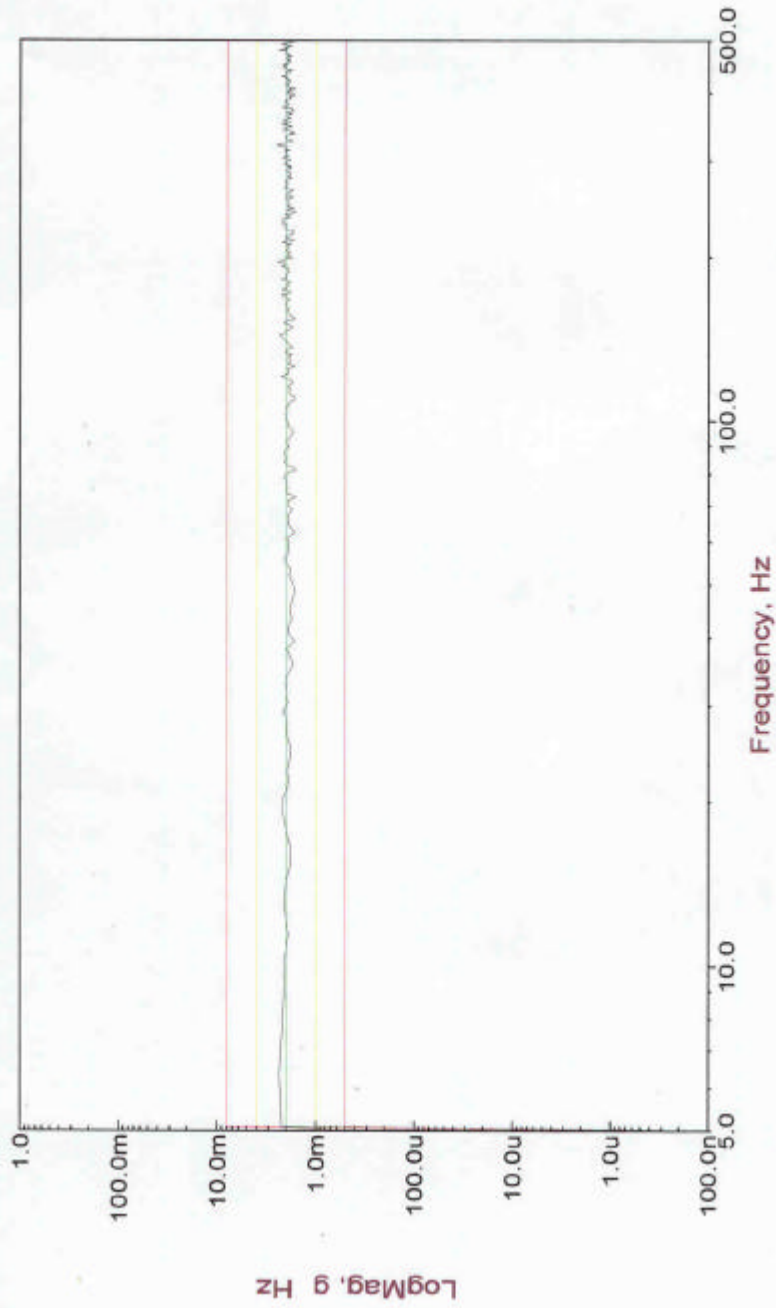
Control

Y-axis: 100
AI Level: 0.99:05
Engage: 1.00:21

L: 1.00 g
Demand: 1.00 g
Actual: 0.99 g

Mode: P
Main Status: Auto
Loop: Closed

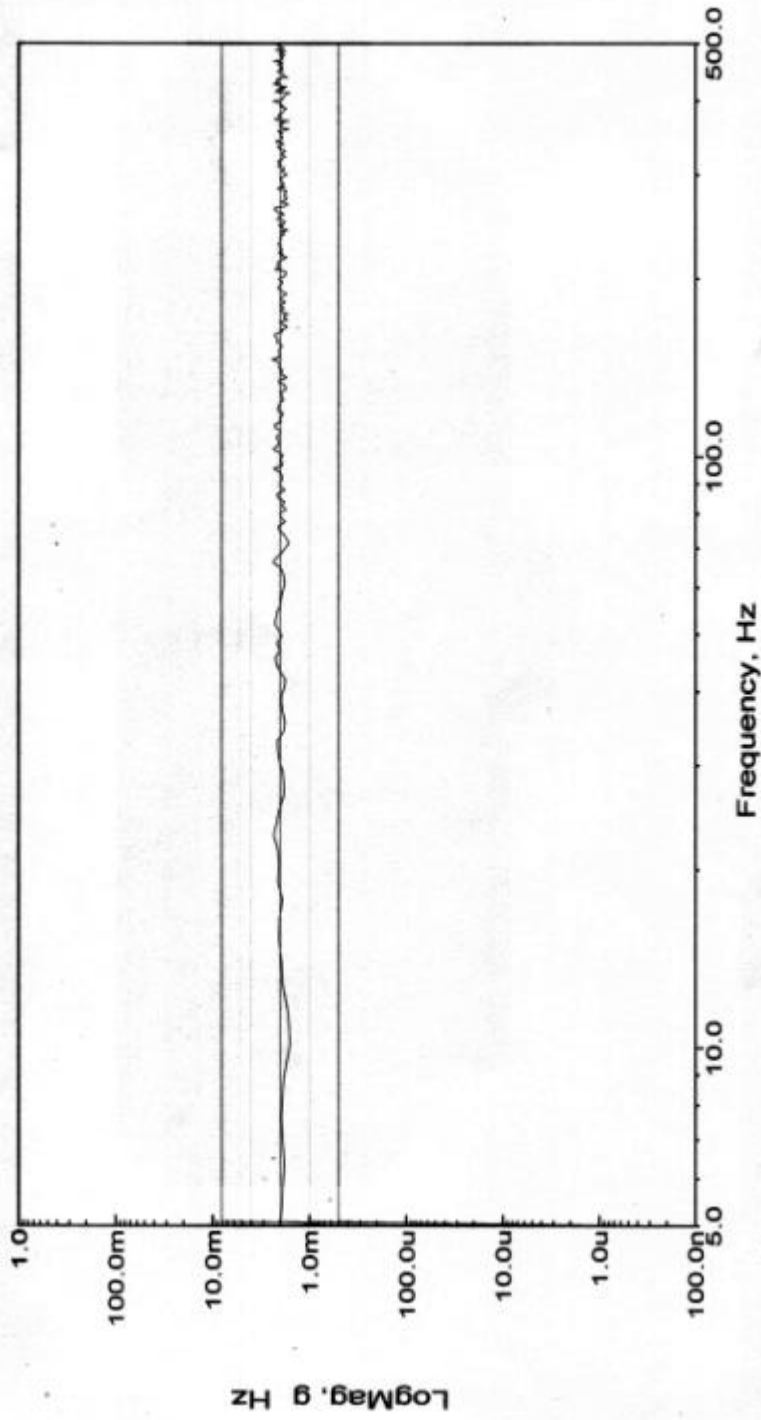
Control

Remaining: 0.00.00
At Level: 1.11.10
Elapsed: 1.00.21

Level: 100.00 %
Demand: 1.00 g
Actual: 0.99 g

Status: Review
Run: (State Auto)
Loop: Closed
