TESTING / INSPECTION REPORT

REPORT NO : VT-140108-2

COMPANY : AAEON Technology Inc.
ADDRESS : 5F, No.135, Lane 235, Pao Chiao Rd.
Hsin-Tien City, Taipei, Taiwan, R. O. C.
TEL : 886-2-8919-1234
FAX : 886-2-8919-1049
SPECIMEN : AEC-6402 (With mSATA)
DATE OF RECEIVED : 2014/01/08
DATE OF TESTED : 2014/01/08

TEST / INSPECTION ITEMS : Vibration Test

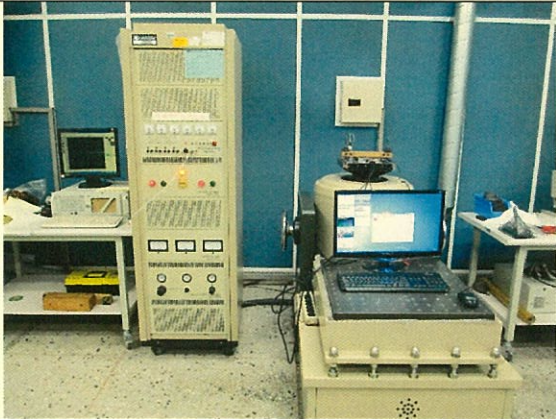
Testing photos	
Tester	Z axis

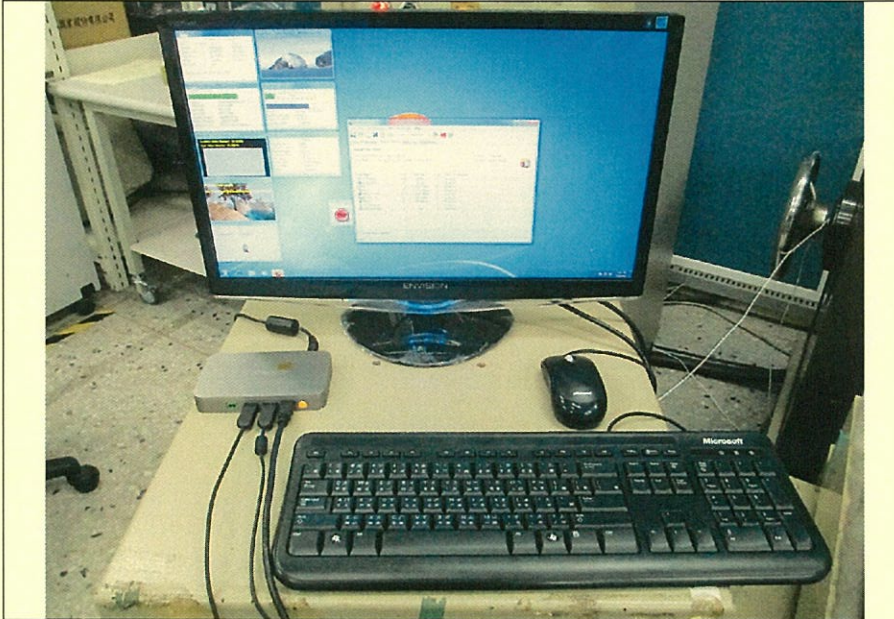
After test

Describe	PASS	FAIL	Non-Judgment
Function judgment ⁽¹⁾	√	---	---
Appearance check ⁽²⁾	√	---	---
(1)—Booting function was normal after the test. (2)—No visible damages were found.
