APD-7211 Vibration Test Report

Test Product: APD-7211,21.3" Panel LCD.

NO.	Description
IEC68-2-6	Testing procedures Test Fc : Vibration Sinusoidal Test

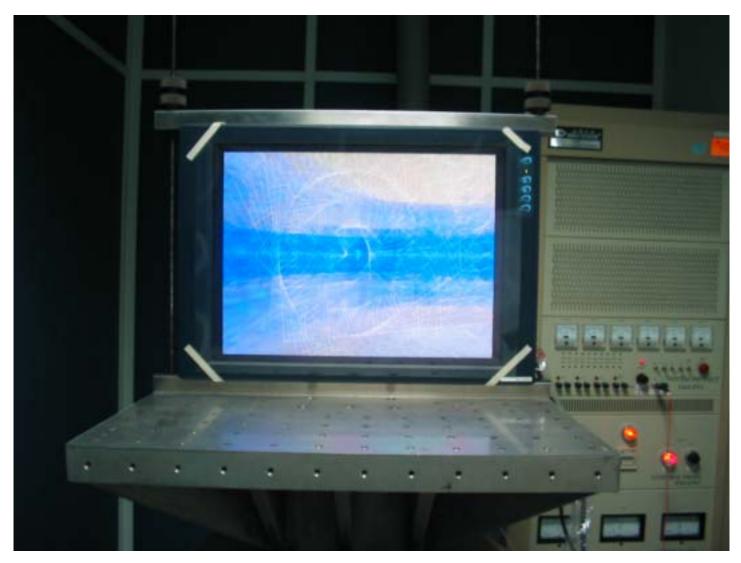
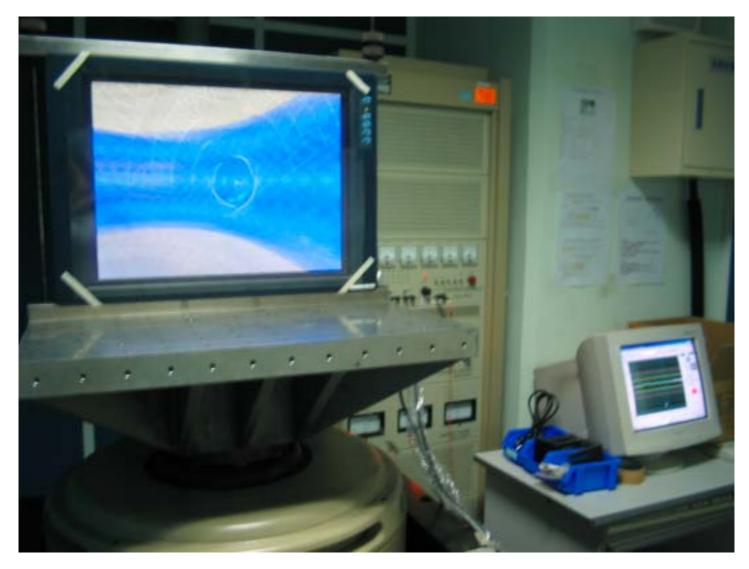
Photo 1 :

APD-7211 operation random vibration test for X-axis

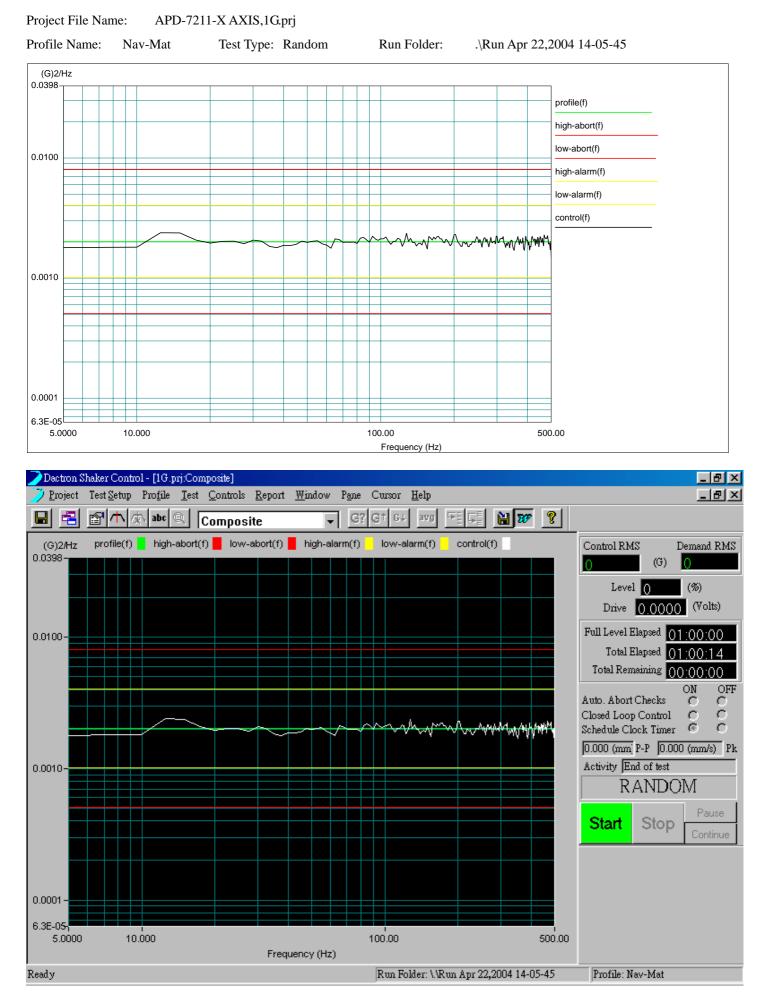
Control RMS:
 1.001871 GFull Level Elapsed Time:
 01:00:00
 Lines:
 225
 Frame Time:
 0.400000 Seconds

Demand RMS:
 1.001343 GRemaining Time:
 00:00:00
 DOF: 154
 dF:
 2.500000 Hz

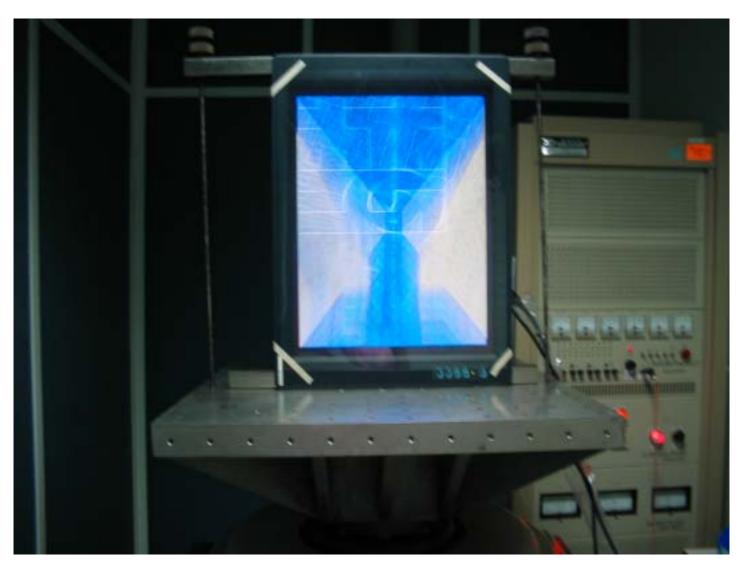
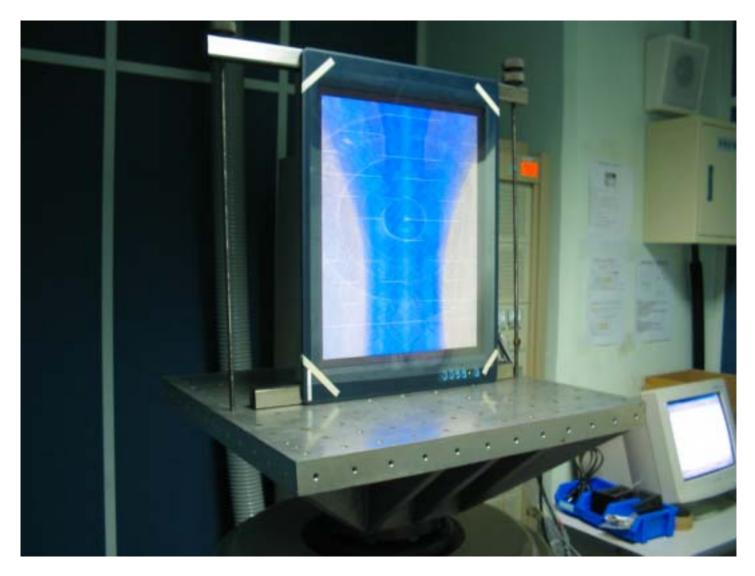
Photo 2:

APD-7211 operation random vibration test for Y-axis

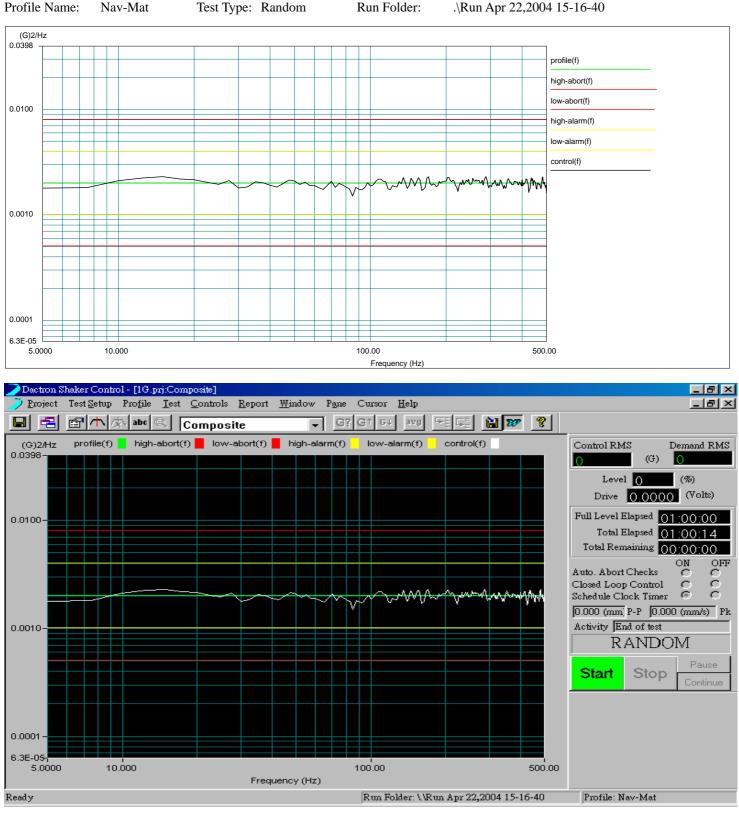
Project File Name: ADP-7211 Y-AXIS 1G.prj

Control RMS:	0.995440 GFull Level Elapsed Tim	ne: 01:00:00	Lines:	225	Frame Time:	0.400000 Seconds
Demand RMS:	1.001343 GRemaining Time:	00:00:00	DOF:154 dF:		2.500000 Hz	
Data sav	ed at 04:26:56 PM, Thursday, April 2	22, 2004	Report created at 0	4:26:5′	7 PM, Thursday, A	pril 22, 2004

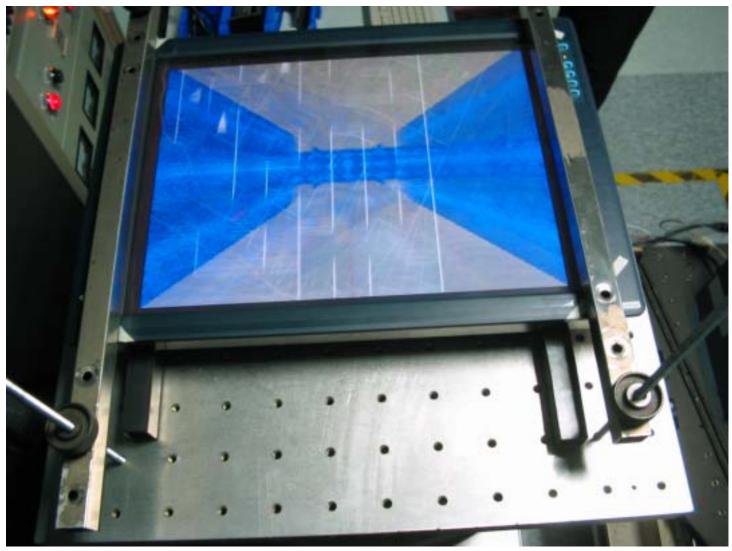
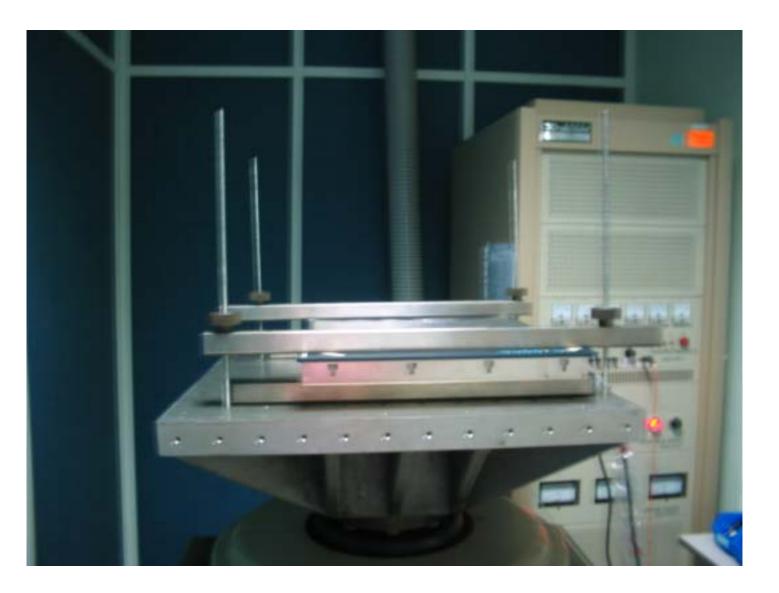
Photo 3 :

APD-7211 operation random vibration test for Z-axis

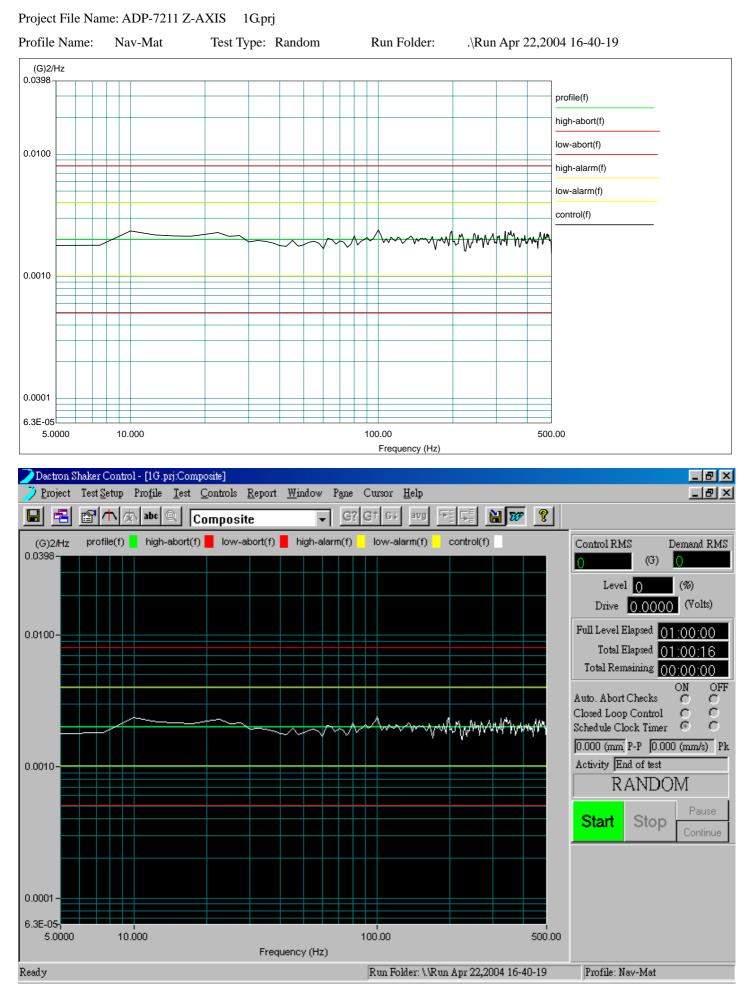
Control RMS:	0.997182 GFull Level Elapsed Time	e: 01:00:00	Lines:	225	Frame Time:	0.400000 Seconds
Demand RMS:	1.001343 GRemaining Time:	00:00:00	DOF:154 dF:		2.500000 Hz	
Data saved at 05:43:23 PM, Thursday, April 22, 2004			Report created at 05	5:43:24	4 PM, Thursday, A	April 22, 2004
