REPORT NO : VT-170531-4

COMPANY : AAEON Technology Inc.  
ADDRESS : 5F, No.135, Lane 235, Pao Chiao Rd.  
Hsin-Tien City, Taipei, Taiwan, R. O. C.  
TEL : 886-2-8919-1234  
FAX : 886-2-8919-1049  
SPECIMEN : BOXER-6839  
DATE OF RECEIVED : 2017/05/31  
DATE OF TESTED : 2017/05/31

TEST / INSPECTION ITEMS : Vibration Test

Random vibration test (Operating)  
Frequency : 5 Hz to 500 Hz  
Acceleration : 5 g rms  
Test Direction : X, Y, Z axis  
Test Time : 1 hr (Each axis)  
Total Test Time : 3 hrs

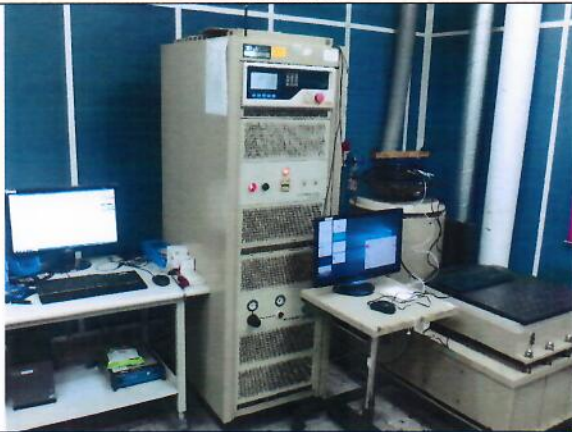
**Tester**

Vibration Tester : KING DESIGN KD-9363EM-600F2K-50N120,  
S/N : KDS11054986  
Controller : VCS-913<sup>+</sup>, S/N : 1312384  
Control Accelerometer : Wilcoxon Research WR-777, S/N : 4207  
Calibration Date : 2016/11/25

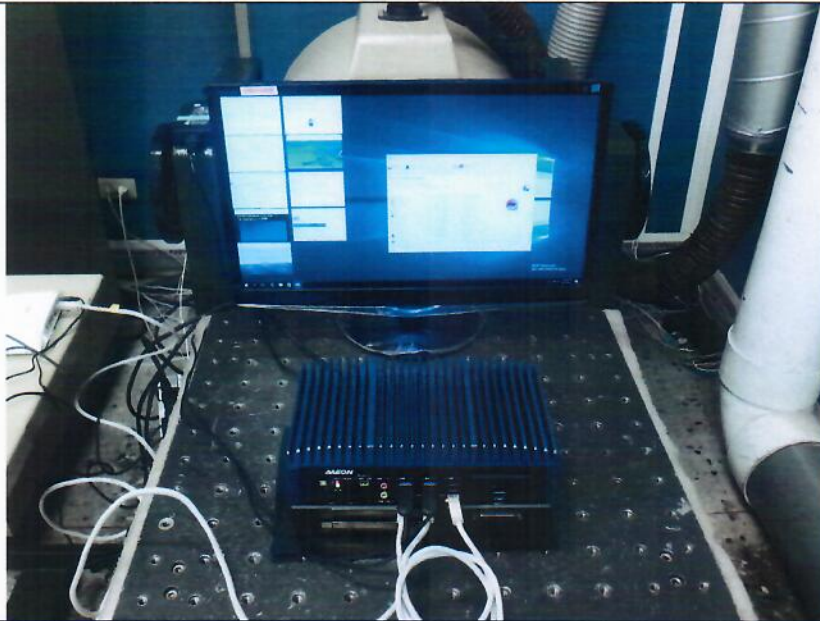
#### After test

(2)—No visible damages were found.
