REPORT NO : VT-161202-2

COMPANY : AAEON Technology Inc.
ADDRESS : 5F, No.135, Lane 235, Pao Chiao Rd.
Hsin-Tien City, Taipei, Taiwan, R. O. C.
TEL : 886-2-8919-1234
FAX : 886-2-8919-1049
SPECIMEN : RTC-1200SK
DATE OF RECEIVED : 2016/12/01
DATE OF TESTED : 2016/12/02

TEST / INSPECTION ITEMS : Vibration Test

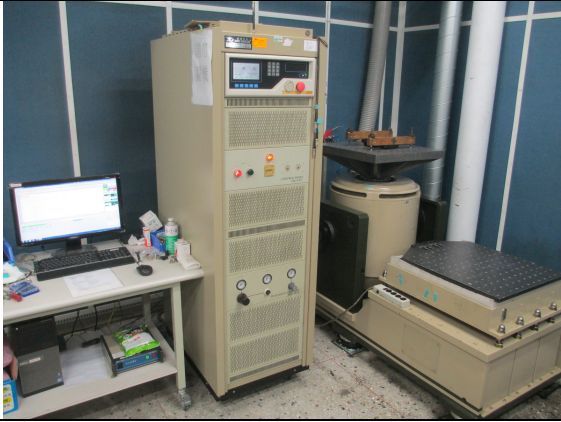
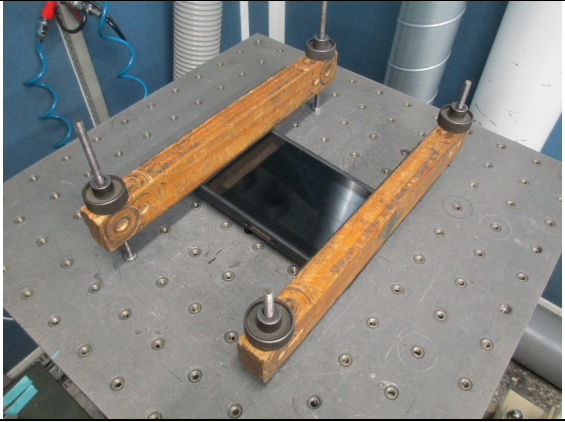
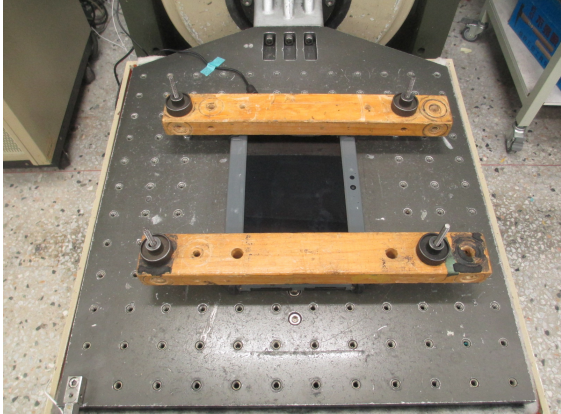
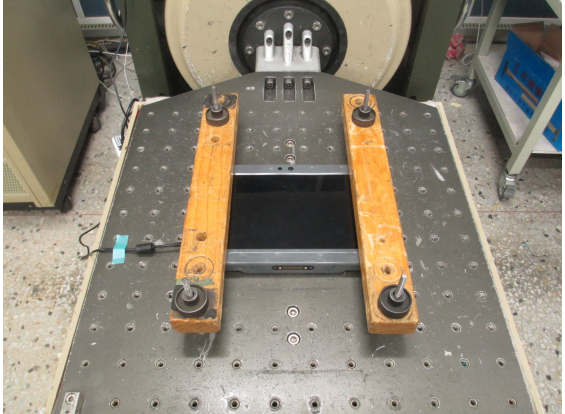
Testing photos (Non-Operating)	
Tester	Z axis

X axis	Y axis

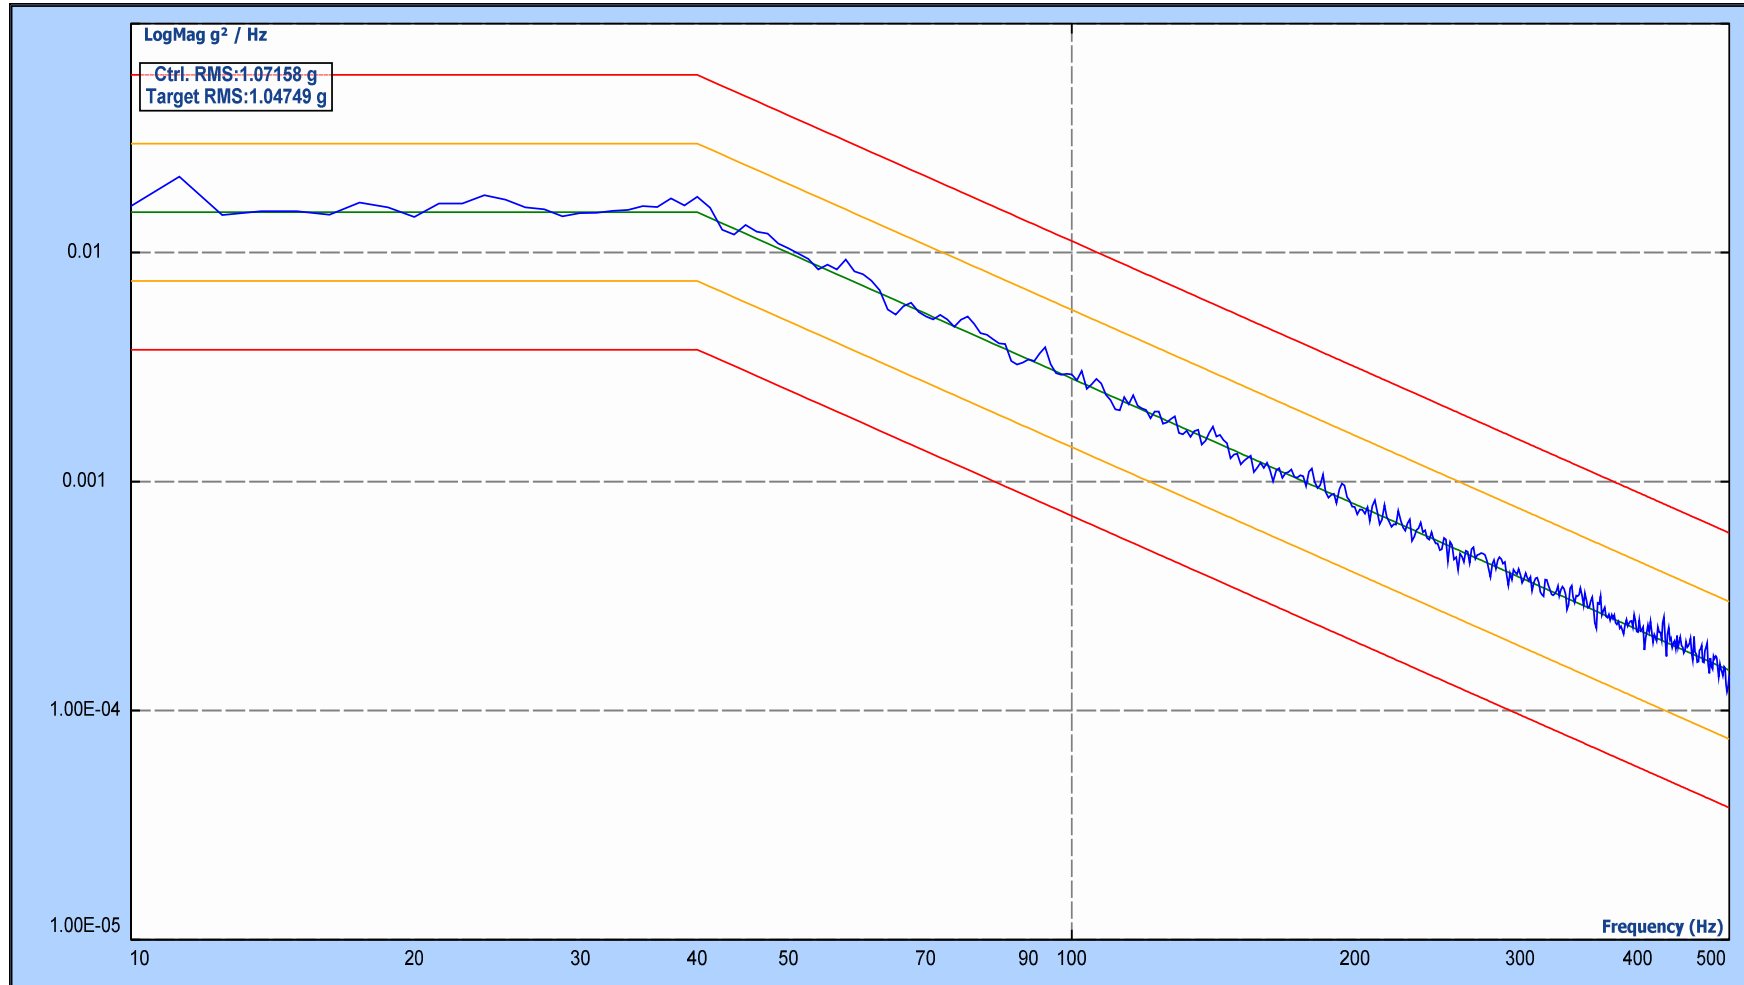
Vertical 810G 514.6C-1

Level: 100.00 %
Velocity Pk: 179.9 mm/s
Remaining: 00:00:00

Drive Pk: 0.519V
Control RMS: 1.072 g
Total Elapsed: 01:01:17

Est. Disp. : 3.859 mm Pk-Pk
Target RMS: 1.047 g
Full Level Elapsed: 01:00:00

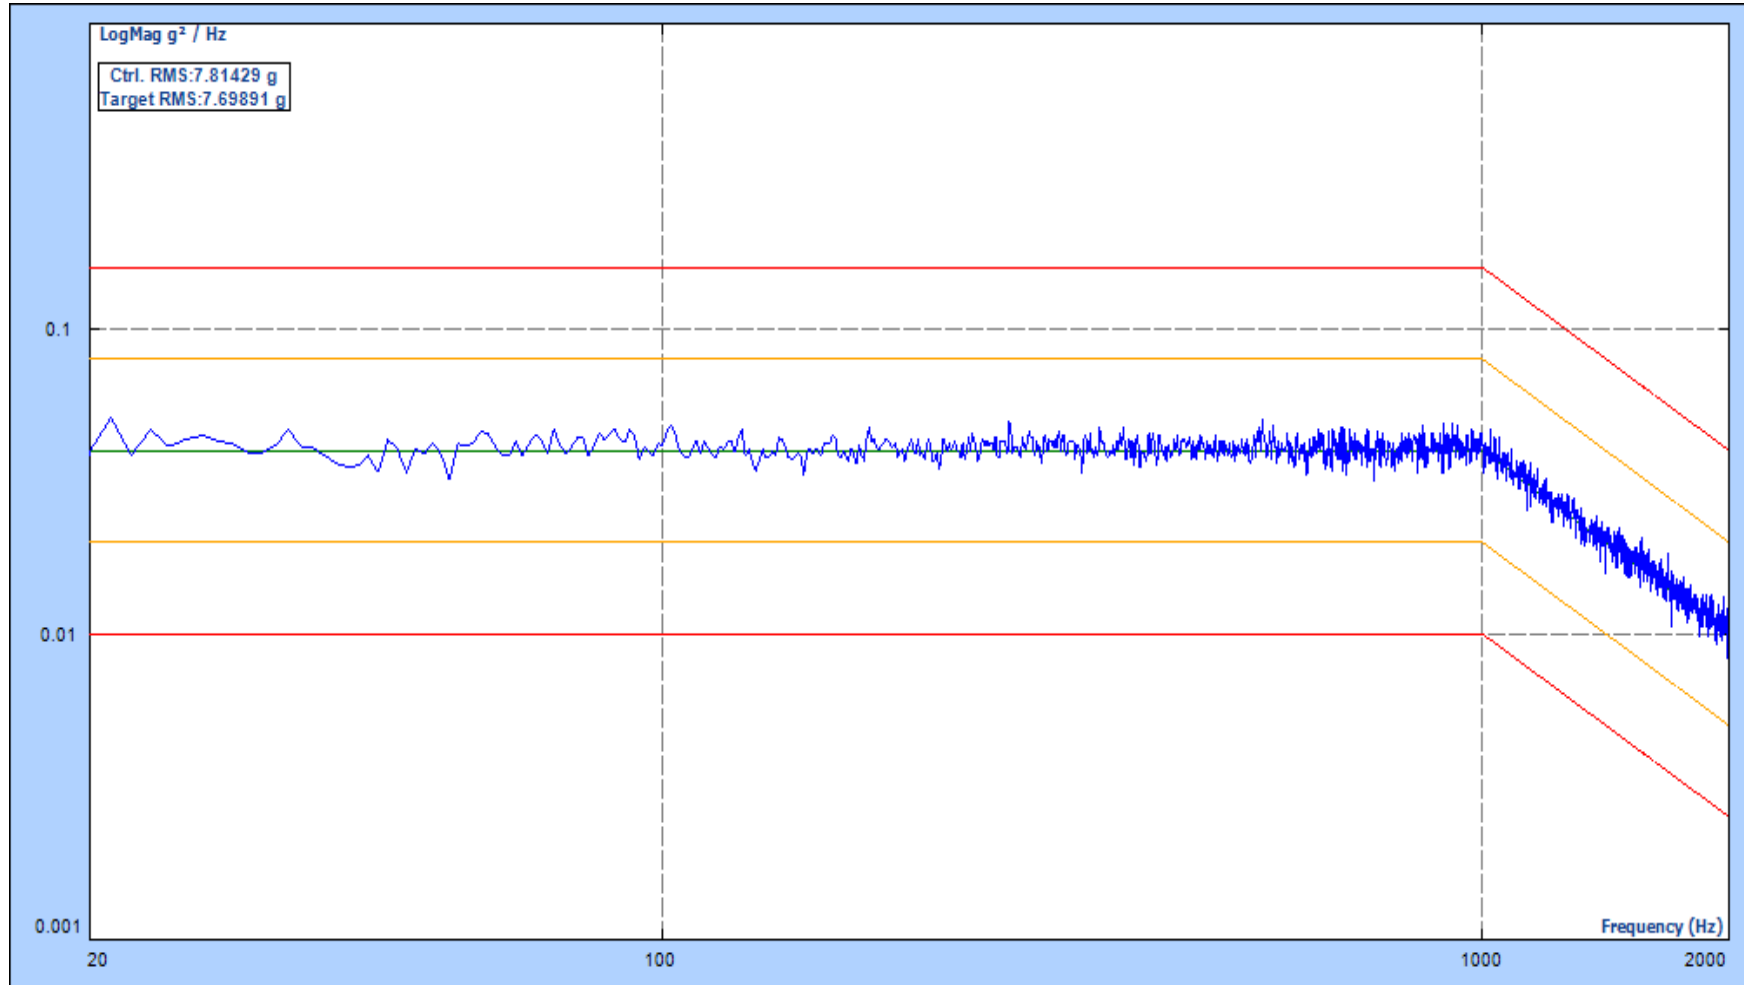
Z axis MIL-STD 810G 514.6E-1

Level: 100.00 %
Velocity Pk: 215.8 mm/s
Remaining: 00:00:00

Drive Pk: 3.140V
Control RMS: 7.814 g
Total Elapsed: 01:01:28

Est. Disp. : 2.084 mm Pk-Pk
Target RMS: 7.698 g
Full Level Elapsed: 01:00:00

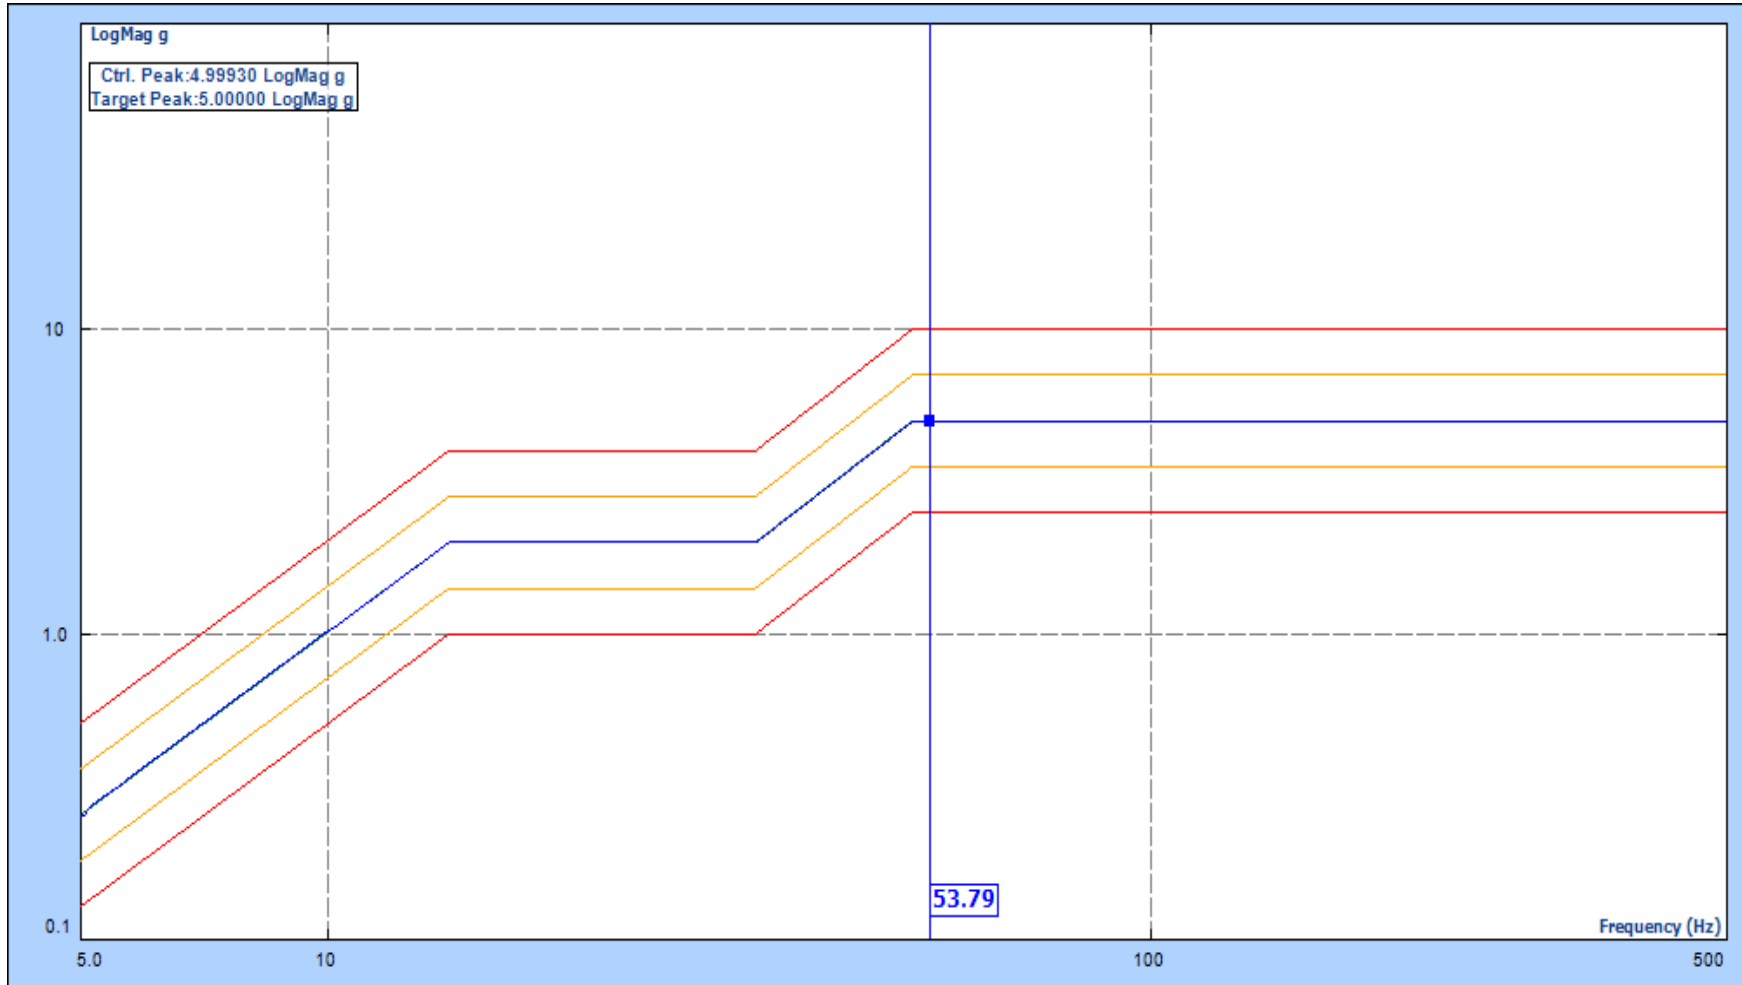
Y axis MIL-STD 810G 514.6E-2

Level: 100.00 %
Velocity Pk: 145.1 mm/s
Remaining: 00:00:00
Sweeping Rate: 1 Oct/Min

Drive Pk: 0.679V
Control Pk: 4.999 g
Total Elapsed: 00:30:55

Est. Disp. : 0.858 mm Pk-Pk
Target Pk: 5.000 g
Full Level Elapsed: 00:30:00

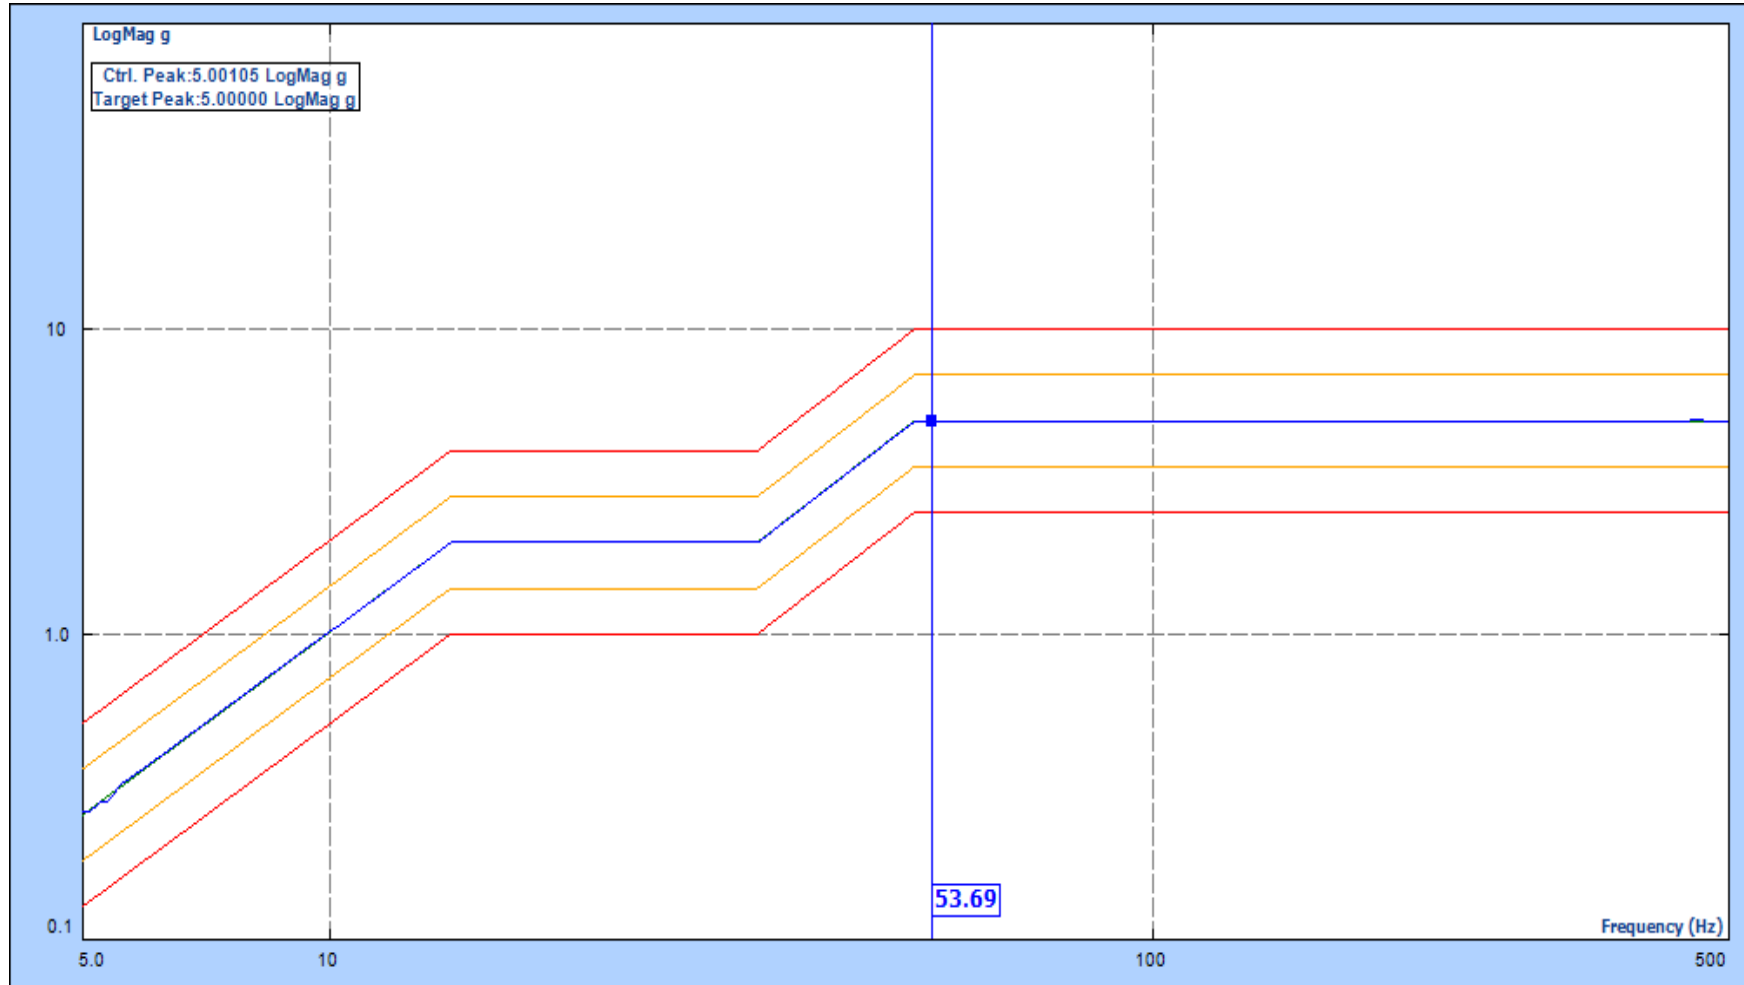
Z axis MIL-STD 810G 514.6E-2

Level: 100.00 %

Velocity Pk: 145.1 mm/s

Drive Pk: 0.408V

Control Pk: 5.001 g

Est. Disp. : 0.859 mm Pk-Pk

Target Pk: 5.000 g
