TESTING / INSPECTION REPORT

REPORT NO : VT-160108-1

COMPANY : AAEON Technology Inc.
ADDRESS : 5F, No.135, Lane 235, Pao Chiao Rd.
Hsin-Tien City, Taipei, Taiwan, R. O. C.
TEL : 886-2-8919-1234
FAX : 886-2-8919-1049
SPECIMEN : VPC-3300S (With SSD)
DATE OF RECEIVED : 2016/01/07
DATE OF TESTED : 2016/01/08

TEST / INSPECTION ITEMS : Vibration Test

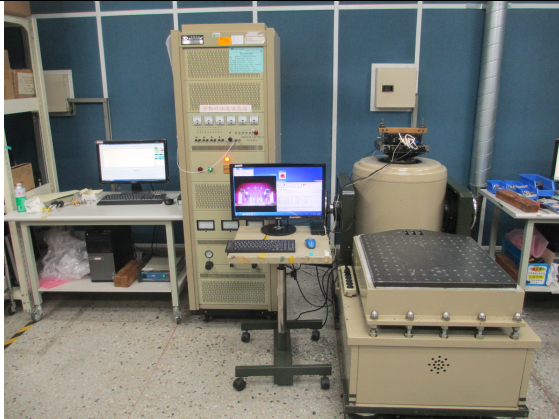
Testing photos (Operating)

Tester

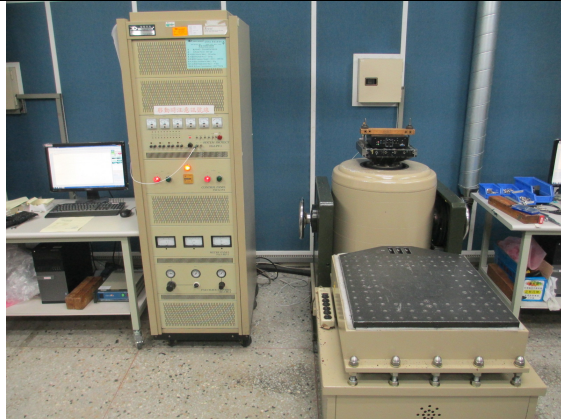
Testing photos (Non-Operating)

Tester

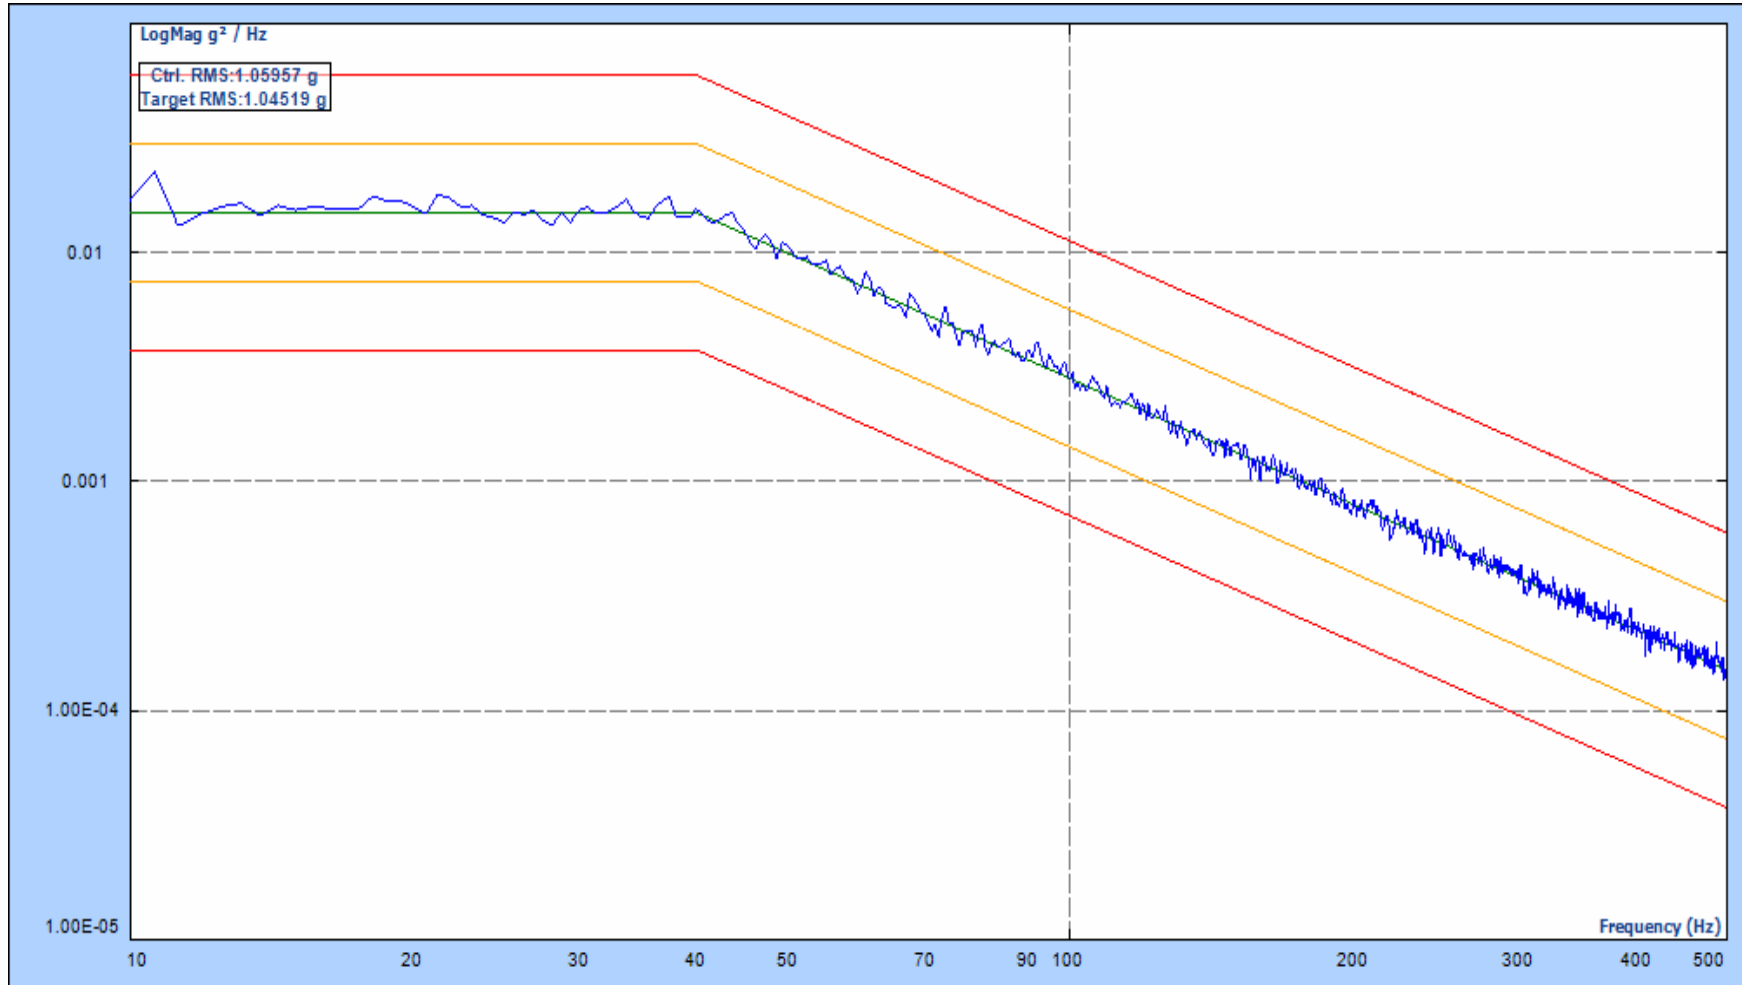
Level: 100.00 %

Velocity Pk: 174.9 mm/s

Drive Pk: 0.538V

Control RMS: 1.060 g

Est. Disp. : 3.666 mm Pk-Pk

Target RMS: 1.045 g

Full Level Elapsed: 01:00:00

Random vibration test (Operating)

Vertical		Transverse		Longitudinal	
Frequency Hz	P.S.D. g ² /Hz	Frequency Hz	P.S.D. g ² /Hz	Frequency Hz	P.S.D. g ² /Hz
10	0.01500	10	0.00013	10	0.00650
40	0.01500	20	0.00065	20	0.00650
500	0.00015	30	0.00065	120	0.00020
rms = 1.04 g		78	0.00002	121	0.00300
		79	0.00019	200	0.00300
		120	0.00019	240	0.00150
		500	0.00001	340	0.00003
		rms = 0.20 g		rms = 0.74 g

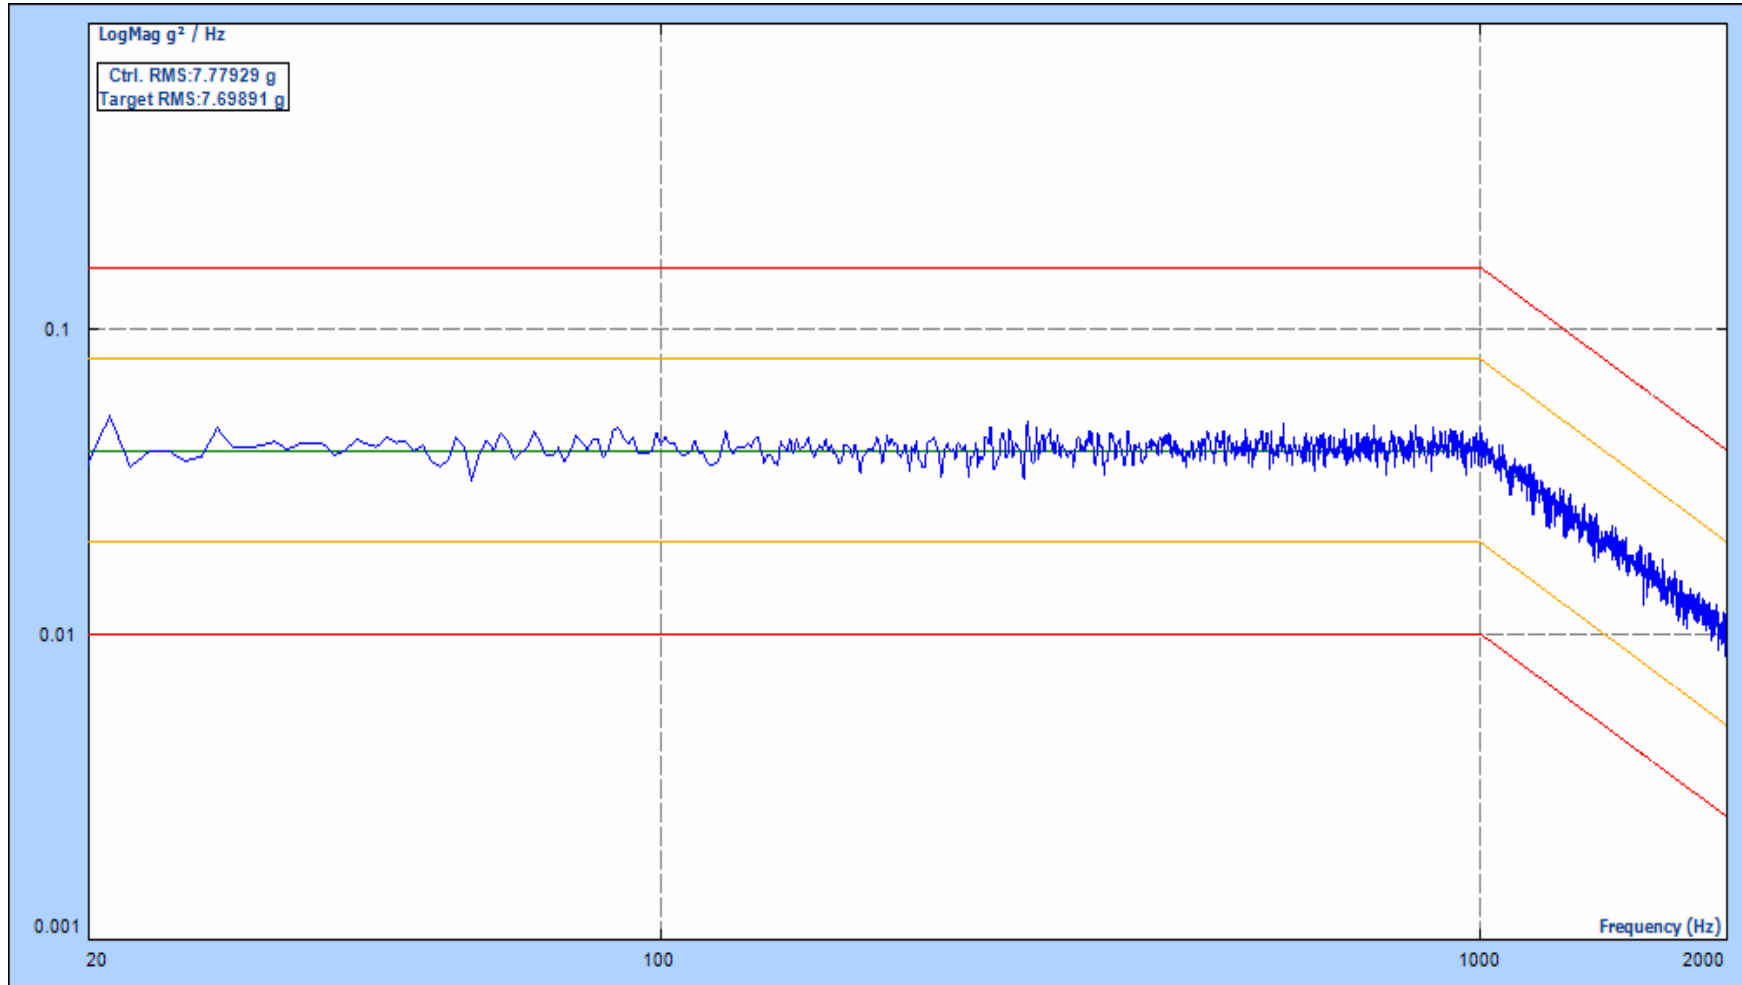
Y axis

Level: 100.00 %

Velocity Pk: 214.0 mm/s

Drive Pk: 4.392V

Control RMS: 7.779 g

Est. Disp. : 2.042 mm Pk-Pk

Target RMS: 7.698 g

Full Level Elapsed: 01:00:00

Random vibration test (Non-Operating)

Acceleration : 7.7 g rms

P.S.D. : 0.04 g²/Hz (20 Hz)
