REPORT NO : VT-160108-2

COMPANY : AAEON Technology Inc.
ADDRESS : 5F, No.135, Lane 235, Pao Chiao Rd.
Hsin-Tien City, Taipei, Taiwan, R. O. C.
TEL : 886-2-8919-1234
FAX : 886-2-8919-1049
SPECIMEN : VPC-5500S (With SSD)
DATE OF RECEIVED : 2016/01/07
DATE OF TESTED : 2016/01/08

TEST / INSPECTION ITEMS : Vibration Test

TESTING / INSPECTION REPORT

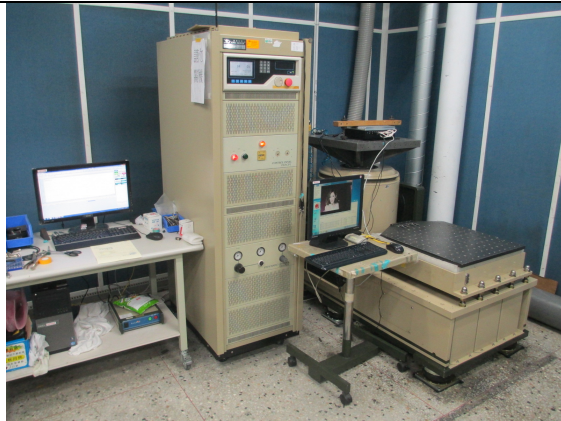
Tester

Testing photos (Operating)

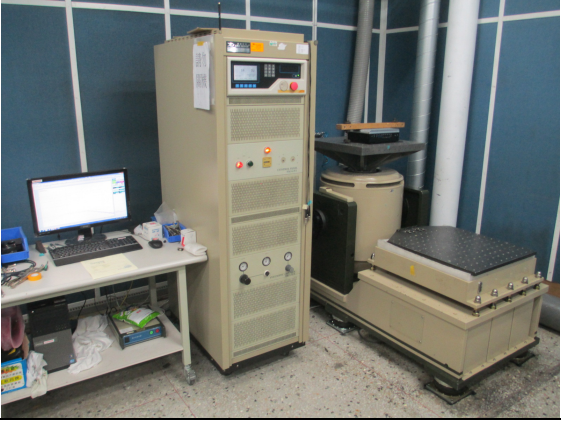
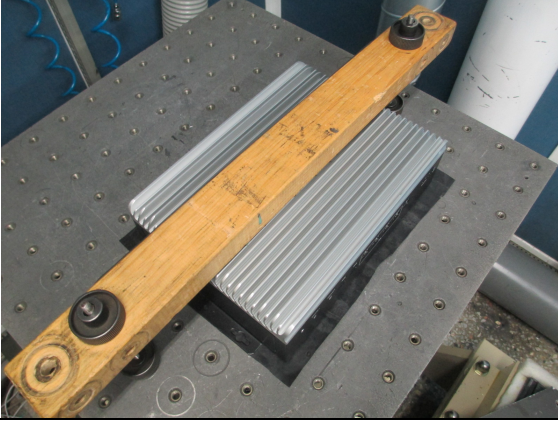
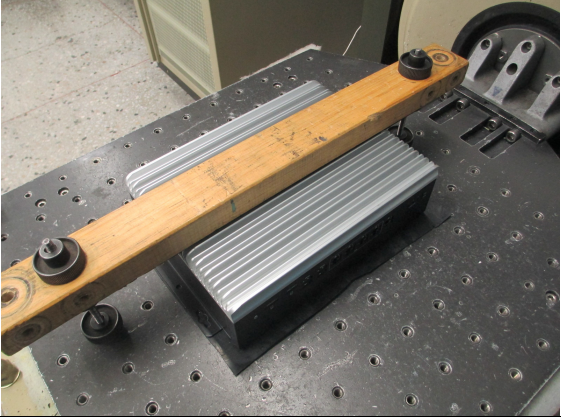
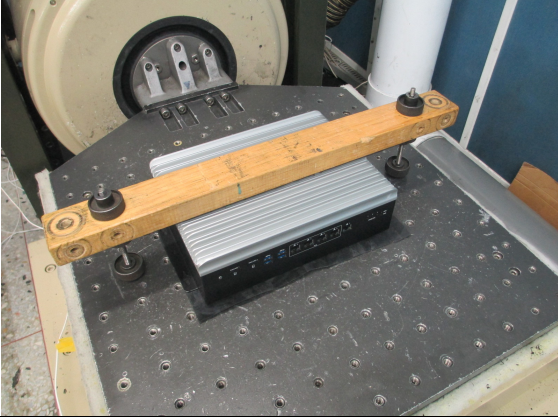
Testing photos (Non-Operating)

Tester	Z

X	Y

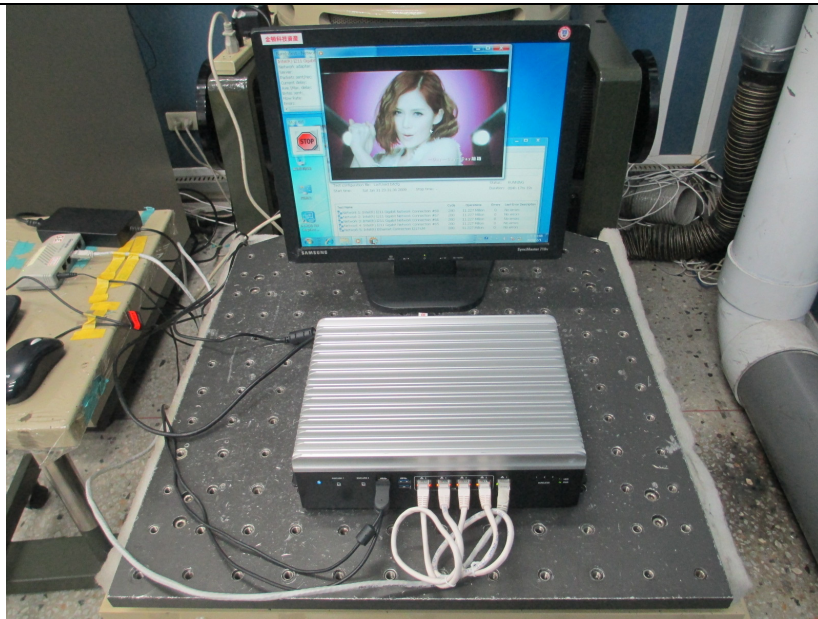
After test

Describe	PASS	FAIL	Non-Judgment
Function judgment ⁽¹⁾	√	---	---
Appearance check ⁽²⁾	√	---	---
(1)—Booting function was normal after the test.			
(2)—No visible damages were found.

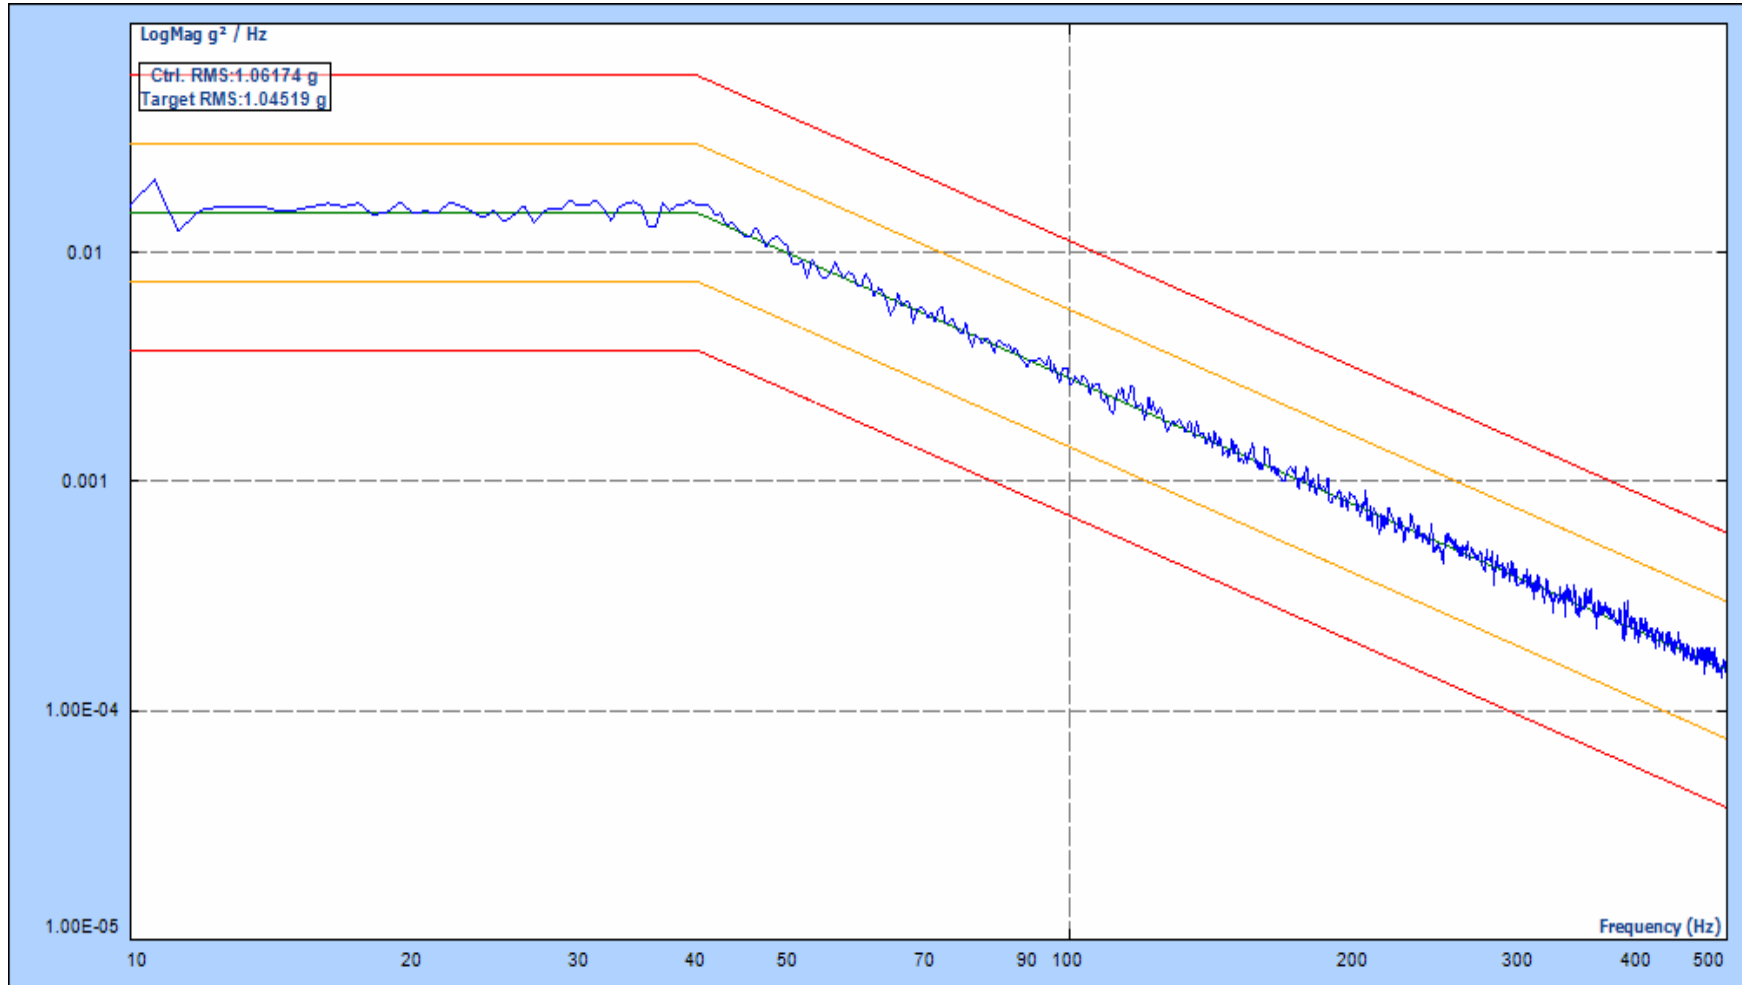
Level: 100.00 %

Velocity Pk: 173.7 mm/s

Drive Pk: 0.326V

Control RMS: 1.062 g

Total Elapsed: 01:01:55

Est. Disp. : 3.612 mm Pk-Pk

Target RMS: 1.045 g

Full Level Elapsed: 01:00:00

Random vibration test (Operating)

Vertical		Transverse		Longitudinal	
Frequency Hz	P.S.D. g ² /Hz	Frequency Hz	P.S.D. g ² /Hz	Frequency Hz	P.S.D. g ² /Hz
10	0.01500	10	0.00013	10	0.00650
40	0.01500	20	0.00065	20	0.00650
500	0.00015	30	0.00065	120	0.00020
rms = 1.04 g		78	0.00002	121	0.00300
		79	0.00019	200	0.00300
		120	0.00019	240	0.00150
		500	0.00001	340	0.00003
		rms = 0.20 g		rms = 0.74 g

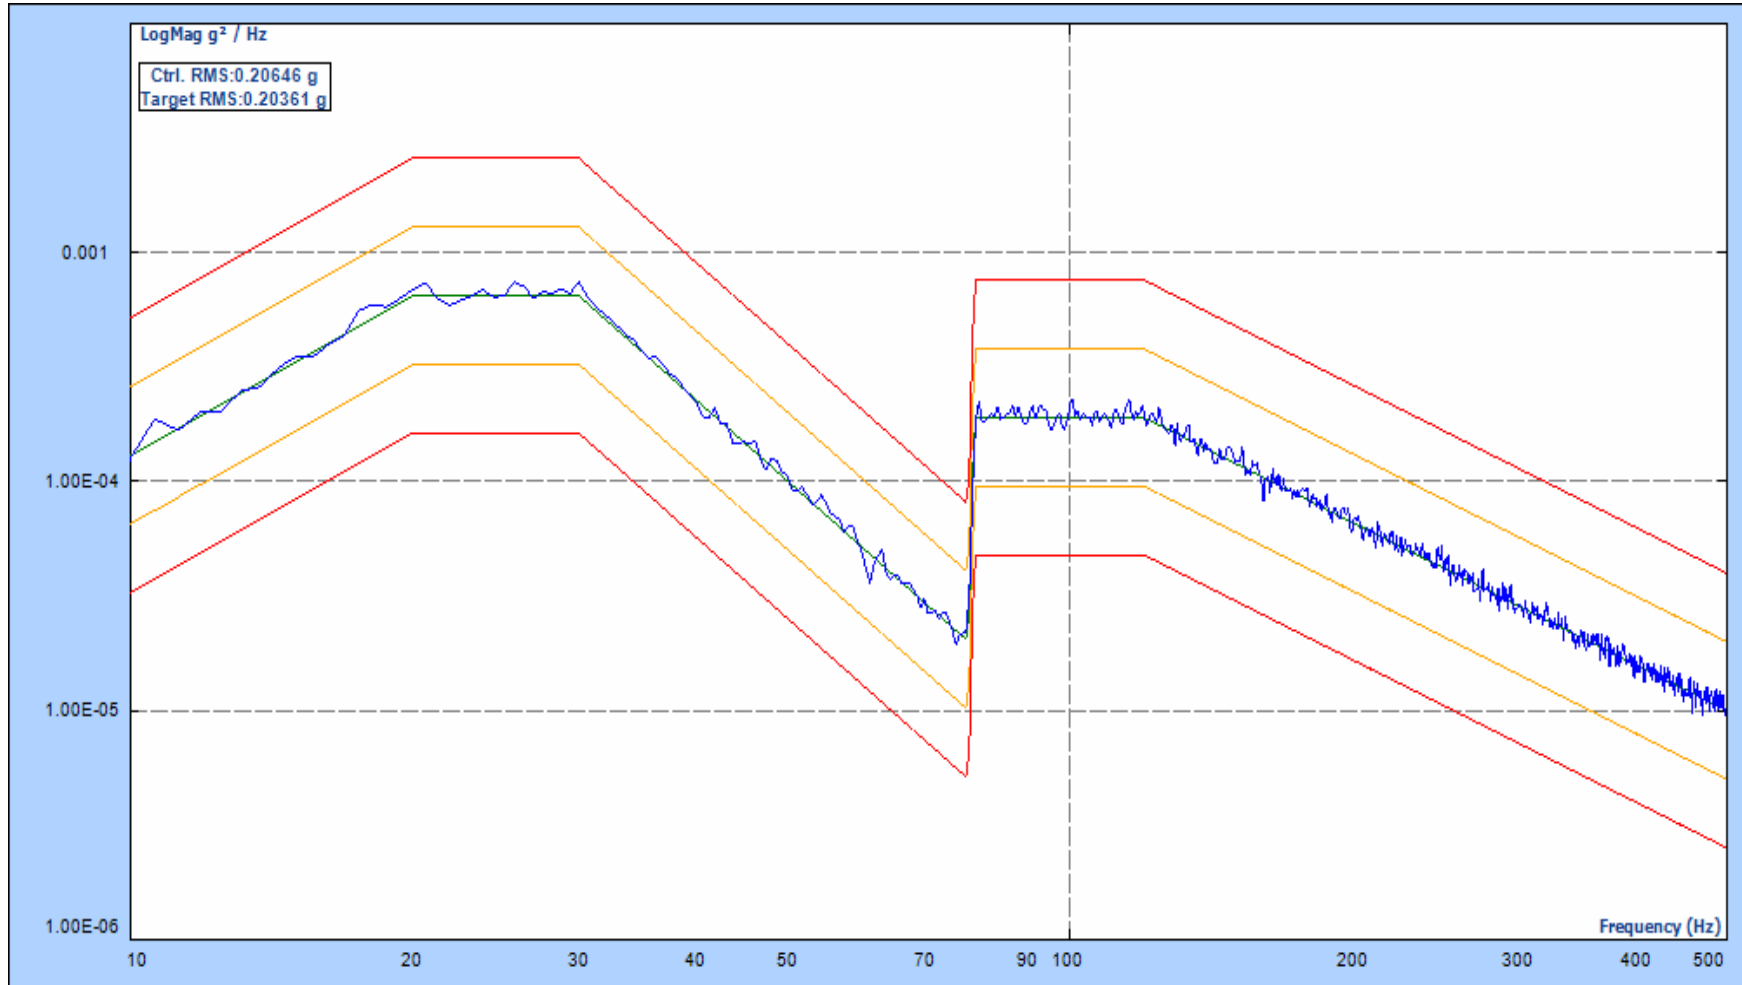
Transverse

Level: 100.00 %

Velocity Pk: 26.93 mm/s

Drive Pk: 0.068V

Control RMS: 0.206 g

Total Elapsed: 01:01:50

Est. Disp. : 0.477 mm Pk-Pk

Target RMS: 0.203 g

Full Level Elapsed: 01:00:00

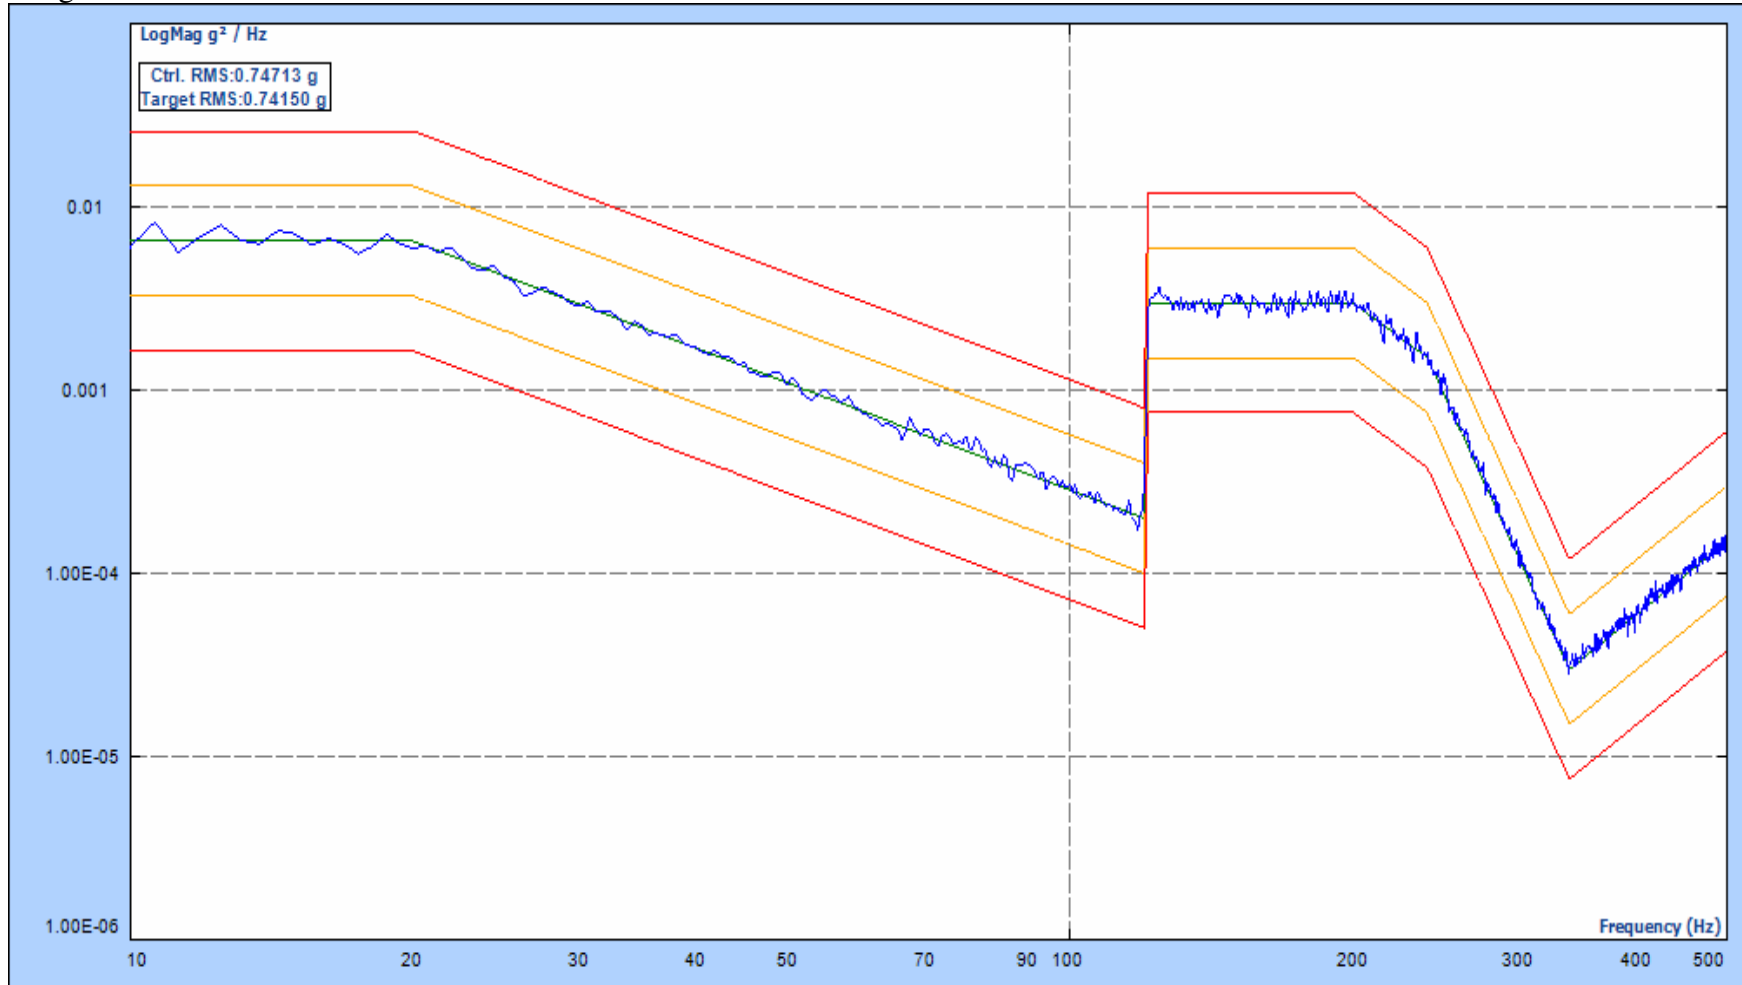
Longitudinal

Level: 100.00 %

Velocity Pk: 102.7 mm/s

Drive Pk: 0.210V

Control RMS: 0.747 g

Total Elapsed: 01:01:55

Est. Disp. : 2.291 mm Pk-Pk

Target RMS: 0.741 g

Full Level Elapsed: 01:00:00

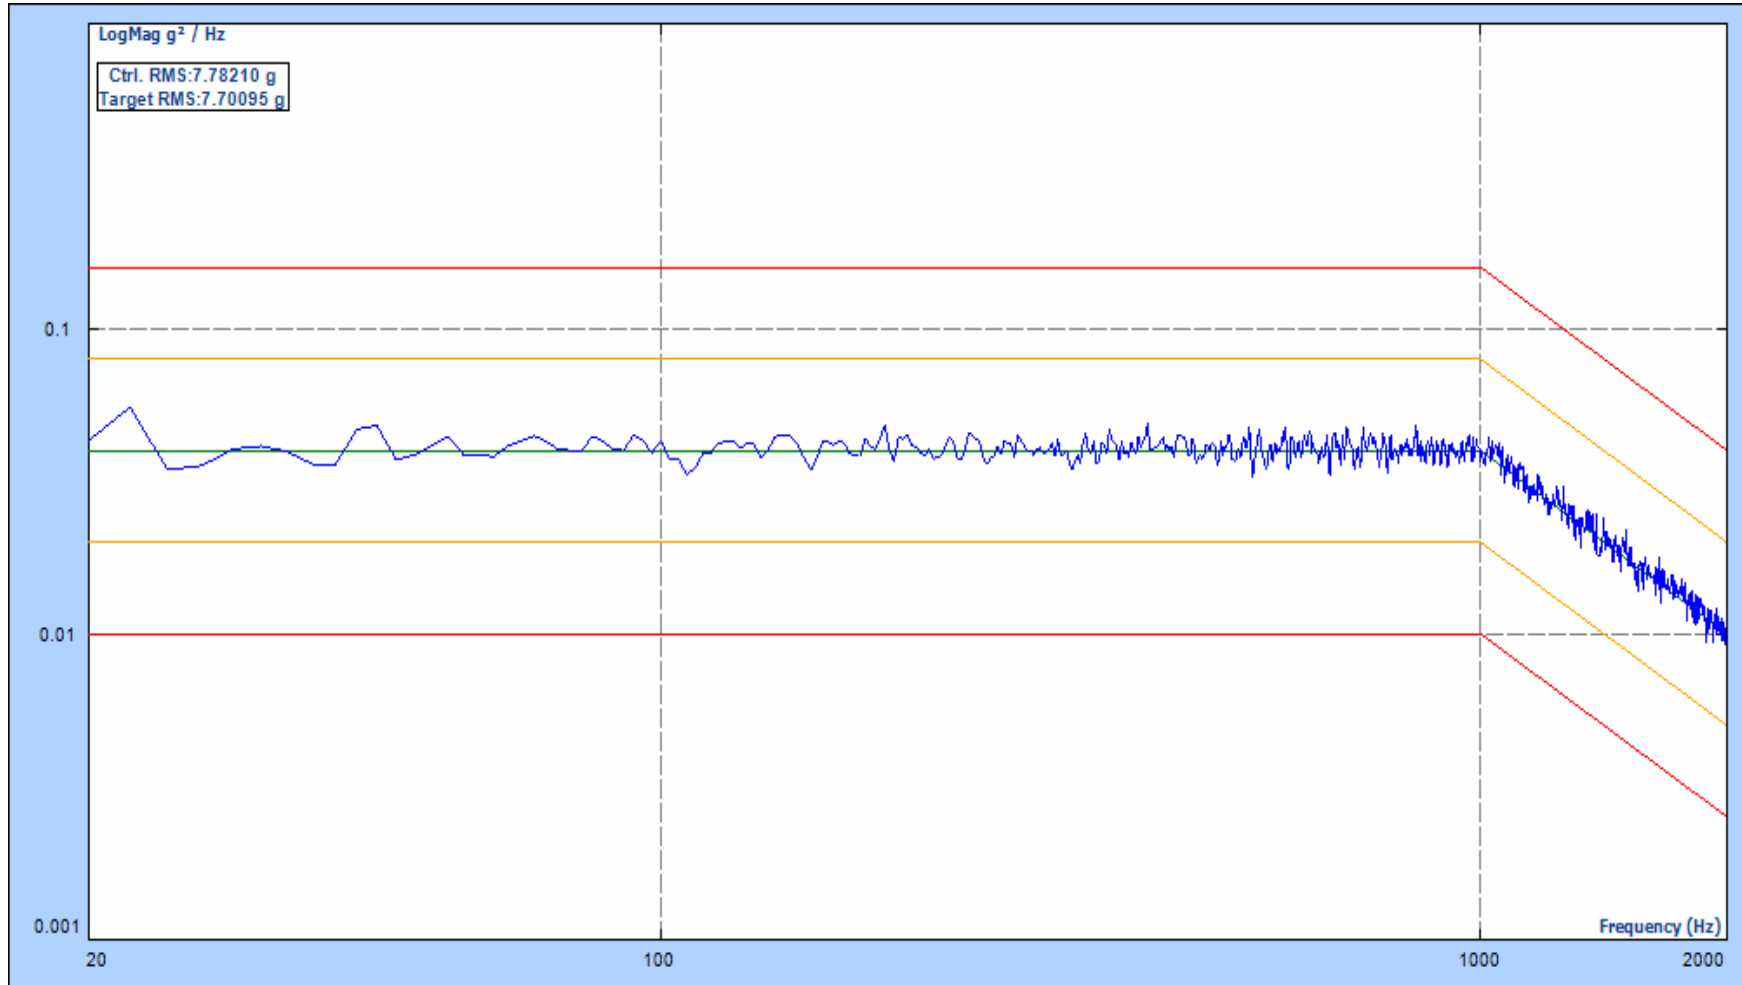
X axis

Level: 100.00 %

Velocity Pk: 219.5 mm/s

Drive Pk: 1.543V

Control RMS: 7.782 g

Total Elapsed: 01:01:08

Est. Disp. : 2.195 mm Pk-Pk

Target RMS: 7.699 g

Full Level Elapsed: 01:00:00

Random vibration test (Non-Operating)

Acceleration : 7.7 g rms

P.S.D. : 0.04 g²/Hz (20 Hz)

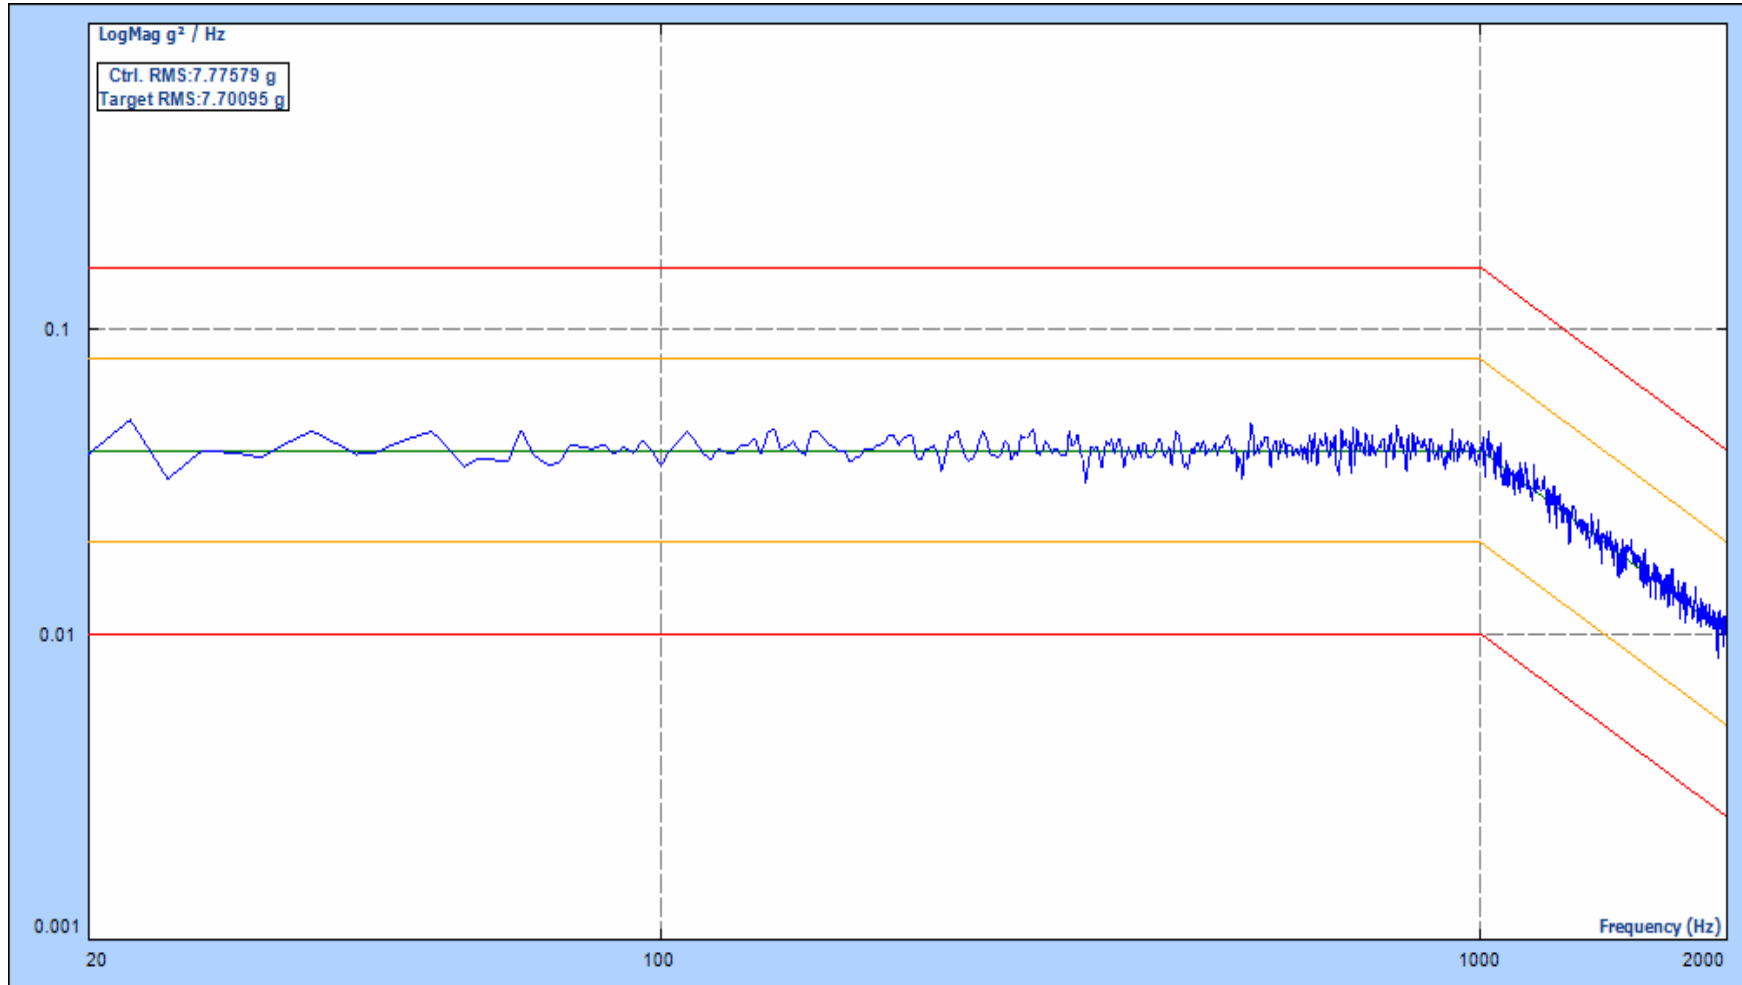
Y axis

Level: 100.00 %

Velocity Pk: 217.3 mm/s

Drive Pk: 1.657V

Control RMS: 7.776 g

Total Elapsed: 01:01:08

Est. Disp. : 2.141 mm Pk-Pk

Target RMS: 7.699 g

Full Level Elapsed: 01:00:00

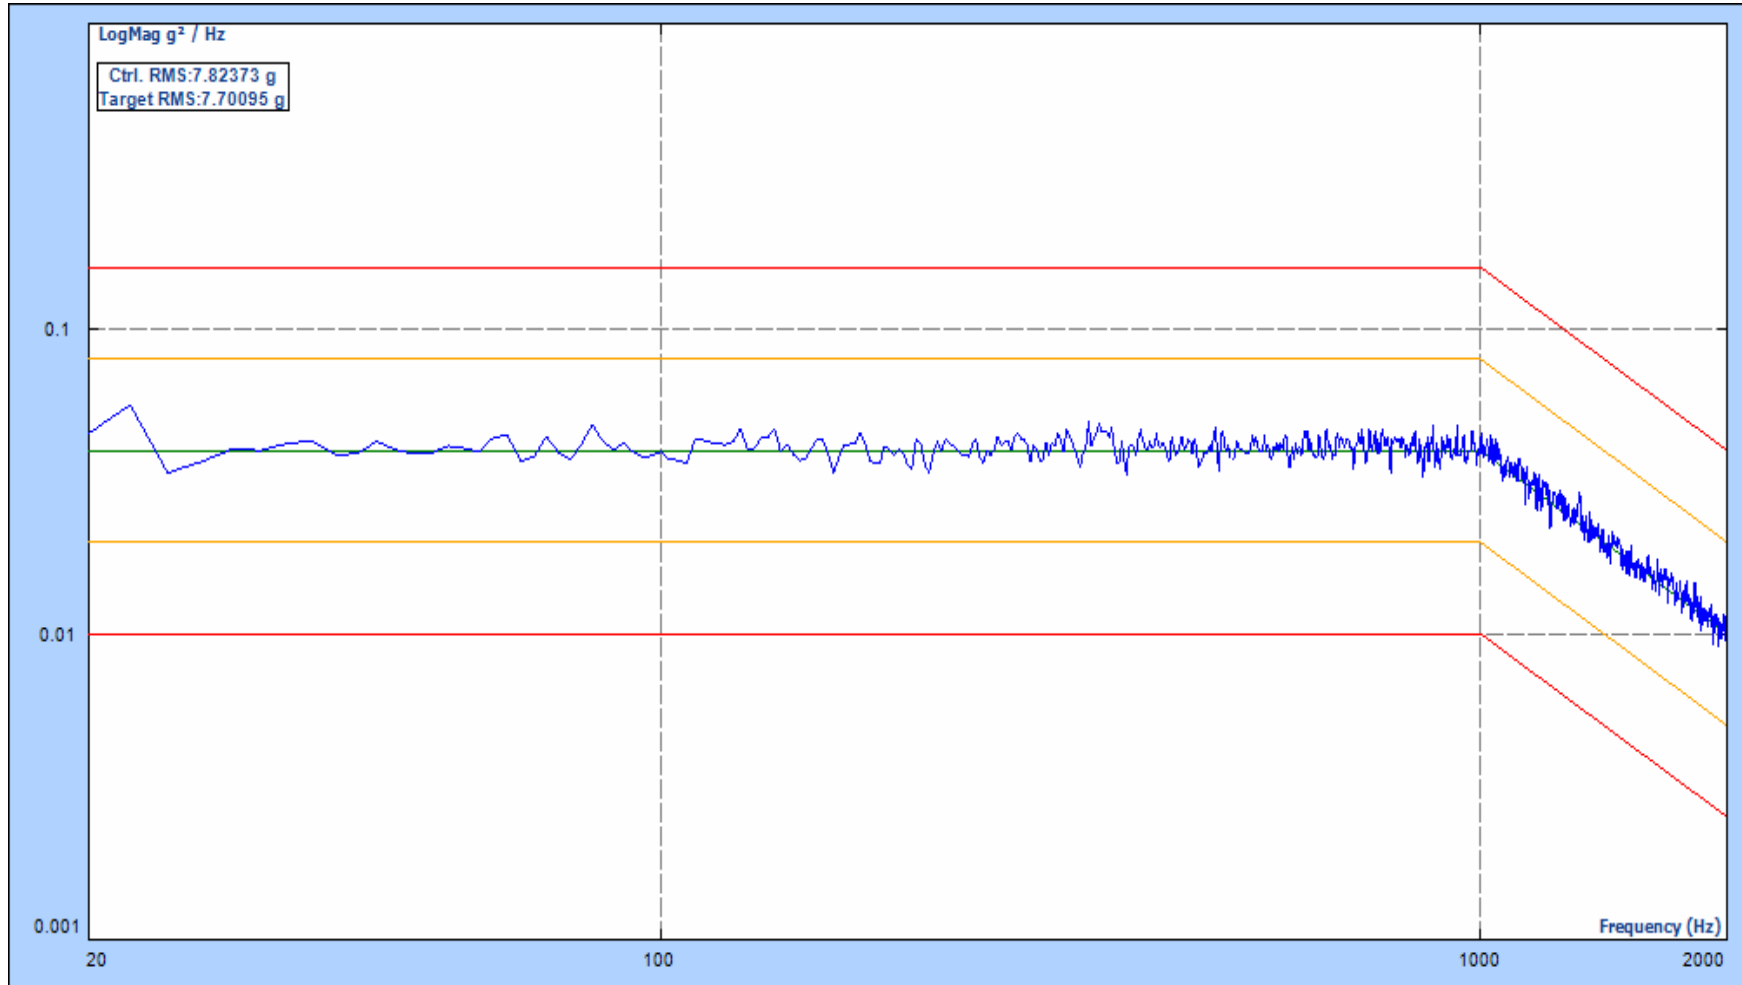
Z axis

Level: 100.00 %

Velocity Pk: 220.8 mm/s

Drive Pk: 1.483V

Control RMS: 7.824 g

Total Elapsed: 01:01:07

Est. Disp. : 2.221 mm Pk-Pk

Target RMS: 7.699 g

Full Level Elapsed: 01:00:00
