**TESTING / INSPECTION REPORT**

REPORT NO : ST-120405-2

SPECIMEN : FWS-2200

TEST / INSPECTION ITEMS : Shock Test

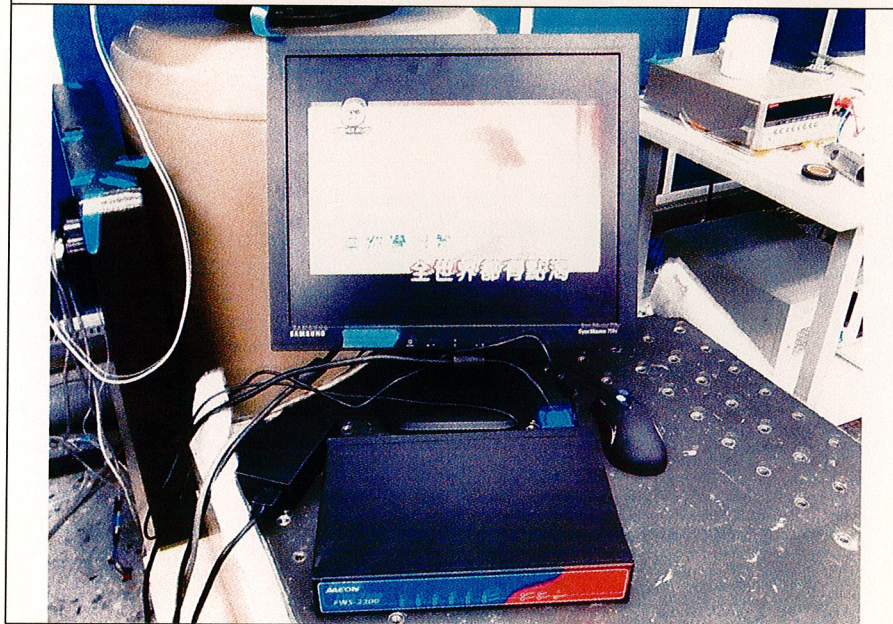
#### After test

| Describe | PASS | FAIL | Non-Judgment |
|---|---|---|---|
| (2)—No visible damages were found. | | | |
