**TESTING / INSPECTION REPORT**

REPORT NO : VT-140905-1

COMPANY : AAEON Technology Inc.  
ADDRESS : 5F, No.135, Lane 235, Pao Chiao Rd.  
Hsin-Tien City, Taipei, Taiwan, R. O. C.  
TEL : 886-2-8919-1234  
FAX : 886-2-8919-1049  
SPECIMEN : RTC-700C  
DATE OF RECEIVED : 2014/09/03  
DATE OF TESTED : 2014/09/05

TEST / INSPECTION ITEMS : Vibration Test

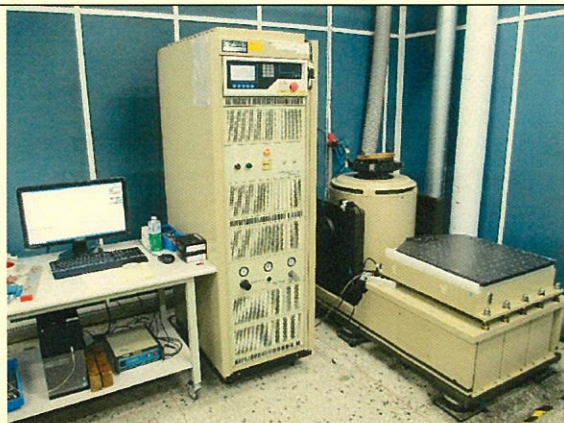
**Tester**

### Testing photos (Operating)

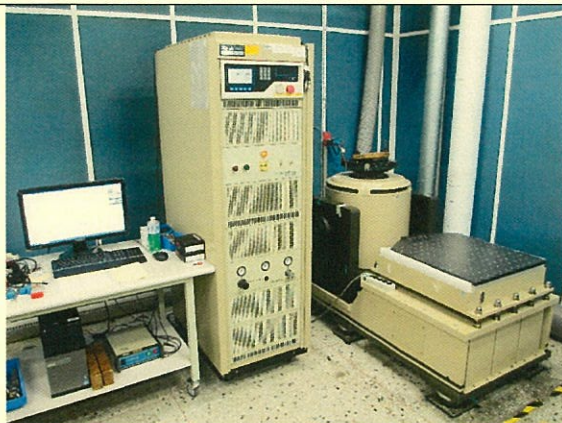
**Tester**

### Testing photos (Non-Operating)

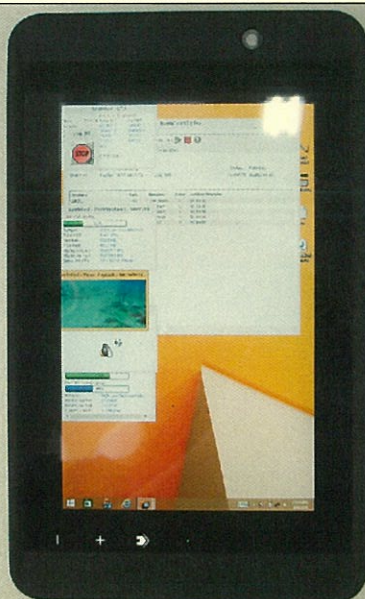
| Describe | PASS | FAIL | Non-Judgment |
|---|---|---|---|
| (2)—No visible damages were found. | | | |

#### After test
