AIS-Q572

Environment Test Report

Report NO: 11I020009

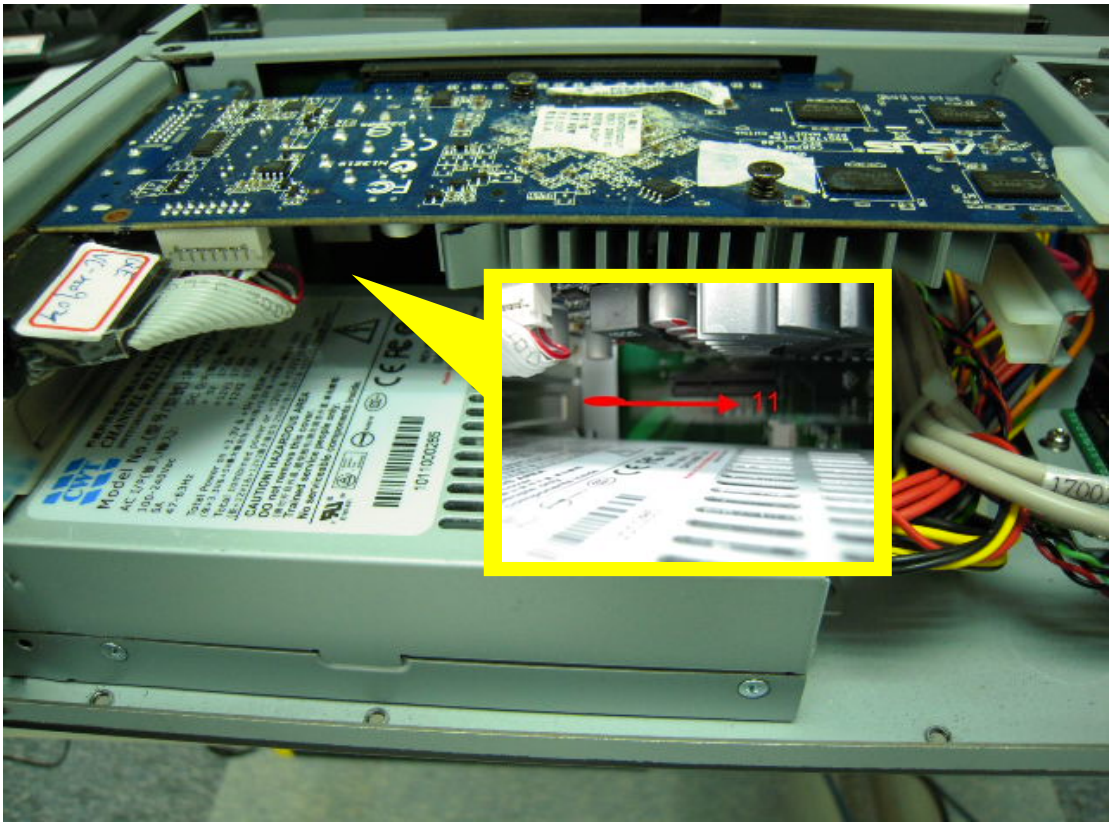
Measuring Thermal Couple Position：

No problem was found during the temperature rise operation test.

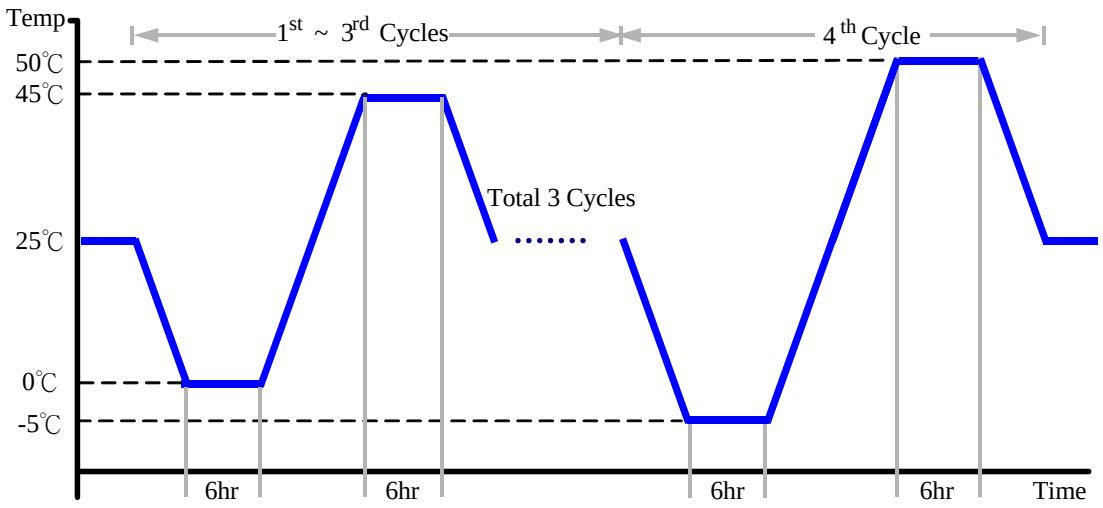
No problem was found during the temperature operation cycle test.

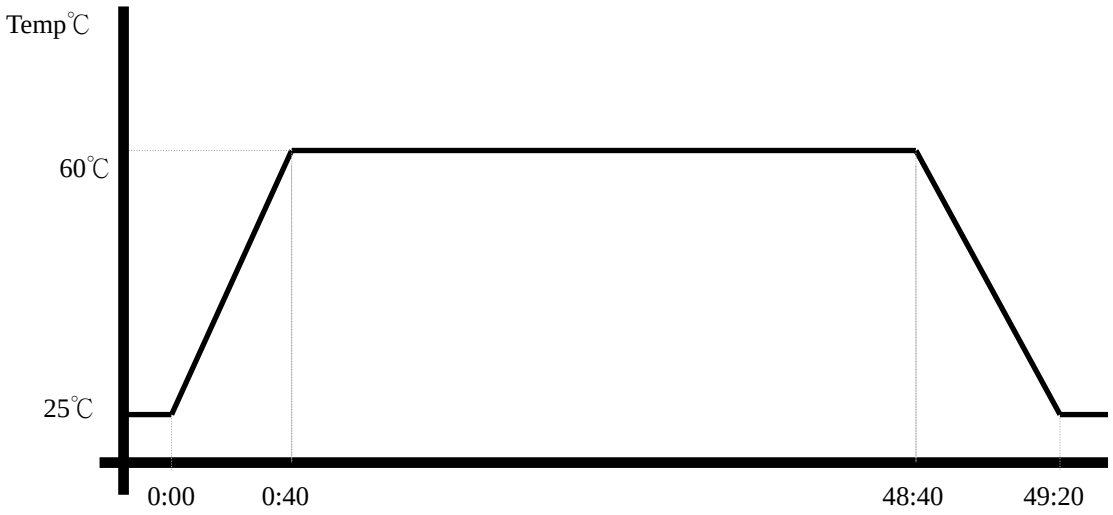
No problem was found after the high temperature storage test.

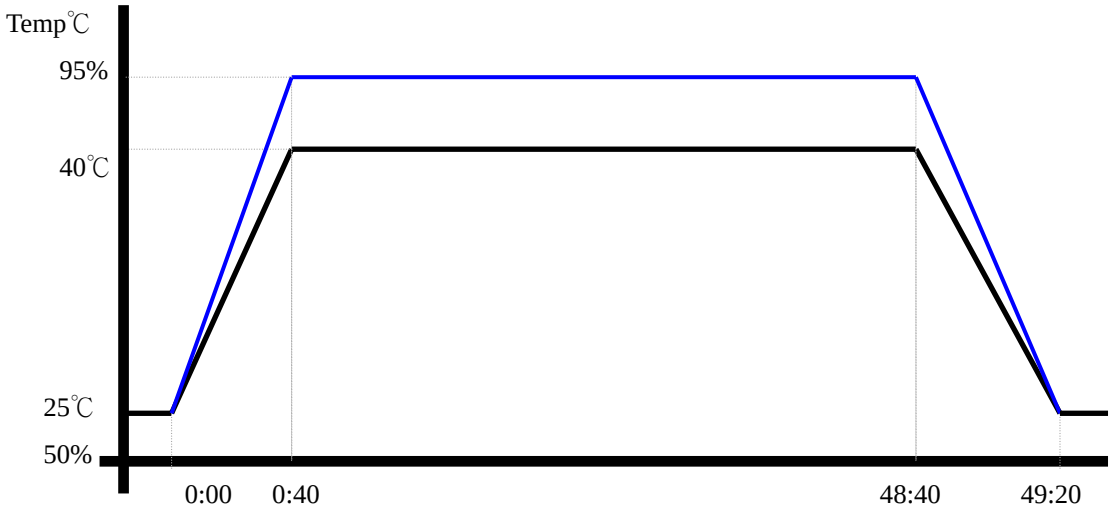
Test Result:
No problem was found after the humidity storage test.

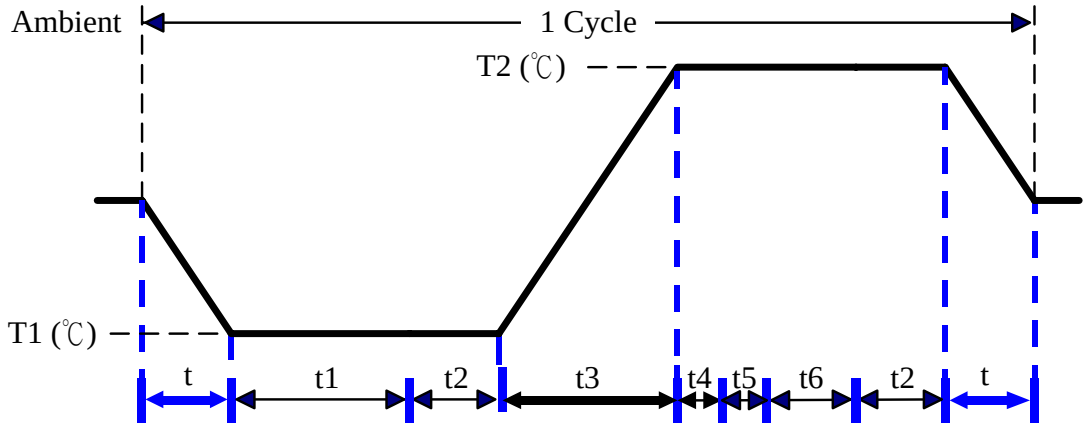
a. No problem was found during the cold start test.

b. No problem was found during the hot start test.
