TESTING / INSPECTION REPORT

REPORT NO : VT-170609-1

SPECIMEN : BOXER-6639M (With SSD)

TEST / INSPECTION ITEMS : Vibration Test

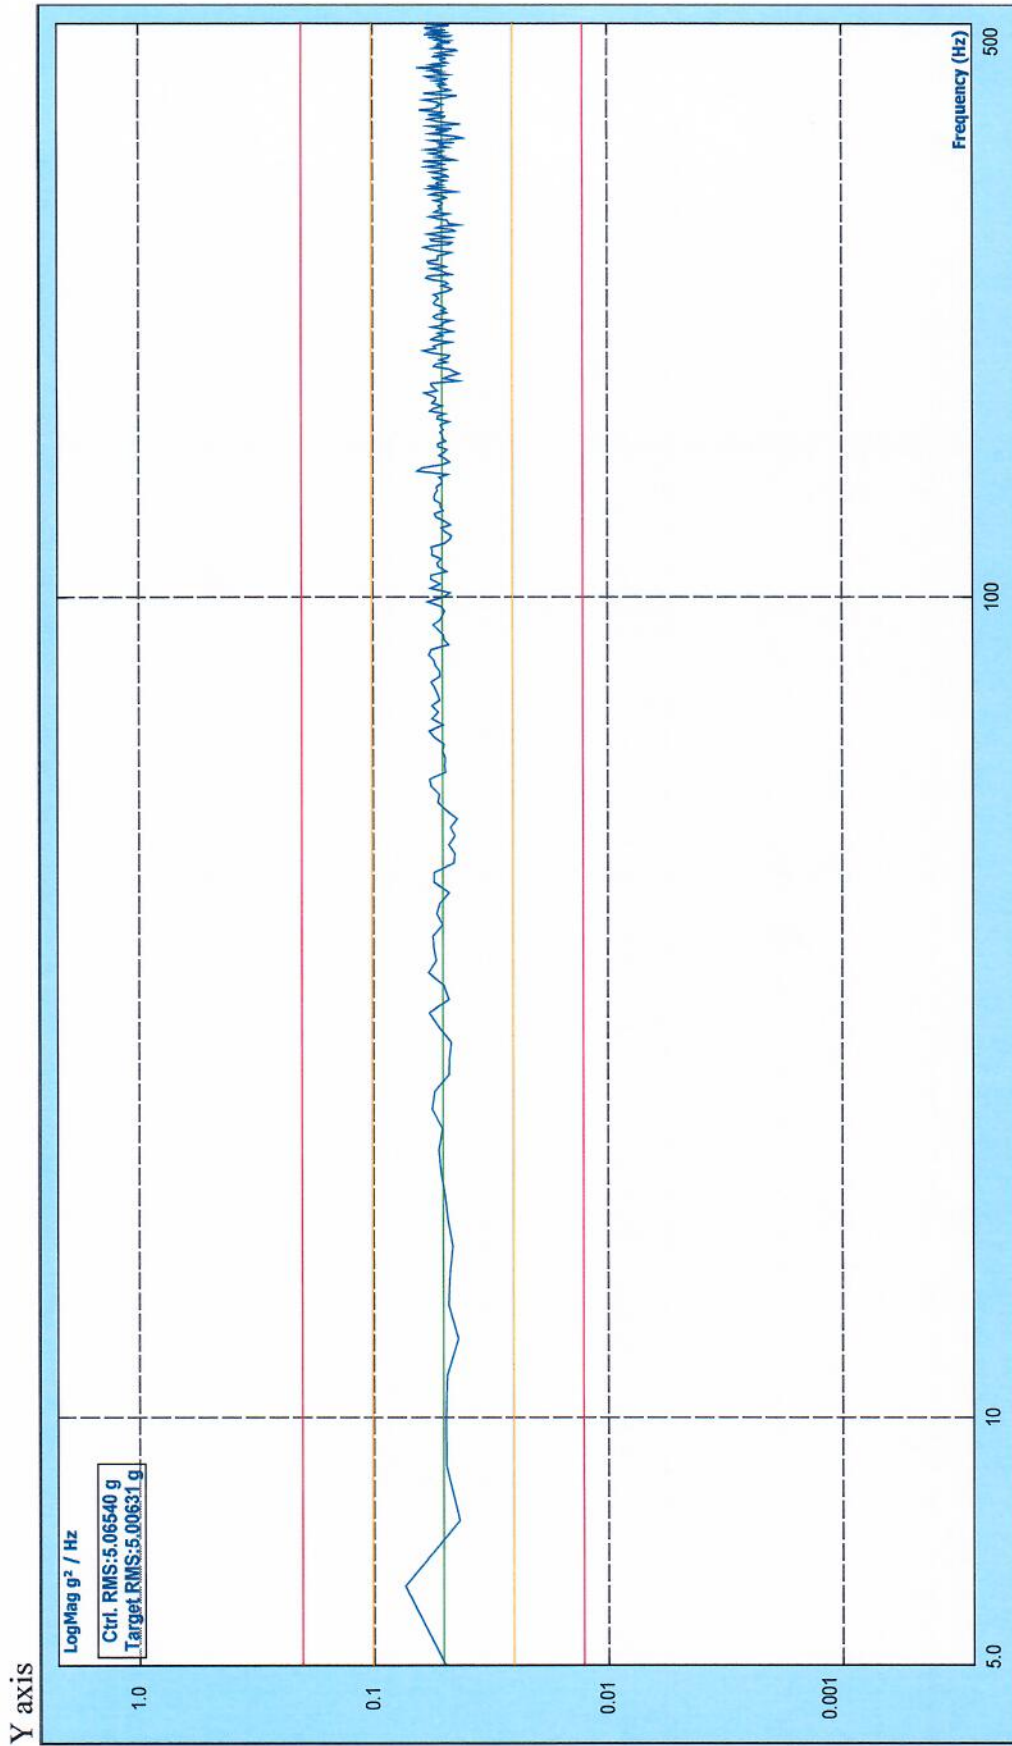
Level: 100.00 %
 Velocity Pk: 0.511 m/s
 Remaining: 00:00:00

Drive Pk: 1.356V
 Control RMS: 5.065 g
 Total Elapsed: 01:01:20

Est. Disp. : 0.022 m Pk-Pk
 Target RMS: 5.000 g
 Full Level Elapsed: 01:00:00

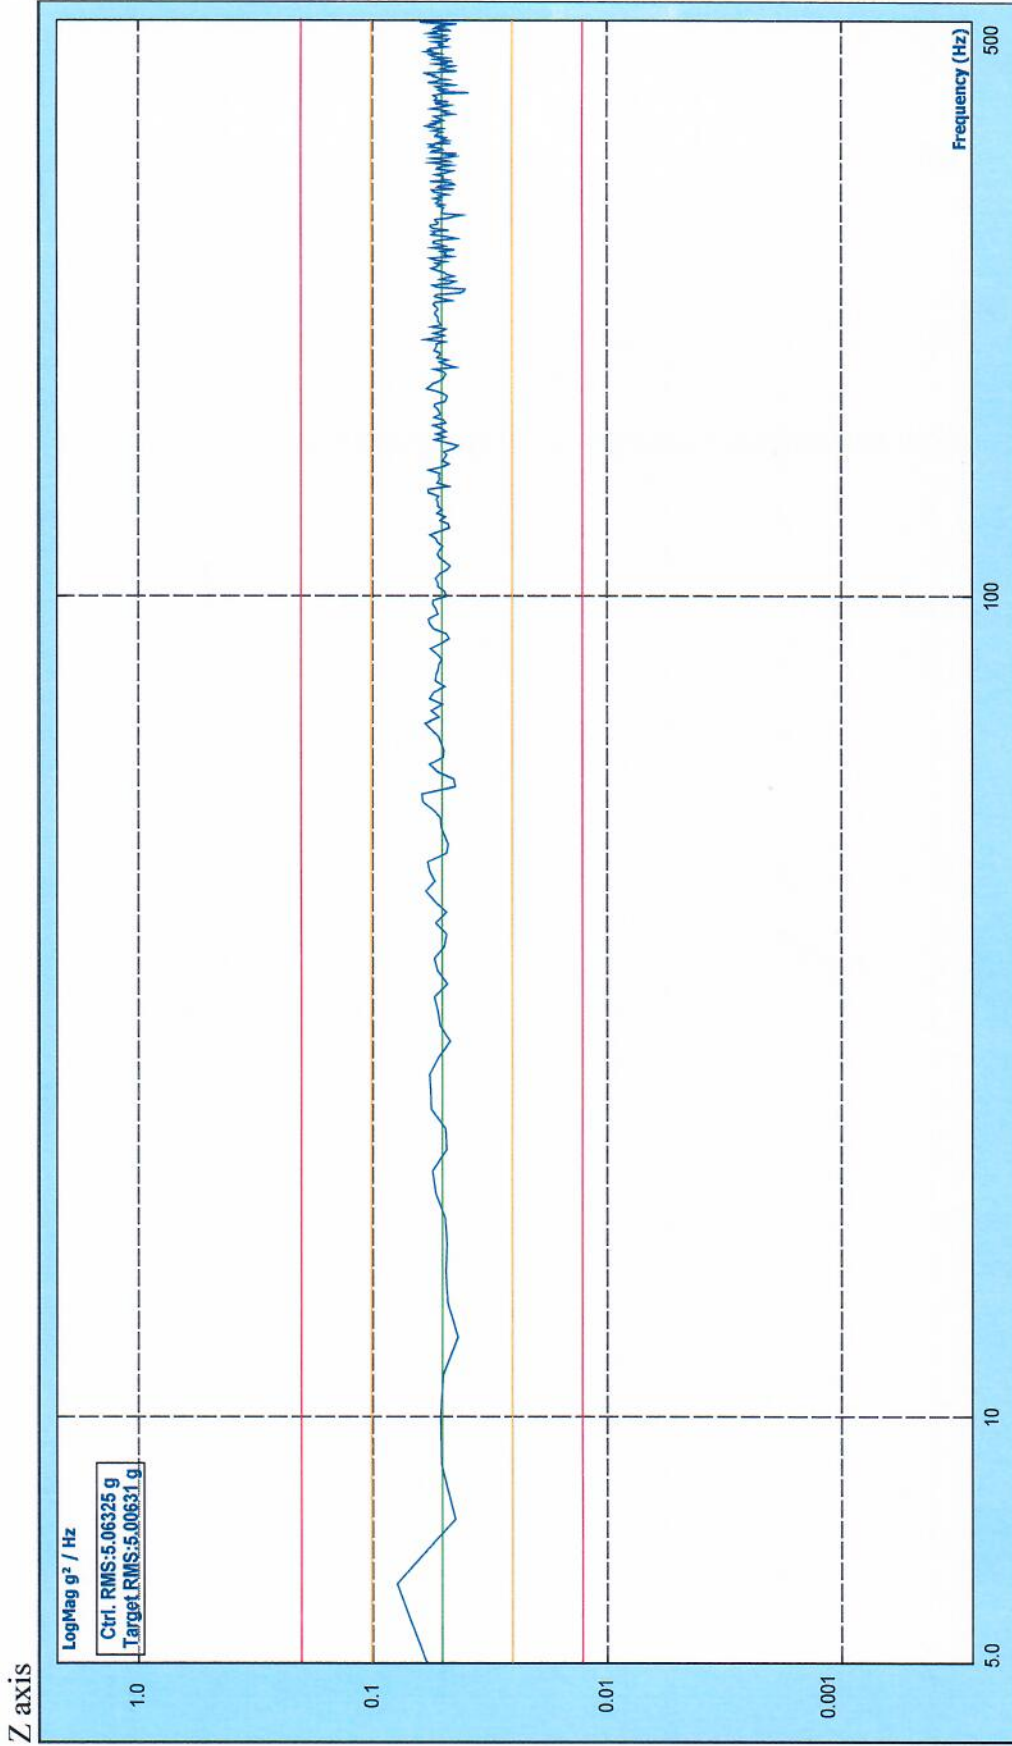
Level: 100.00 %
 Velocity Pk: 0.528 m/s
 Remaining: 00:00:00

Drive Pk: 1.444V
 Control RMS: 5.063 g
 Total Elapsed: 01:01:21
