REPORT NO : VT-120118-7

SPECIMEN : TKS-G20-LN05B (with CFD)

TEST / INSPECTION ITEMS : Vibration Test

## TESTING / INSPECTION REPORT

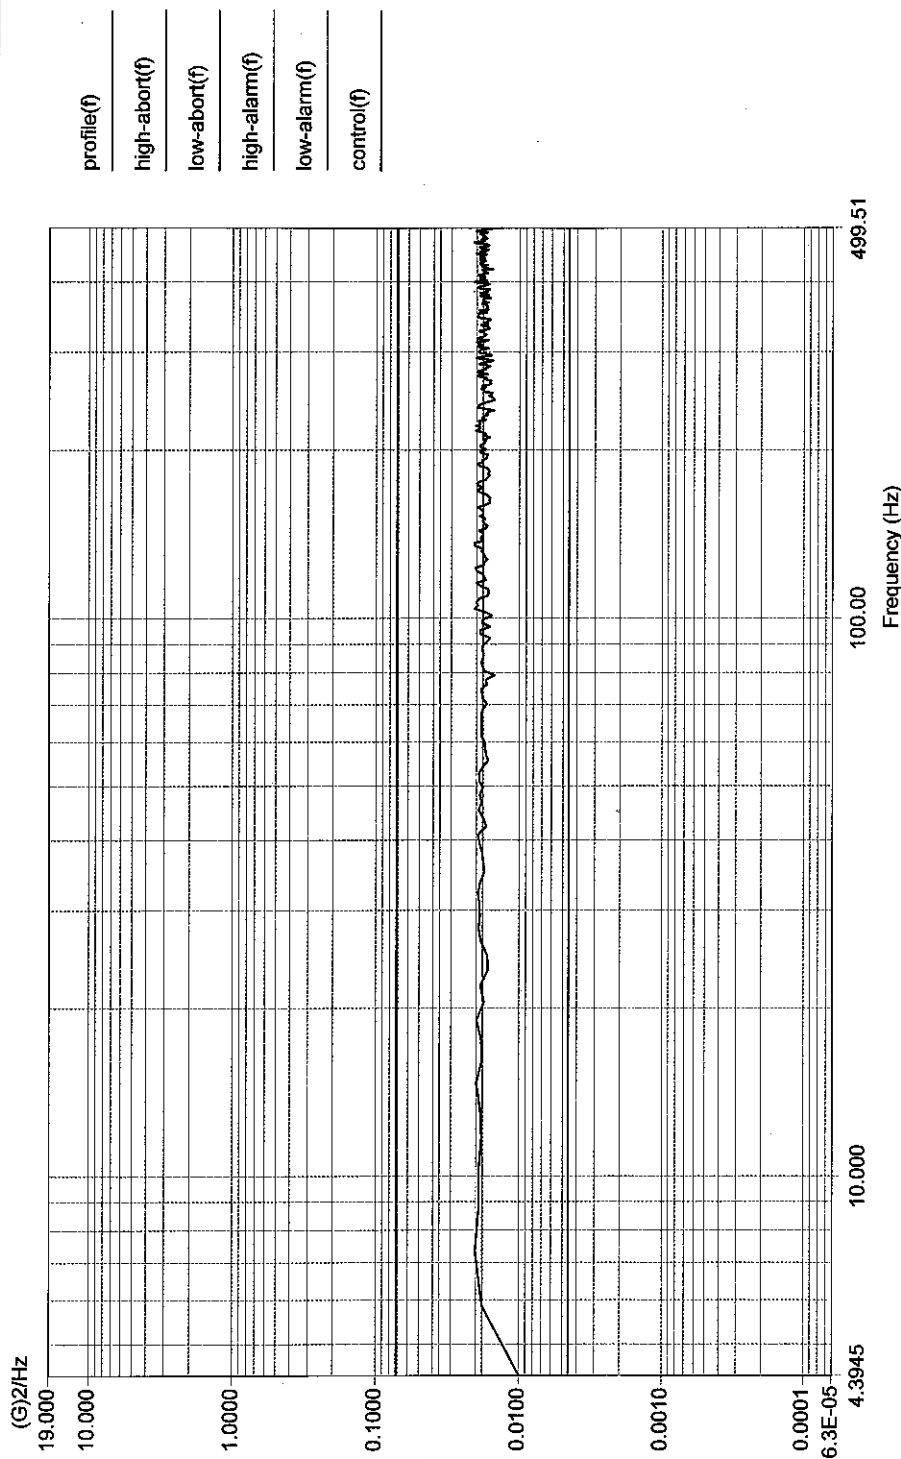
X Axis

Control RMS: 3.001796 G Full Level Elapsed Time: 00:59:59 Lines: 450 Frame Time: 0.682667 Seconds

Demand RMS: 3.002646 G Remaining Time: 00:00:00 DOF: 154 dF: 1.464844 Hz

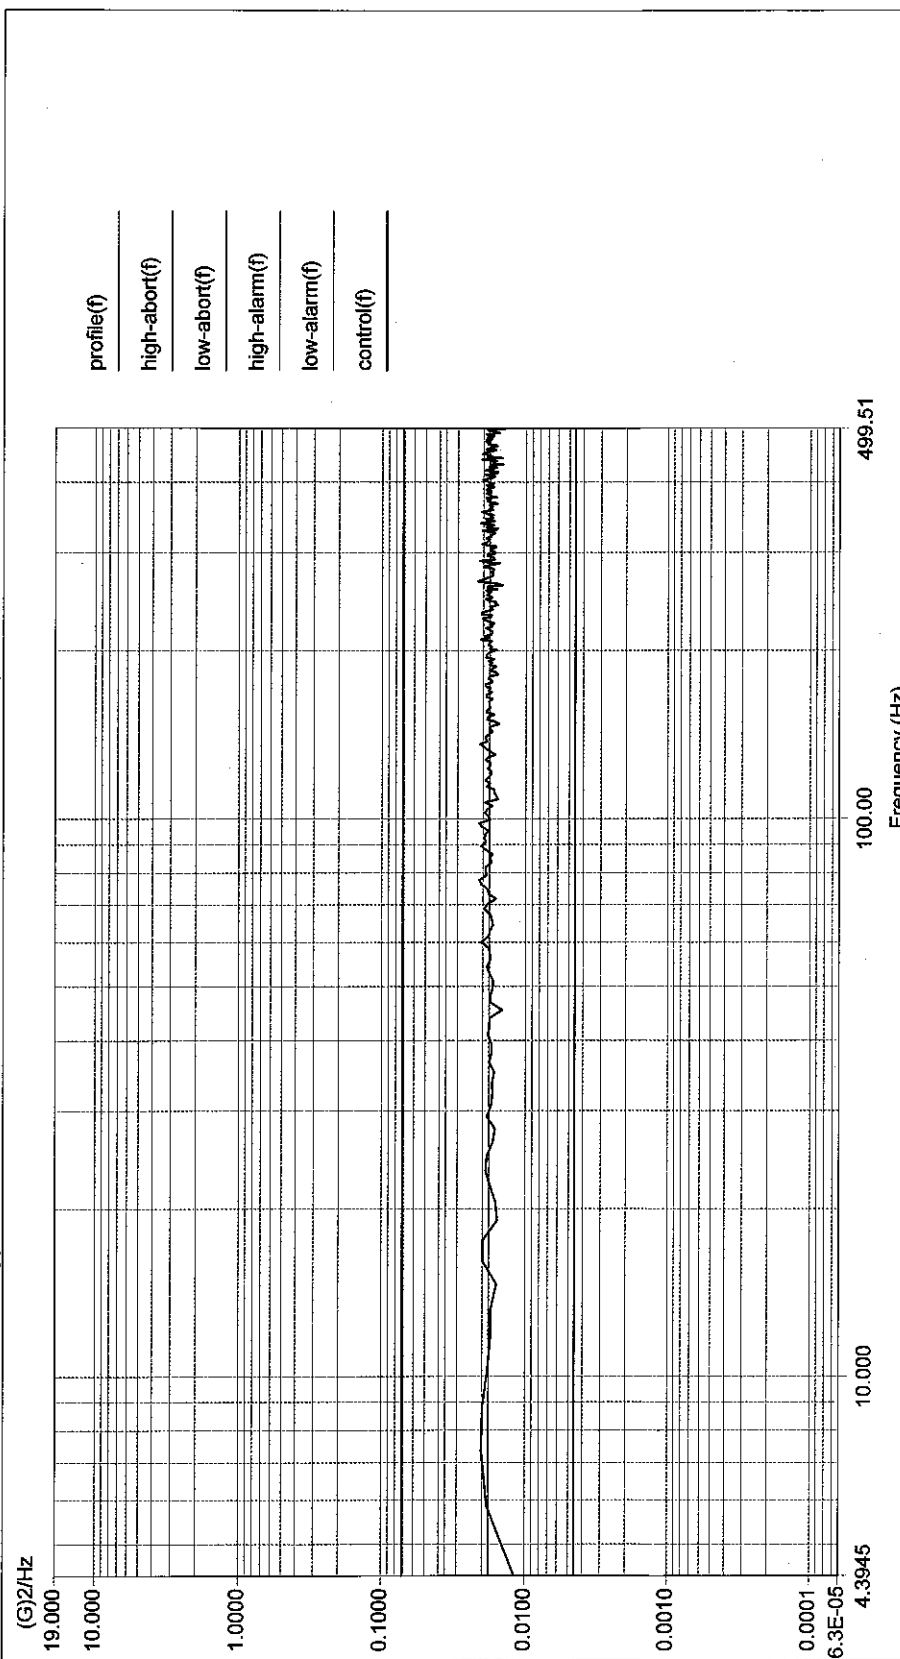
Y Axis

Control RMS: 2.998939 G Full Level Elapsed Time: 00:59:59 Lines: 450 Frame Time: 0.682667 Seconds

Demand RMS: 3.002646 G Remaining Time: 00:00:00 DOF: 154 dF: 1.464844 Hz

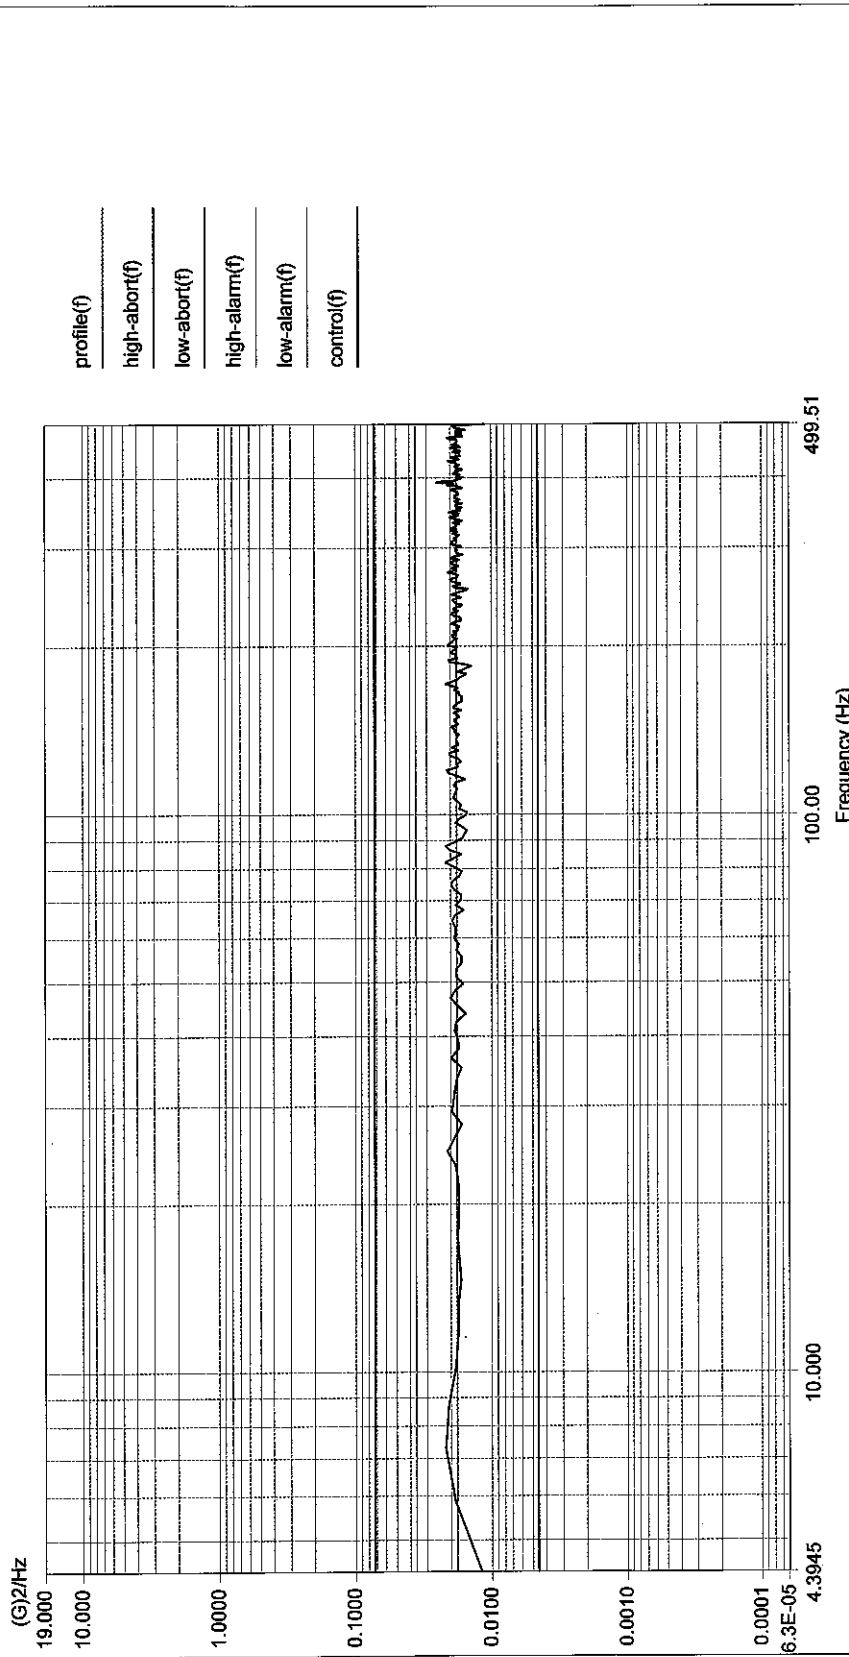
Z Axis

Control RMS: 3.009145 G Full Level Elapsed Time: 00:59:59 Lines: 450 Frame Time: 0.682667 Seconds
