FWS-7250

With 2.5" SATA HDD * 2

Vibration Test Report

Report NO: 14I030029

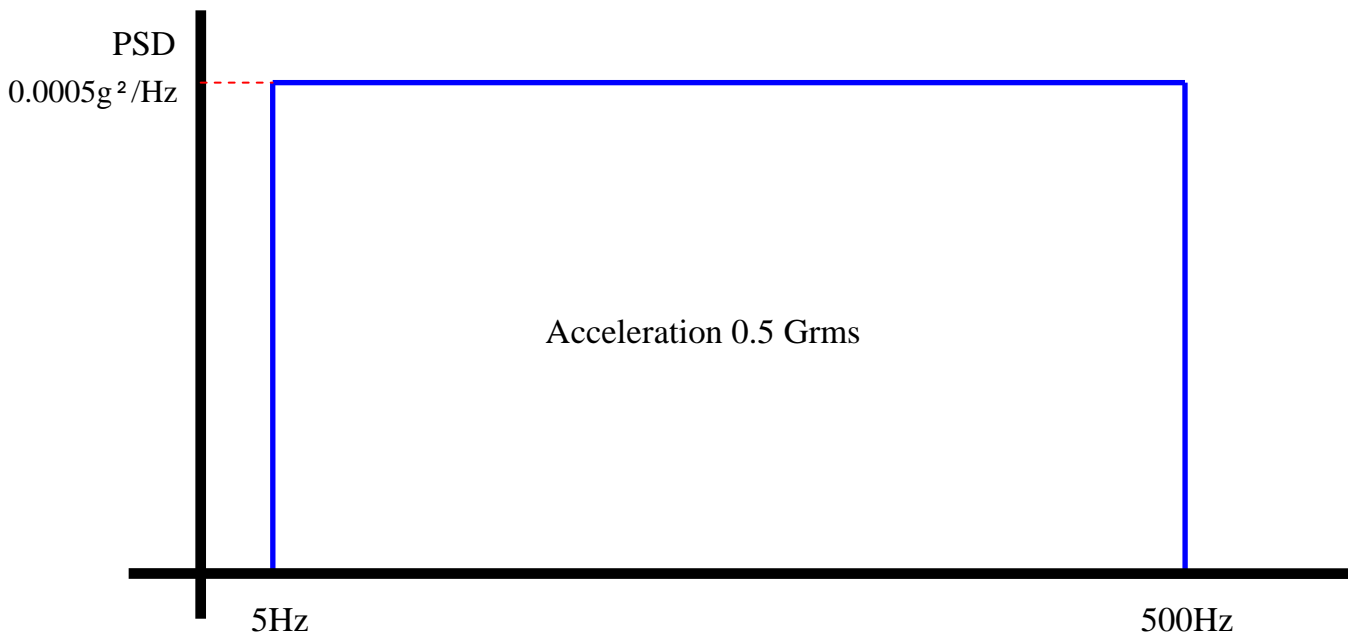
7. Test Vibration Curve:

1. Operation
2. Test Acceleration: 0.5 Grms Random
3. Test Frequency: 5-500Hz
4. Test Axis: X, Y, Z axes
5. Test Time: 60min each axis
6. Test Software: Windows 8 /

Run one Microsoft media player with BurnIn test 8.0 Pro simultaneously.

No structure deformation was found, and function was working normally.

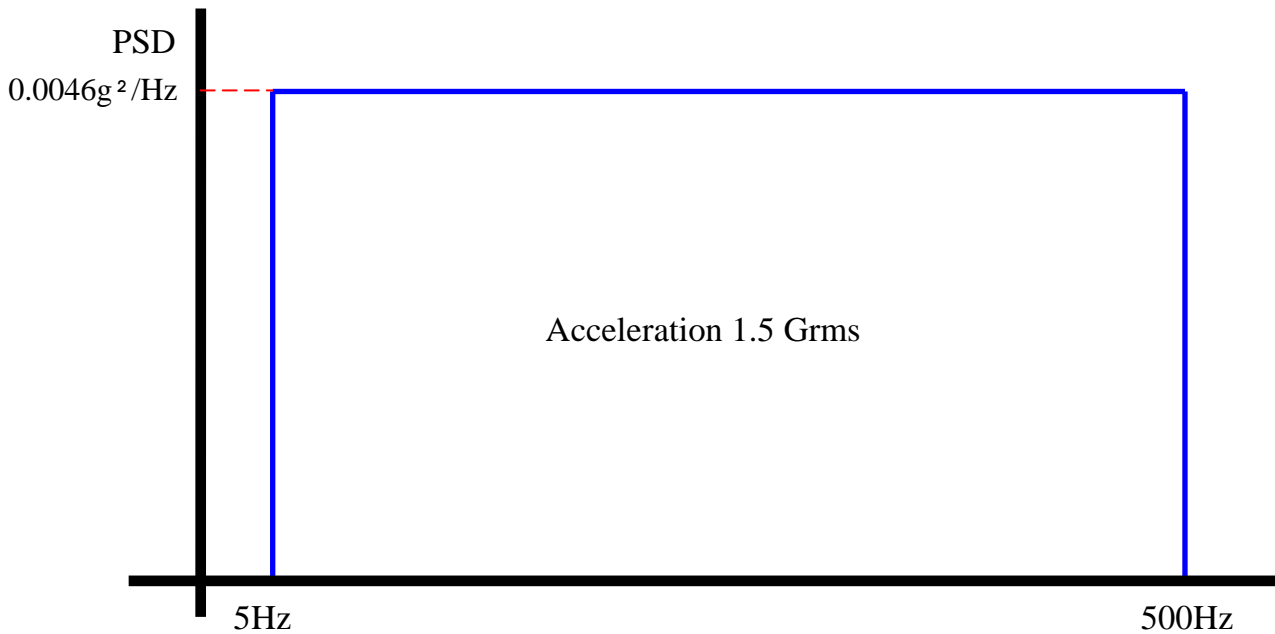
1. Non-operation
2. Test Acceleration: 1.5 Grms Random
3. Test Frequency: 5-500Hz
4. Test Axis: X, Y, Z axes
5. Test Time: 60min each axis
7. Test Vibration Curve:

No structure deformation was found, and function was working normally after vibration test.
