# **FWS-7350**

## **Vibration Test Report**

**Report NO: 14I030007**

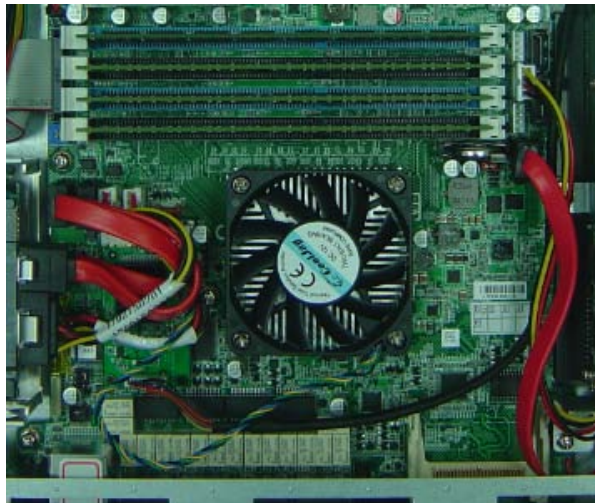
## CPU Cooler

Num	Item	Spec
<b>System:</b>		FWS-7350
1.	<b>Main Board:</b>	FWB-7350 A1.0
	1. BIOS:	FWS-7350 R0.B
	2. CPU	Intel Atom C2758 2.4GHz
	4. Memory	ADATA DDR3L 1600 8GX18
	5. 2.5" SATA HDD	TOSHIBA MQ01ABD032 2.5" 320GB
	6. Test Software:	Windows 7 / Run BurnIn test 7.0 Pro
2.	<b>Power Supply</b>	FSP100-50LG
