# Product Verification Report

Report No : 05I010010

Product Model	<b>AMC-250</b>
Product Description	<b>5 Slot Wall Mounting Chassis</b>
Test Reason	<input checked="" type="checkbox"/> New product <input checked="" type="checkbox"/> Case Model : AMC-250 <input checked="" type="checkbox"/> Backplane PCB Model & Version: BP-205SP-P4 REV: A1.0 <input checked="" type="checkbox"/> bundle Main board PCB Model & Version: HSB-811P REV: A0.1  <input type="checkbox"/> Renew product <input type="checkbox"/> PCB : <input type="checkbox"/> BIOS:  <input type="checkbox"/> Revision change <input type="checkbox"/> PCB : <input type="checkbox"/> BIOS:

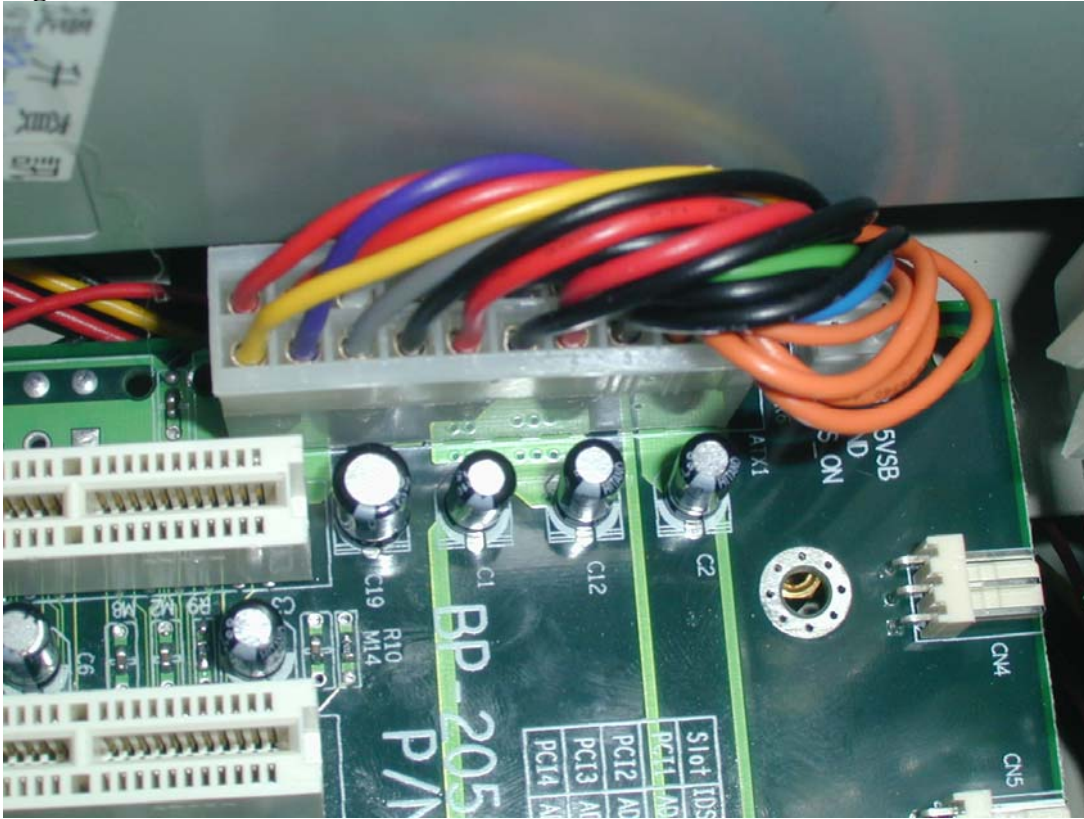
Fig 1

Result Summary
<b>Note<sup>1</sup></b> The distance is too close between Power connector and Floppy .It will be solved in new revision.Fig.1
<b>Note<sup>2</sup></b> Reset button conflict with the metal frame of the chassis .
