# OMNI-2155-SKU

with 2.5" SATA HDD

## Package Drop Test Report

Report No: 16P030020

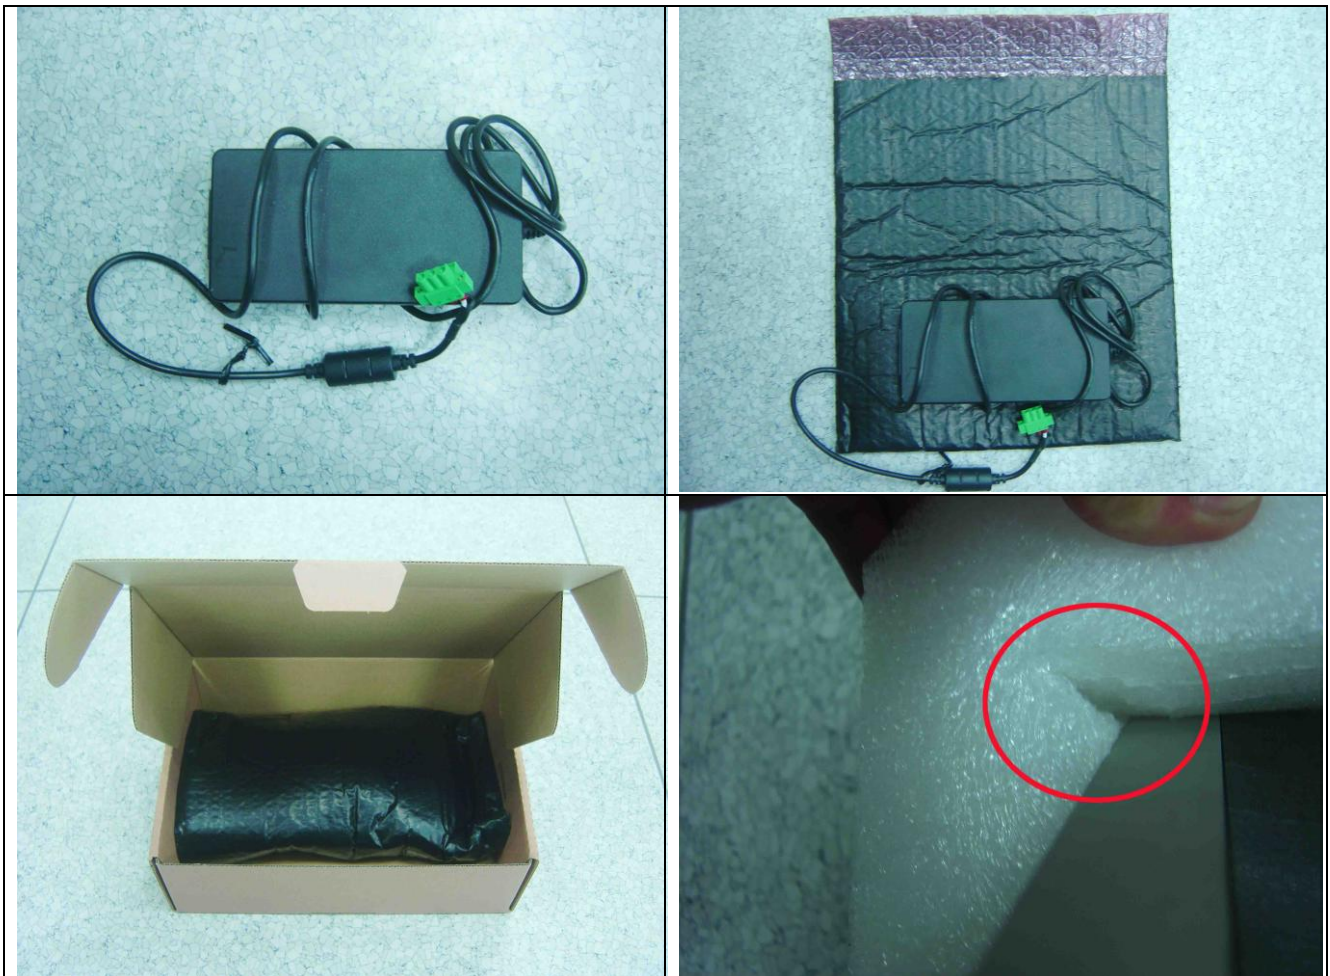
### After Test

Summary	<p><input type="checkbox"/> <b>Pass</b></p> <p><input type="checkbox"/> <b>Fail</b> Note : There is/are ___ defect(s) not list in the report, please check it in the DTS Website.</p> <p><input checked="" type="checkbox"/> <b>Pass with Deviation</b> <b>Comment:</b> The EPE had crack, but structure of EPE and system is OK</p>
---------	--

The EPE had crack, but the structure is OK, System no structure deformation and function was working normally after drop test.
