OMNI-5215-SKU

Supplier: PO KI PAPER CONTAINER. ,LTD / Carton size: 670(L)*200(W)*525(H) mm

Package Drop Test Report

Report NO: 17P030011

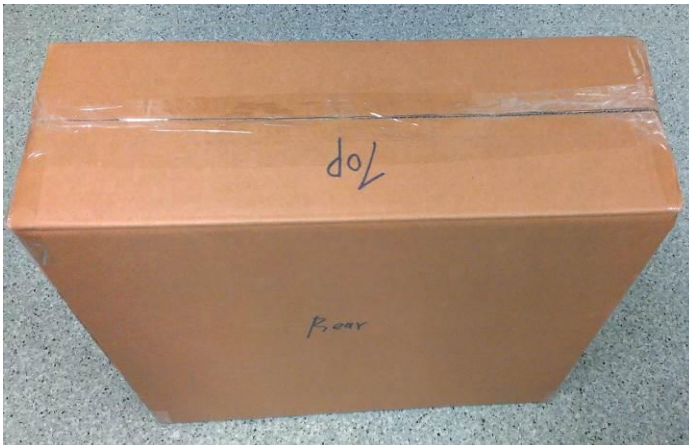
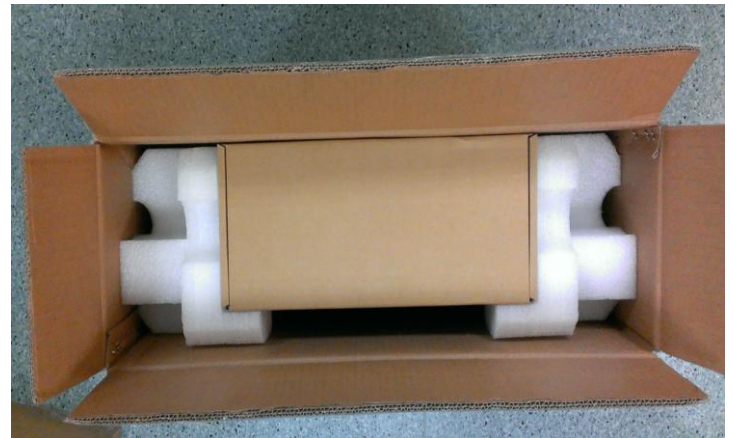
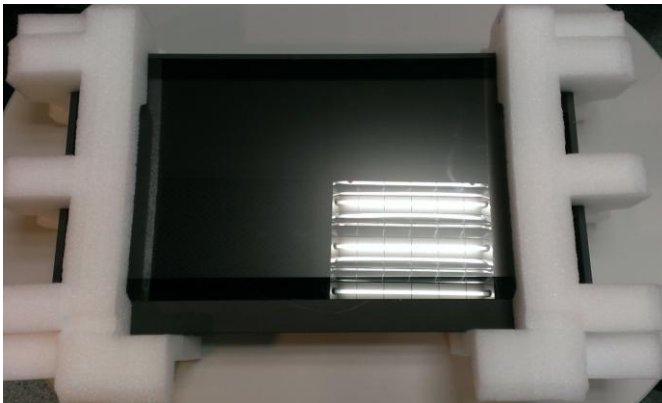
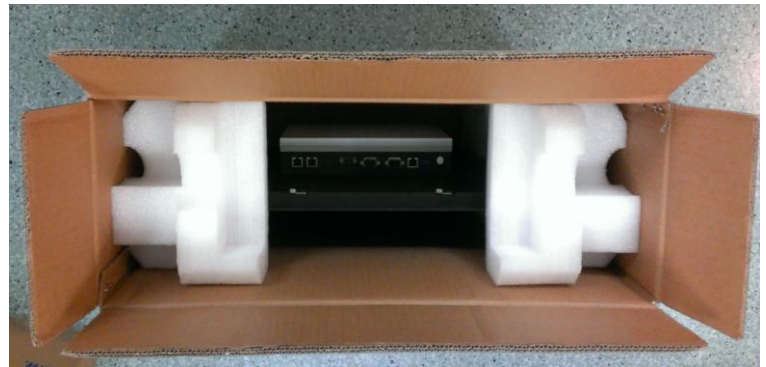
After Test

The EPE had crack, but the structure is OK, System no structure deformation and function was working normally after drop test.

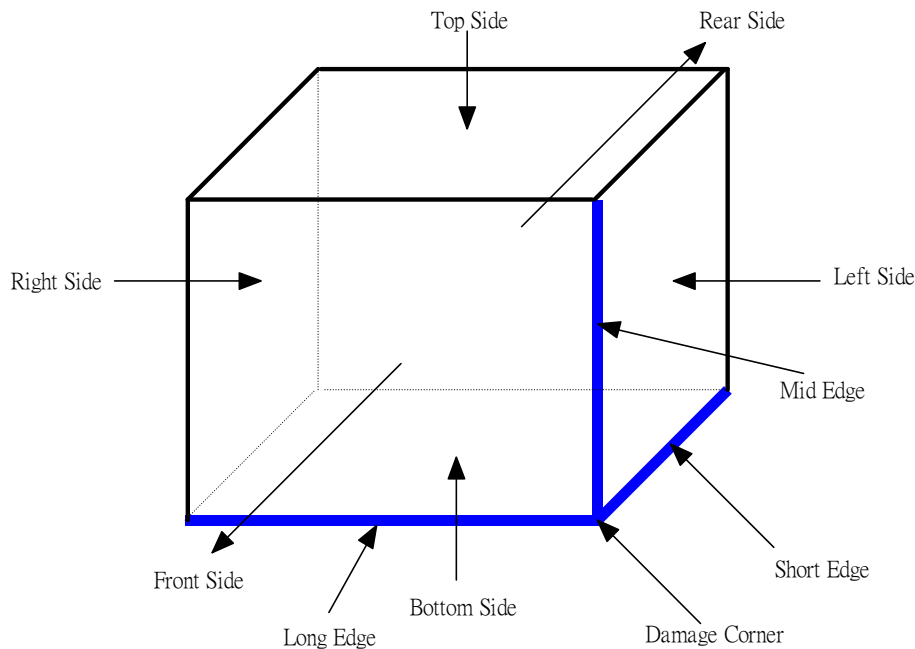
1. Test Phase: One corner. Three edges. Six face
2. Test Cycle: 1 Cycle
3. Test Height: 76cm
4. Test Weight: 9.1Kg
5. Sample Package: 1unit in single-package.
6. Test Drawing:
