# Test item list

# Package Drop Test

**Test Product:** VPC-5600S

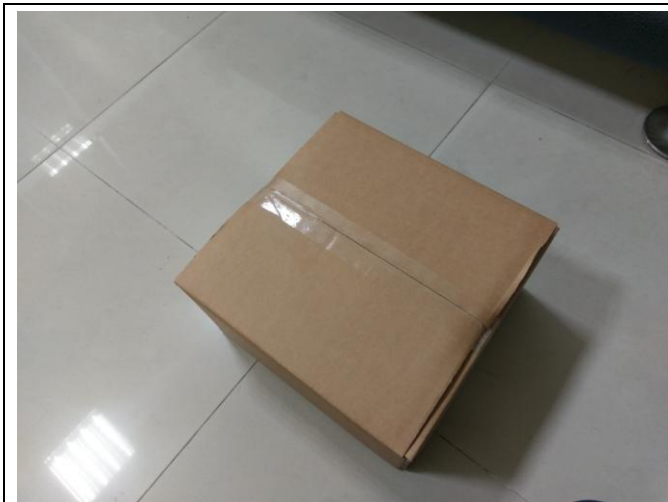
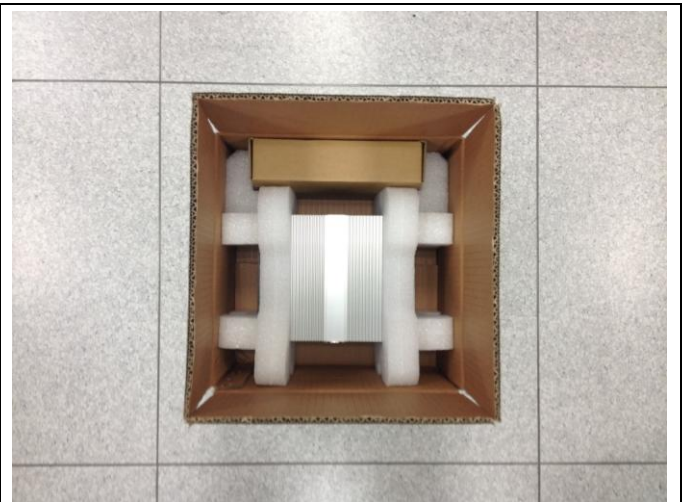
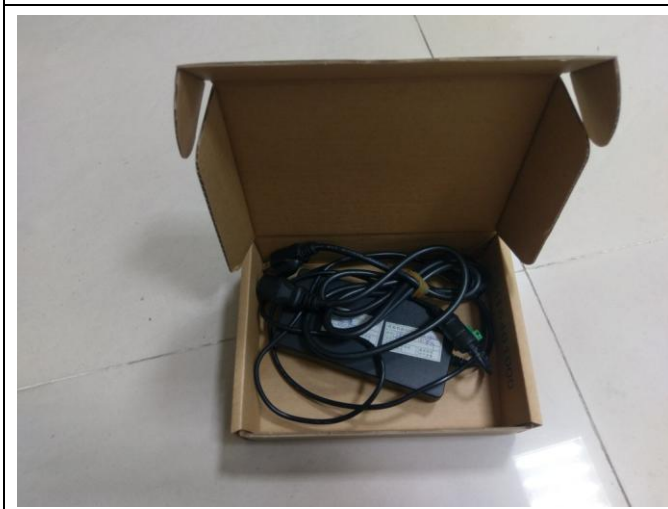
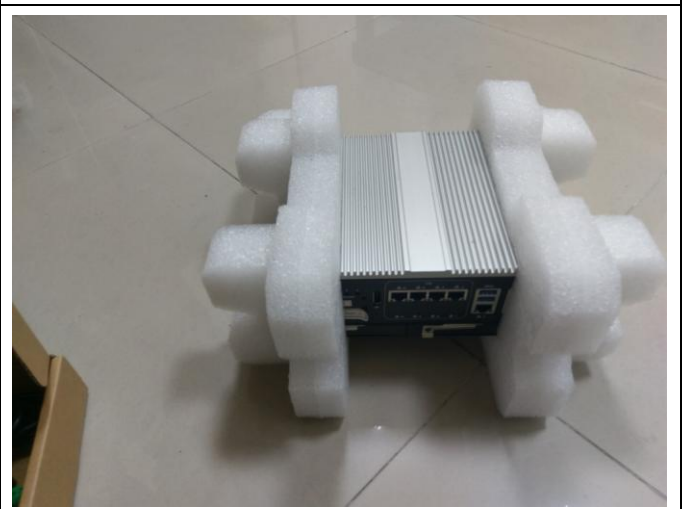
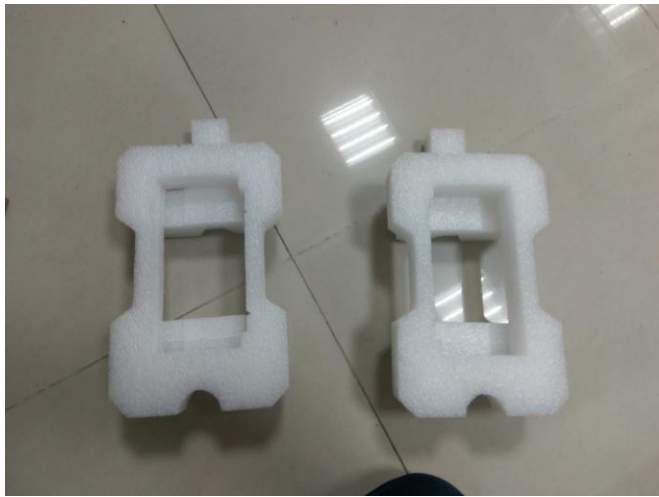
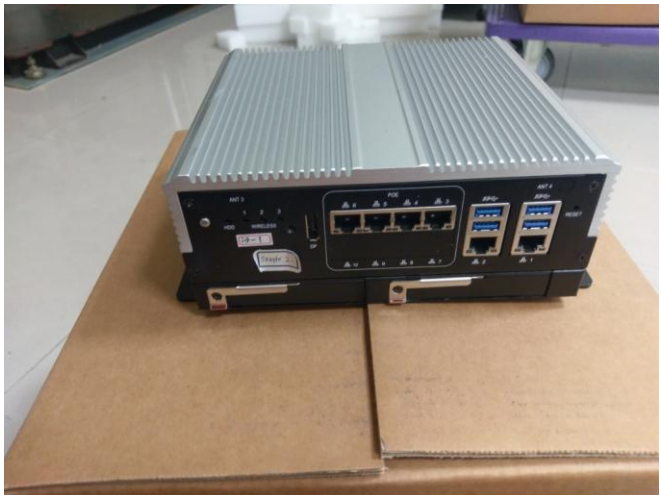
### After Test

The packaging is not broken, main board no structure deformation and function was working normally after the drop test.

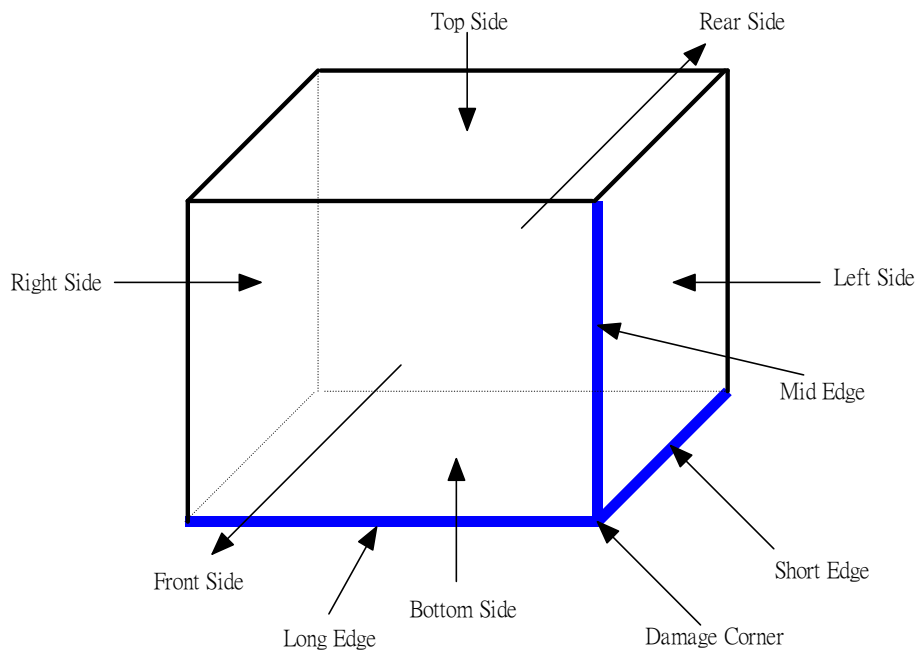
1. Test Phase: One corner. Three edges. Six face
2. Test Cycle: 1 Cycle
3. Test Height: 76cm
4. Test Weight: 4.9Kg
5. Sample Package: 1unit in single-package.
6. Test Drawing:
