TESTING / INSPECTION REPORT

REPORT NO : DT-001220-1

COMPANY : AAEON Technology Inc.

TEST / INSPECTION ITEMS : Drop Test (See Page 2)

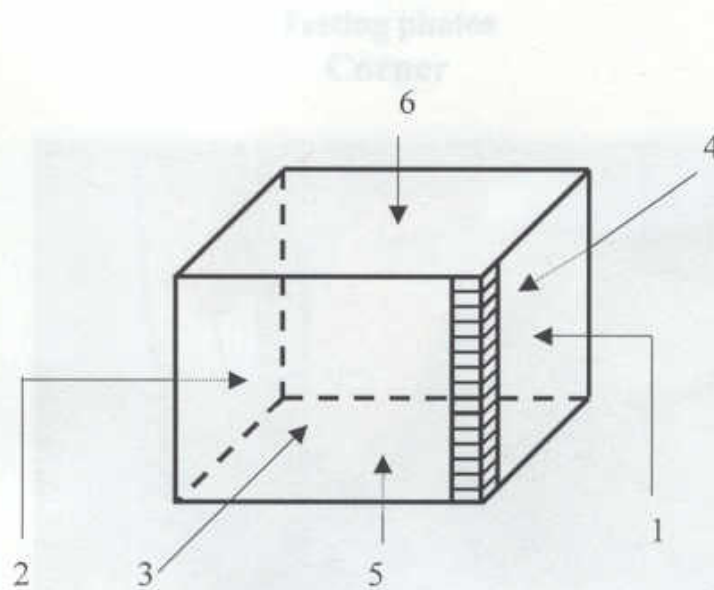
1	The 1-3-5 Corner	Corner
2	The shortest edge radiating from that corner	Edge
3	The next longest edge radiating from that corner	Edge
4	The longest edge radiating from that corner	Edge
5	Flat on one of the smallest faces	Flat
6	Flat on one of the opposite small faces	Flat
7	Flat on one of the medium faces	Flat
8	Flat on one of the opposite medium faces	Flat
9	Flat on one of the largest faces	Flat
10	Flat on one of the opposite largest faces	Flat

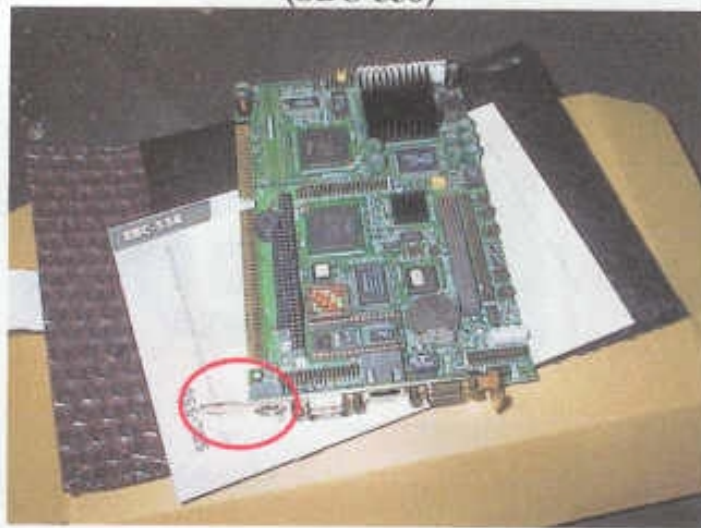
(SBC-558)

Appearance
Full-Size CPU Card	No damage
Half-Size CPU Card	Damage (See page 12~13)
Compact Board	No damage
PC/104	No damage
Media PC	No damage

Testing photos Damage

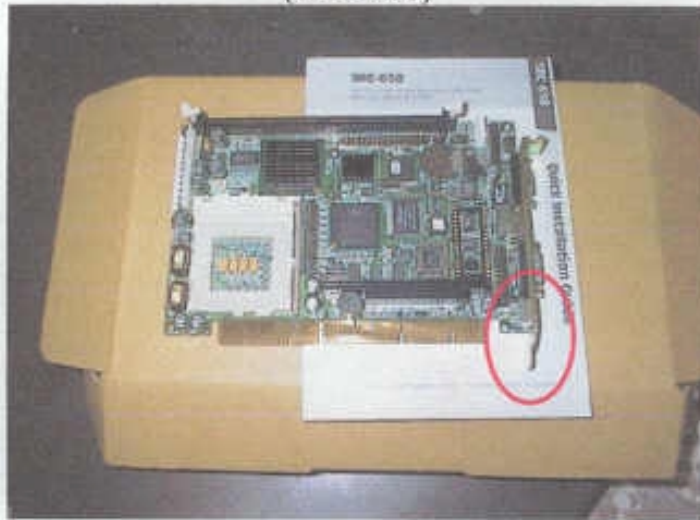
(SBC-658)

Testing photos Damage
