TESTING / INSPECTION REPORT

DATE : July 17, 2000
REPORT NO : DT-000717-5

SPECIMEN : Control Boxes & Chassis

TEST / INSPECTION ITEMS : Drop Test (See Page 2)

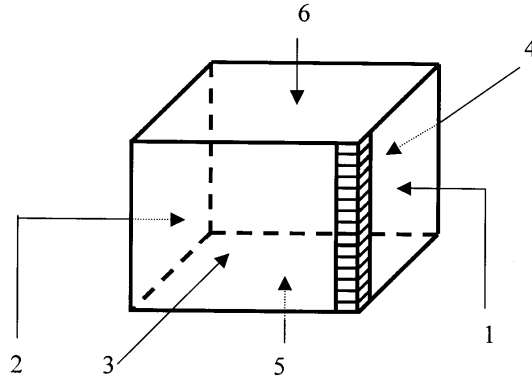
| 1 | The 1-3-5 Corner | Corner |
| 2 | The shortest edge radiating from that corner | Edge |
| 3 | The next longest edge radiating from that corner | Edge |
| 4 | The longest edge radiating from that corner | Edge |
| 5 | Flat on one of the smallest faces | Flat |
| 6 | Flat on one of the opposite small faces | Flat |
| 7 | Flat on one of the medium faces | Flat |
| 8 | Flat on one of the opposite medium faces | Flat |
| 9 | Flat on one of the largest faces | Flat |
| 10 | Flat on one of the opposite largest faces | Flat |
