TESTING / INSPECTION REPORT

REPORT NO : ST-110629-1

SPECIMEN : AGD-317D

TEST / INSPECTION ITEMS : Shock Test

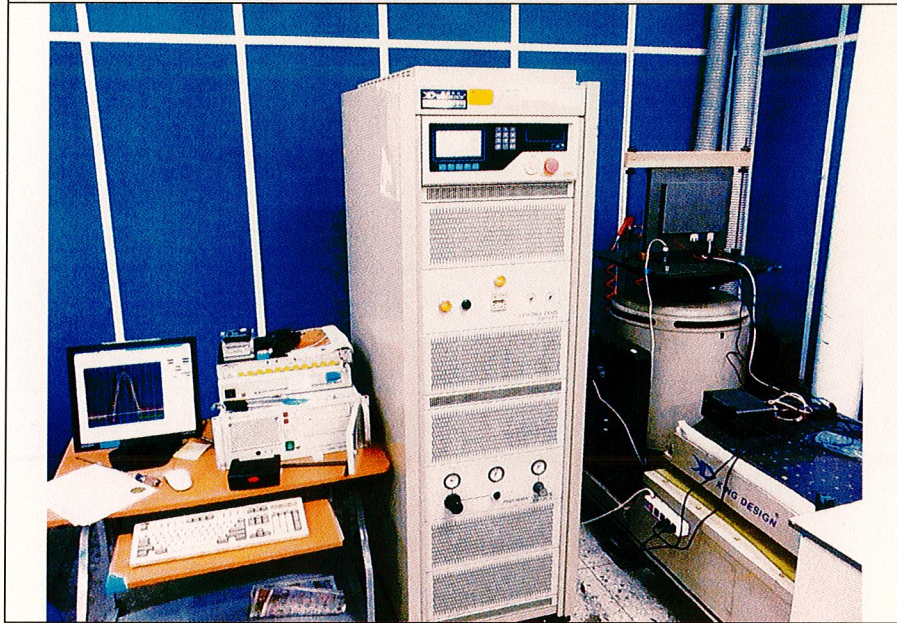
Before test

Testing photos (Operating)

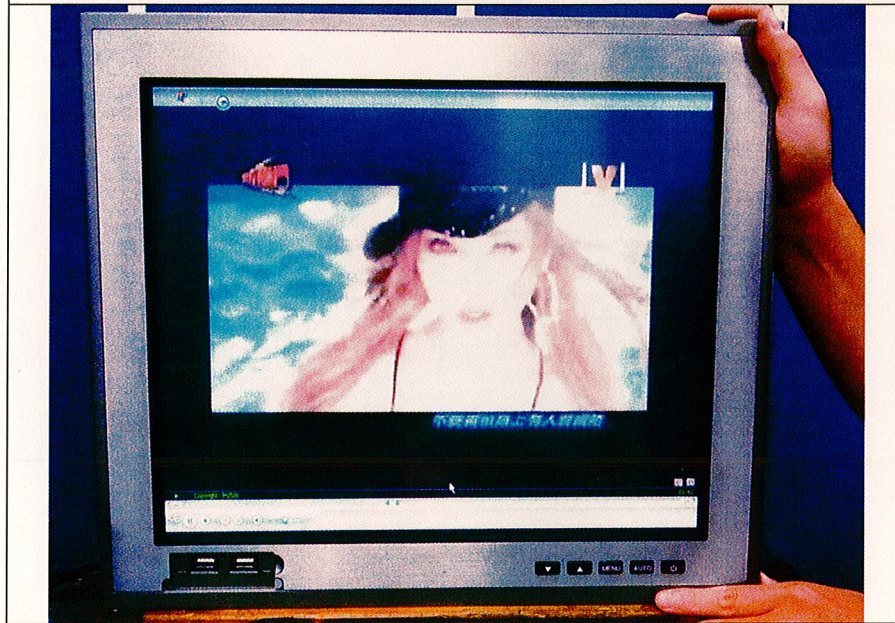
After test

Describe	PASS	FAIL	Non-Judgment
Function judgment ⁽¹⁾	√	---	---
Appearance check ⁽²⁾	√	---	---
(1)—Booting function was normal after the test. (2)—No visible damages were found.

Testing photos

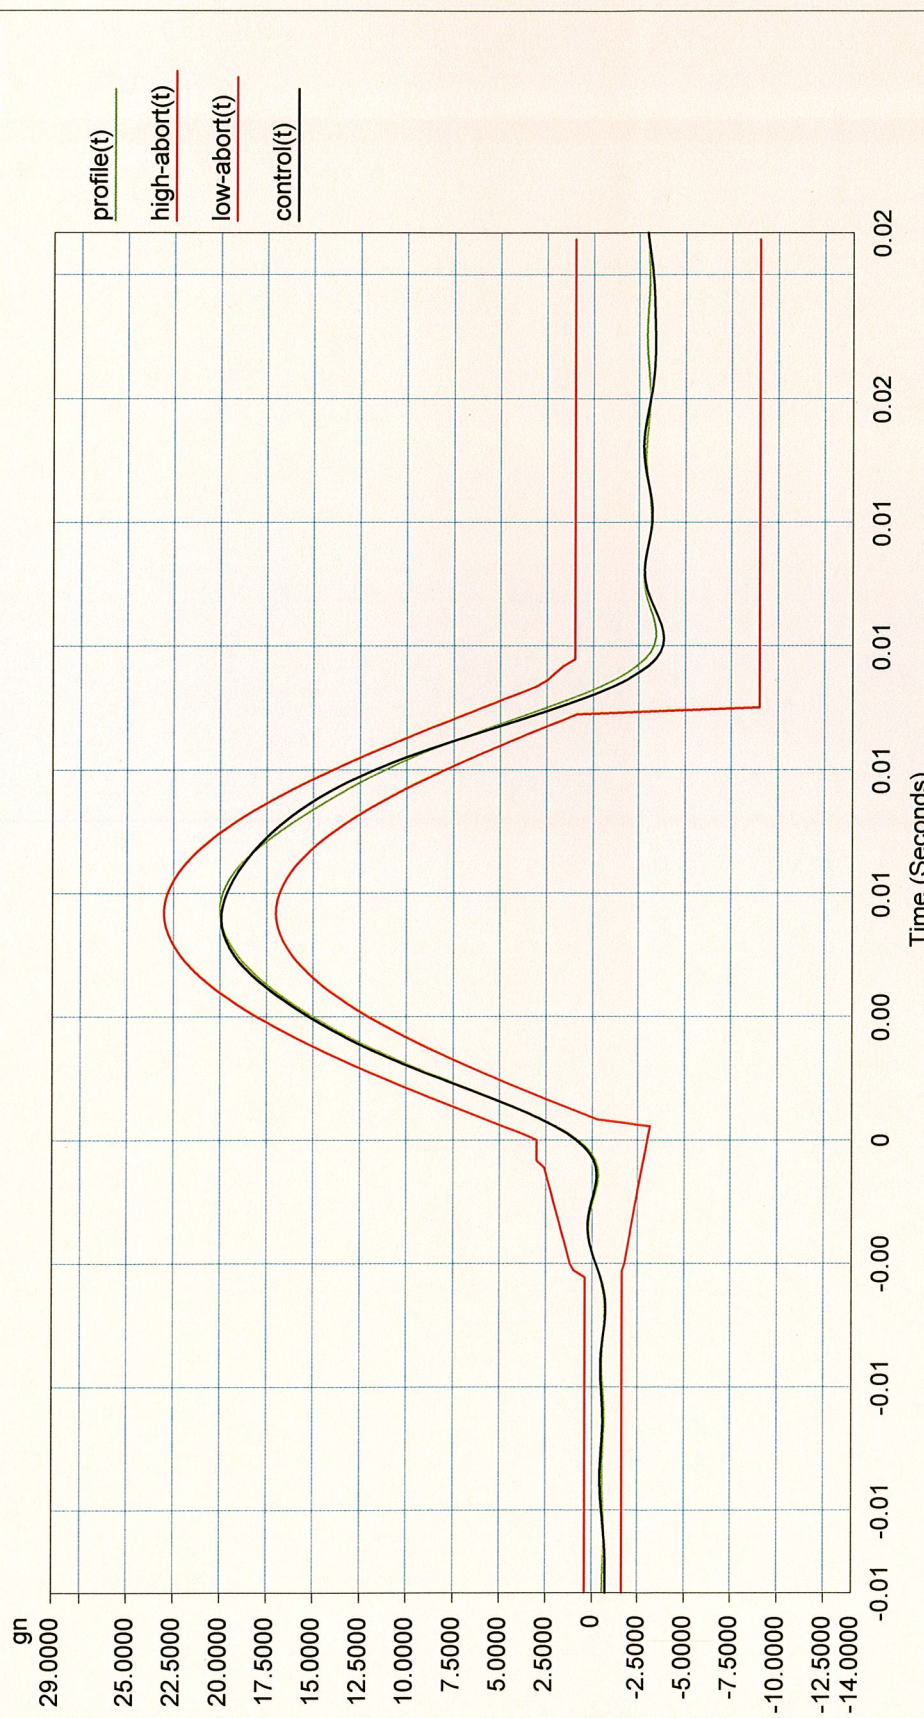
-Y Axis

Profile Name: 20gn 11mSec Test Type: Classical Shock Run Folder: .\RunDefault Jun 29, 2011 11-39-45

Level: 100 % Block Size: 4096 Elapsed Pulses: 12
 Frame Time: 0.682667 Seconds Control Peak: 19.946024 Control RMS: 2.097013 Full Level Elapsed Pulses: 3
 dT: 0.000167 Seconds Demand Peak: 20.000000 Demand RMS: 2.048354 Remaining Pulses: 0
 Pulse Type: Half Sine Amplitude: 20.000000 Pulse Width: 11.000000 ms
