TESTING / INSPECTION REPORT

REPORT NO : ST-150701-1

SPECIMEN : BOXER-6404 (With CFast)

TEST / INSPECTION ITEMS : Shock Test

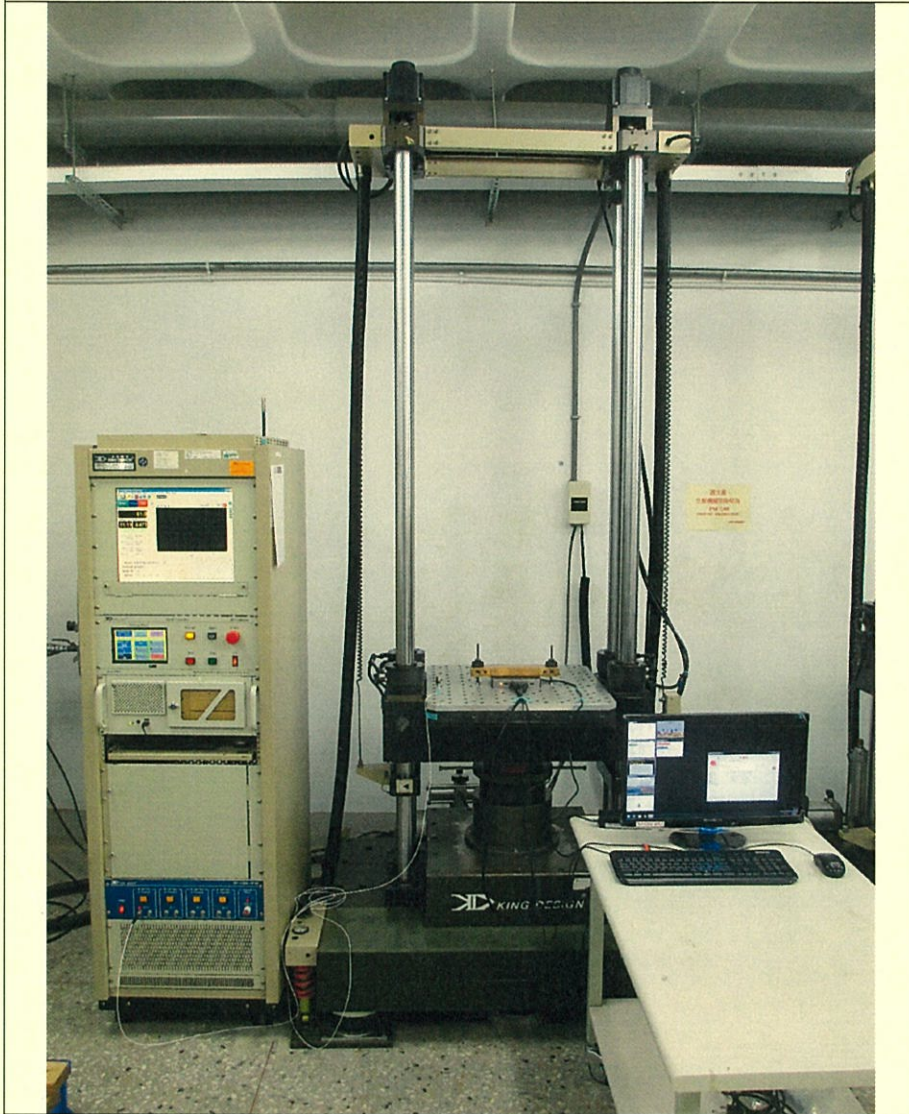
Testing photos

Tester

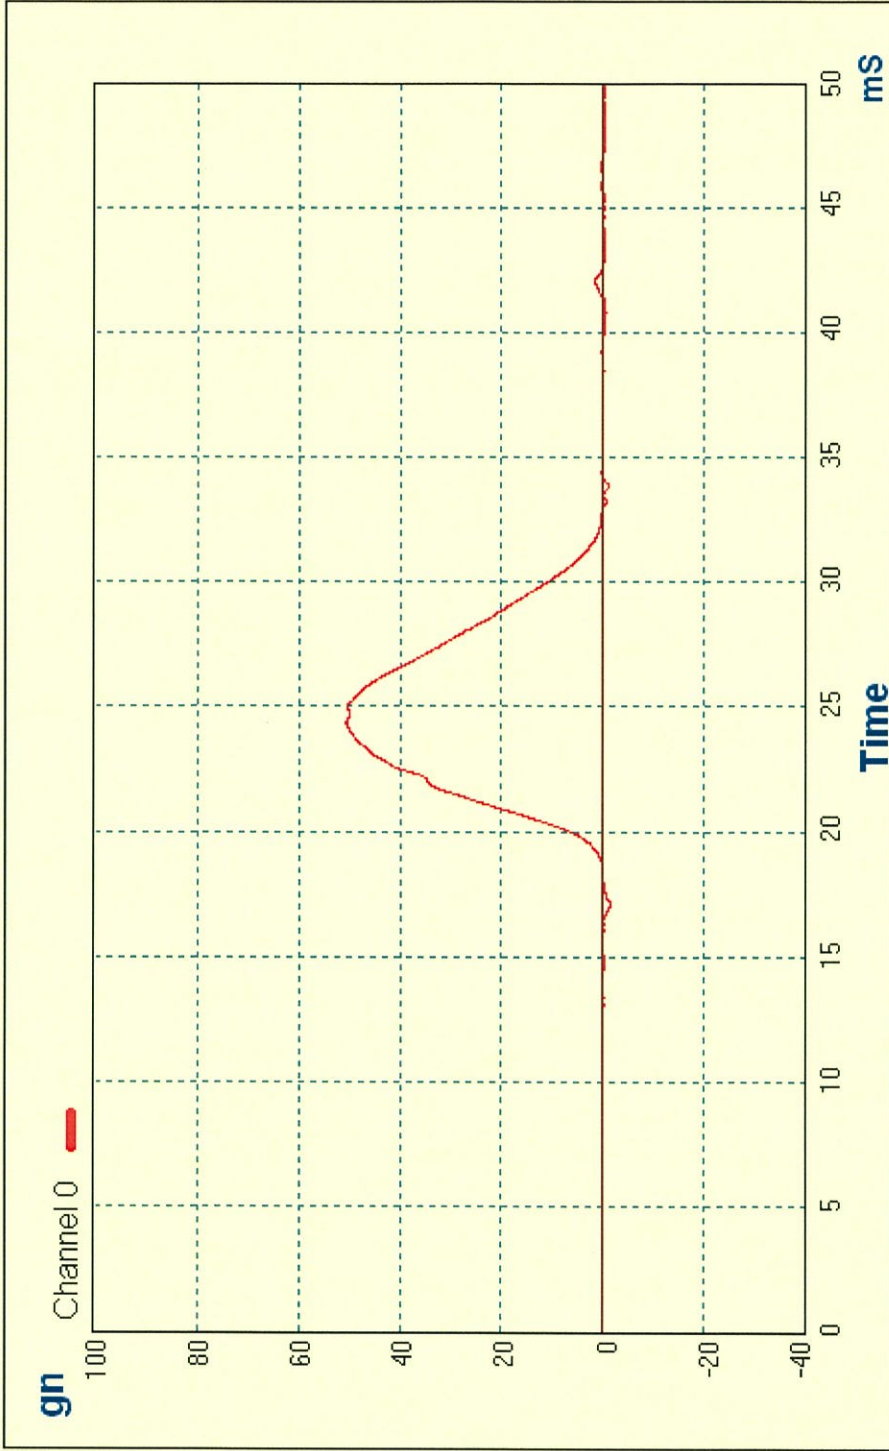
COMPANY : King Design Industrial Co., Ltd. MODEL : Au-Table S/N : A973L716
SHOCK TEST SPECIFICATION : 50 g 11 ms HEIGHT : 225 mm CYCLE OF TEST : 3/3
Testing at : 2015-6-30 下午 03-36-07 07 Data saved at : 2015-6-30 下午 03-36-07 07

Acceleration(gn)	Duration time(ms)	Velocity(m/sec)	Filter(Hz)
+X axis (Ch 0)	50.69	11.06	3.441	500

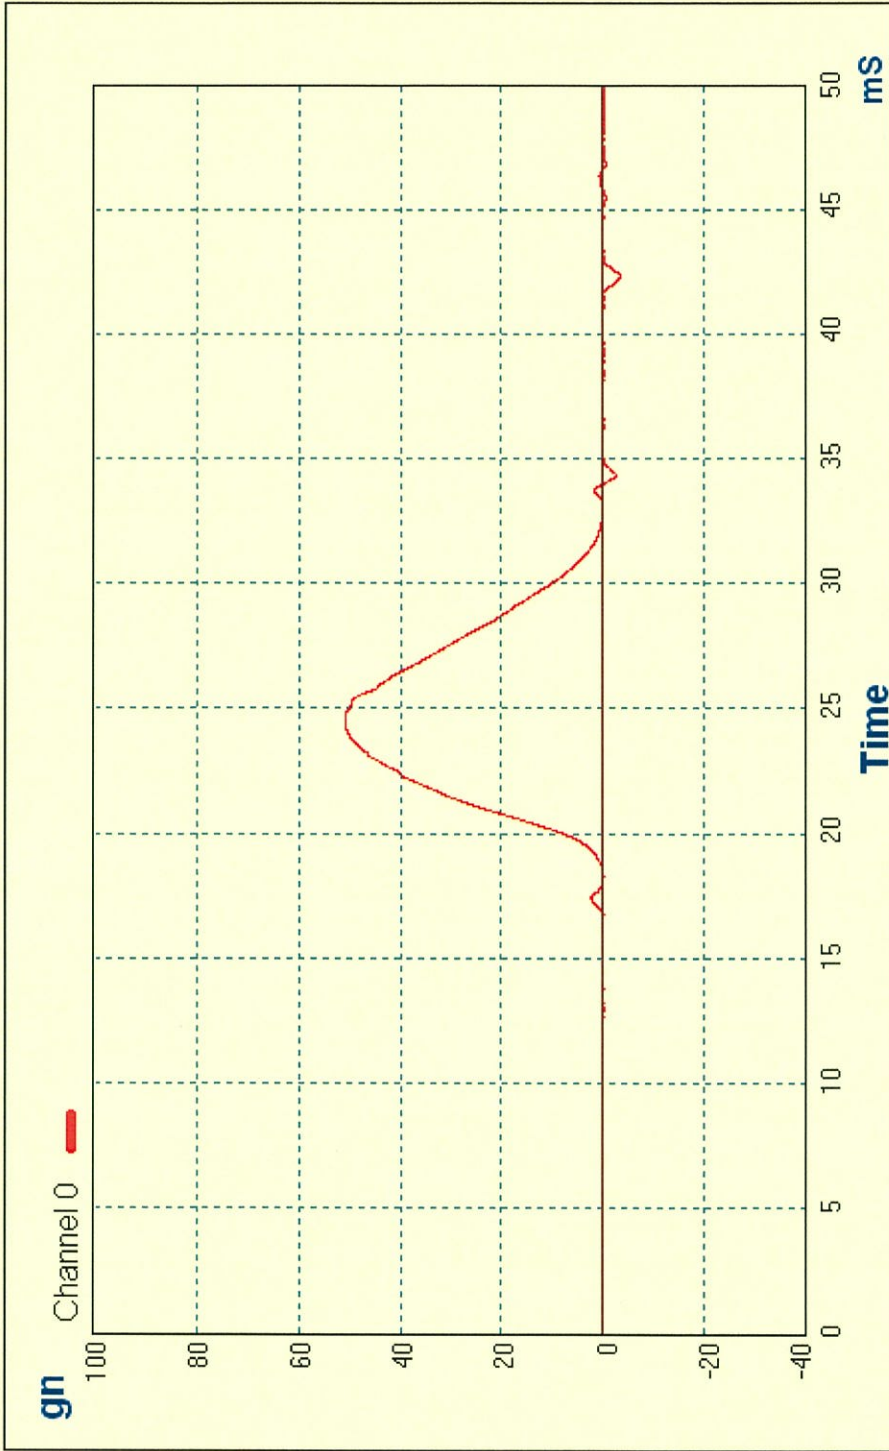
COMPANY : King Design Industrial Co., Ltd. MODEL : Au-Table S/N : A973L716
SHOCK TEST SPECIFICATION : 50 g 11 ms HEIGHT : 225 mm CYCLE OF TEST : 3/3
Testing at : 2015-6-30 下午 03-41-43 43 Data saved at : 2015-6-30 下午 03-41-43 43

Acceleration(gn)	Duration time(ms)	Velocity(m/sec)	Filter(Hz)
-X axis (Ch 0)	50.97	11.09	3.447	500

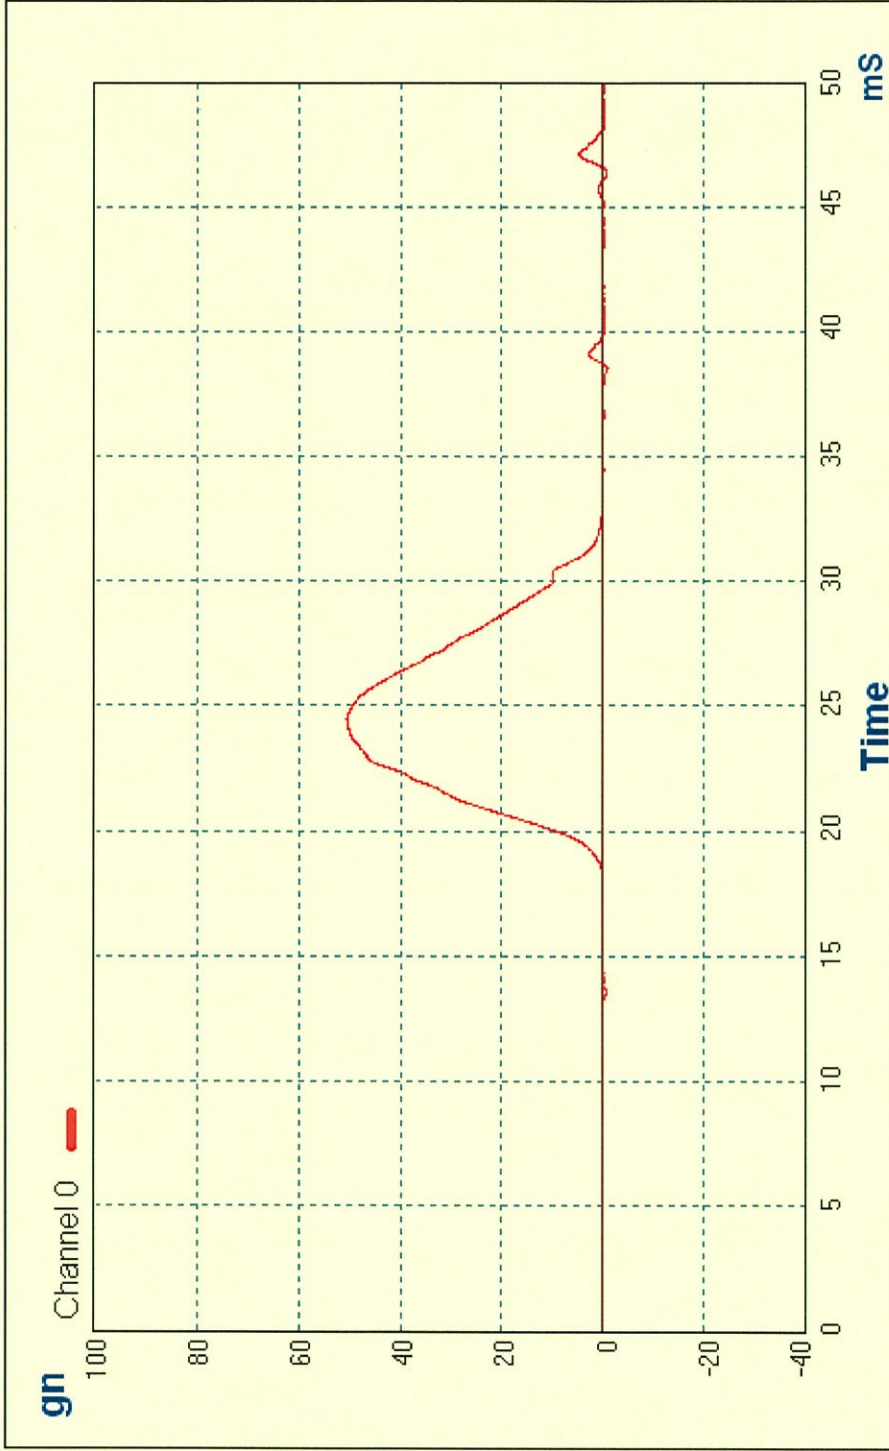
COMPANY : King Design Industrial Co., Ltd. MODEL : Au-Table S/N : A973L716
SHOCK TEST SPECIFICATION : 50 g 11 mS HEIGHT : 225 mm CYCLE OF TEST : 3/3
Testing at : 2015-6-30 下午 03-51-23 23 Data saved at : 2015-6-30 下午 03-51-24 24

Acceleration(gn)	Duration time(ms)	Velocity(m/sec)	Filter(Hz)
+Y axis (Ch 0)	50.65	11.09	3.434	500

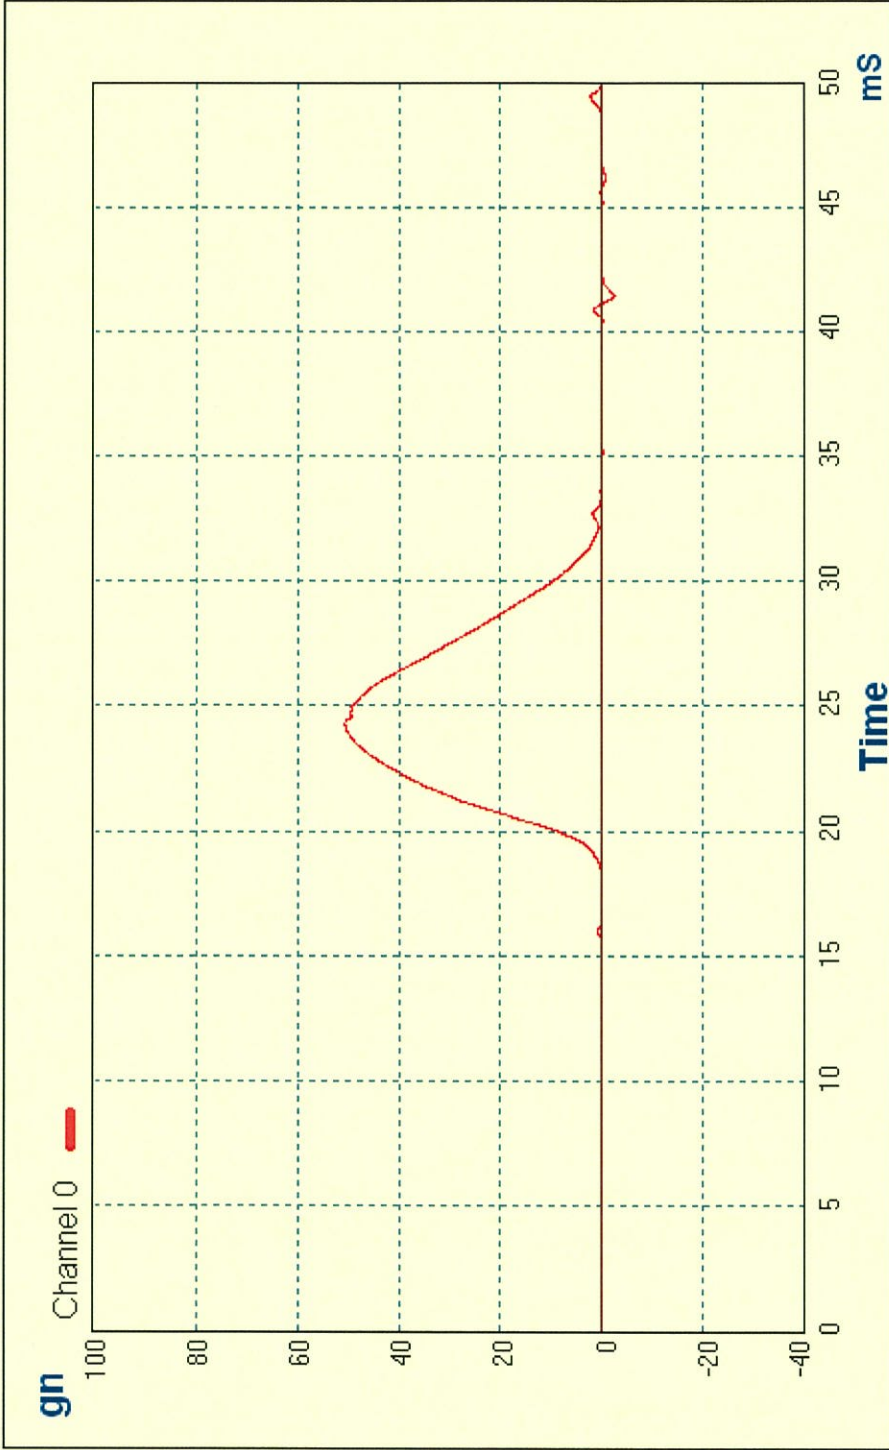
COMPANY : King Design Industrial Co., Ltd. MODEL : Au-Table S/N : A973L716
SHOCK TEST SPECIFICATION : 50 g 11 ms HEIGHT : 225 mm CYCLE OF TEST : 3/3
Testing at : 2015-6-30 下午 03-56-02 02 Data saved at : 2015-6-30 下午 03-56-03 03

Acceleration(gn)	Duration time(ms)	Velocity(m/sec)	Filter(Hz)
-Y axis (Ch 0)	50.69	11.17	3.437	500

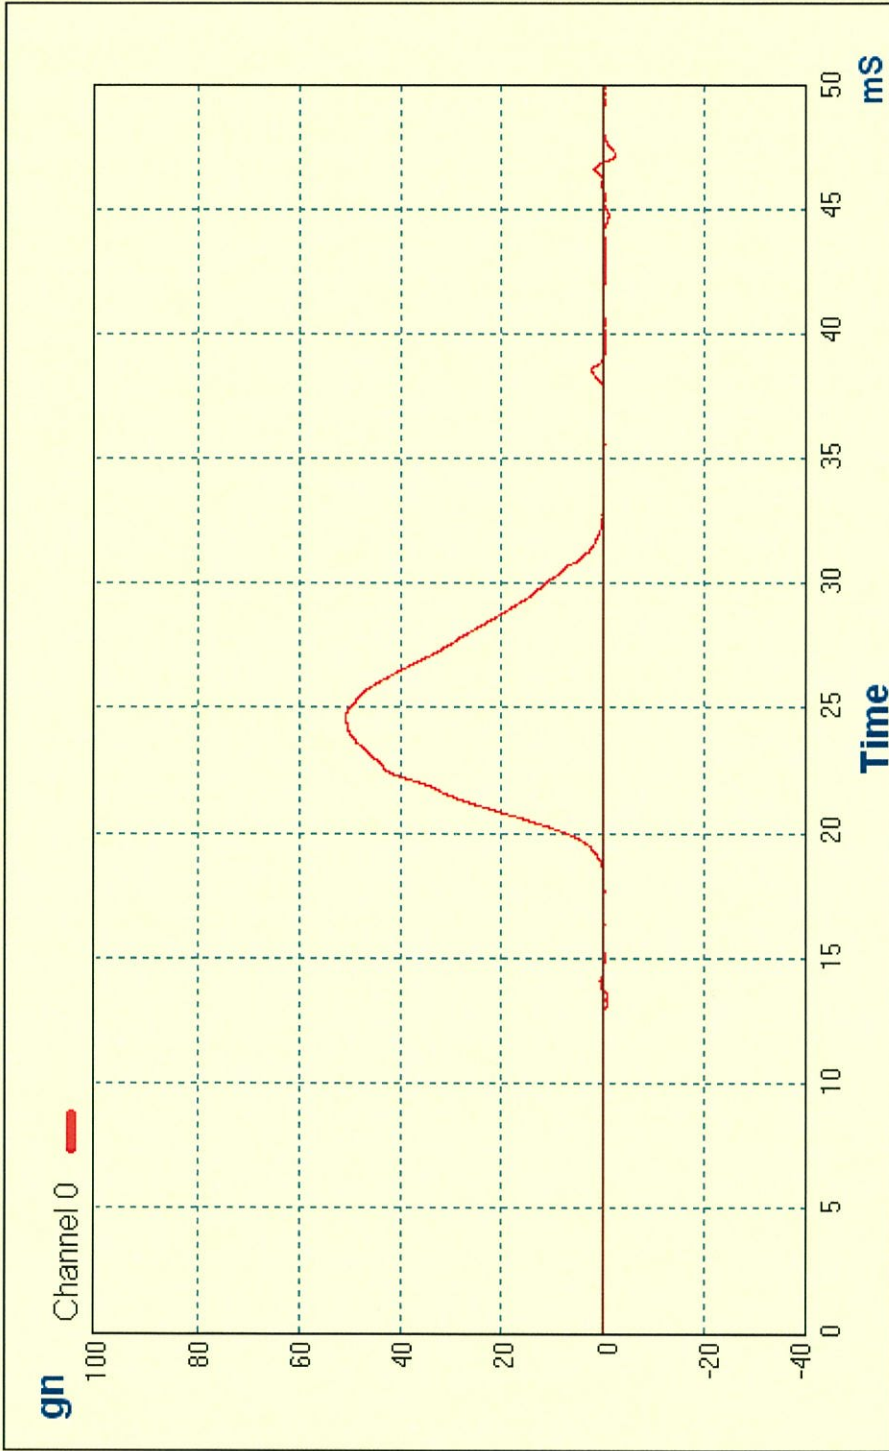
COMPANY : King Design Industrial Co., Ltd. MODEL : Au-Table S/N : A973L716
SHOCK TEST SPECIFICATION : 50 g 11 ms HEIGHT : 225 mm CYCLE OF TEST : 3/3
Testing at : 2015-6-30 下午 03-59-00 00 Data saved at : 2015-6-30 下午 03-59-01 01

Acceleration(gn)	Duration time(ms)	Velocity(m/sec)	Filter(Hz)
+Z axis (Ch 0)	50.80	11.15	3.463	500

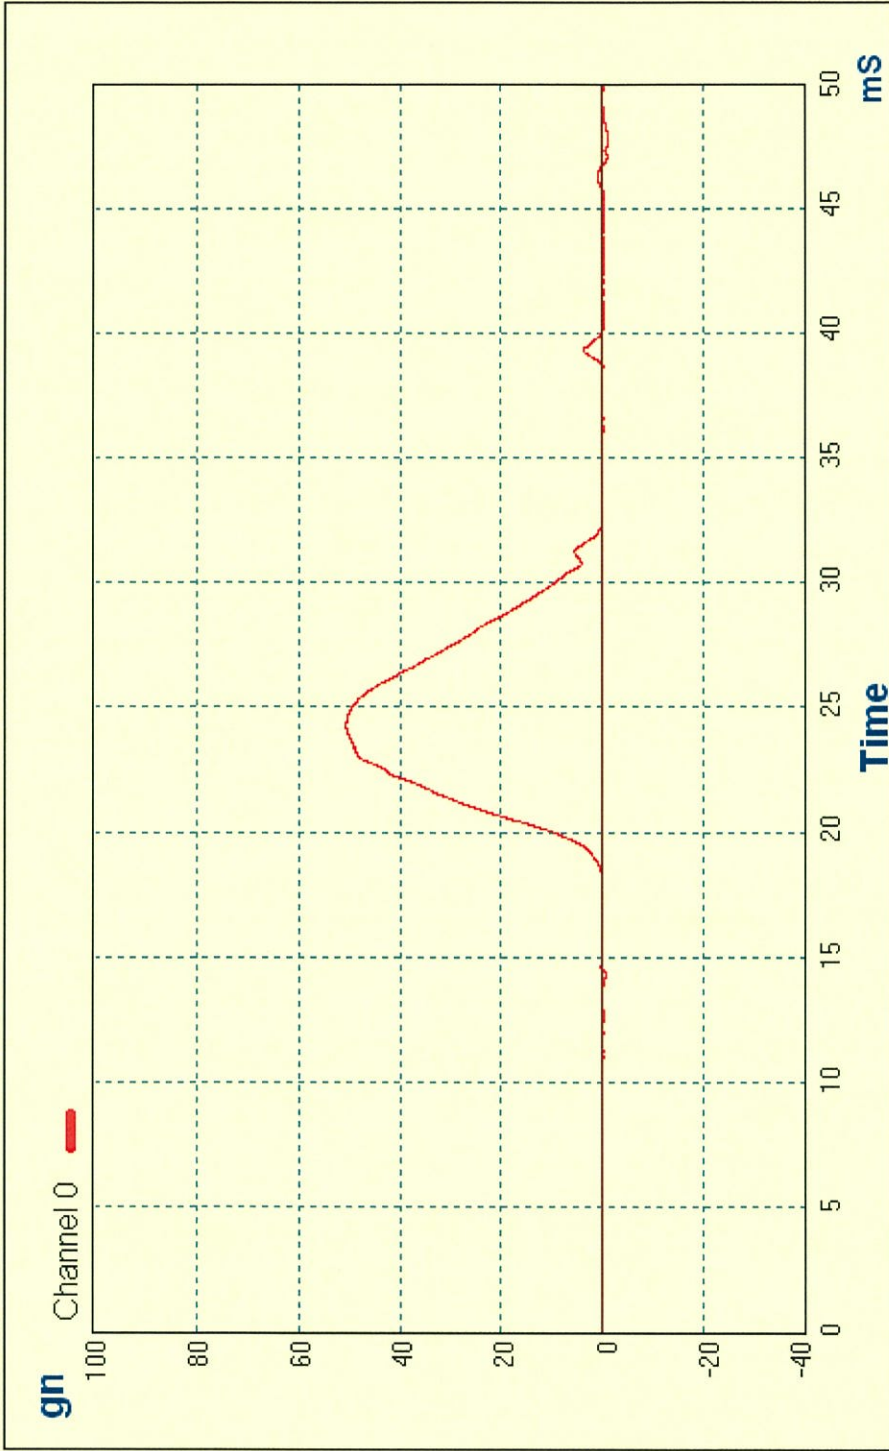
COMPANY : King Design Industrial Co., Ltd. MODEL : Au-Table S/N : A973L716
SHOCK TEST SPECIFICATION : 50 g 11 ms HEIGHT : 225 mm CYCLE OF TEST : 3/3
Testing at : 2015-6-30 下午 04-06-06 06 Data saved at : 2015-6-30 下午 04-06-06 06

Acceleration(gn)	Duration time(ms)	Velocity(m/sec)	Filter(Hz)
-Z axis (Ch 0)	50.89	11.02	3.505	500
